Forensic Evaluation of Cracking in Panels Adjacent to Panel Replacements on Interstate 5 in Washington State

Linda M. Pierce,¹ Jeff S. Uhlmeyer,² Jim Weston,³ and Keith W. Anderson⁴

ABSTRACT

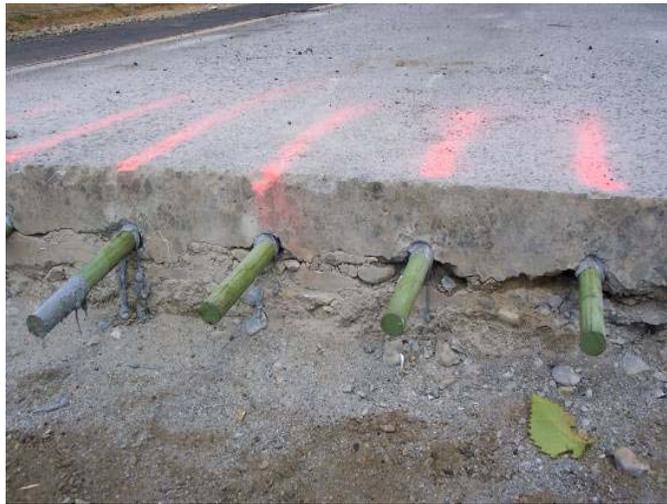
- During dowel bar drilling, spalling and cracking (Figure 10) between drilled holes occurred. The result of the cracking was a reduction in the concrete pavement structural section. In some instances, the contractor was instructed to delete dowel bars to avoid placement within the cracked or spalled area.
- During concrete placement, the contractor needed multiple reminders to correctly set the grade for aggregate base that was placed too high or too low.

Figure 10. Cracking and spalling after dowel bar drilling.

Drilling Operations. If excessive spalling occurs during dowel bar installation, the panel replacement limits should be extended to sound concrete.

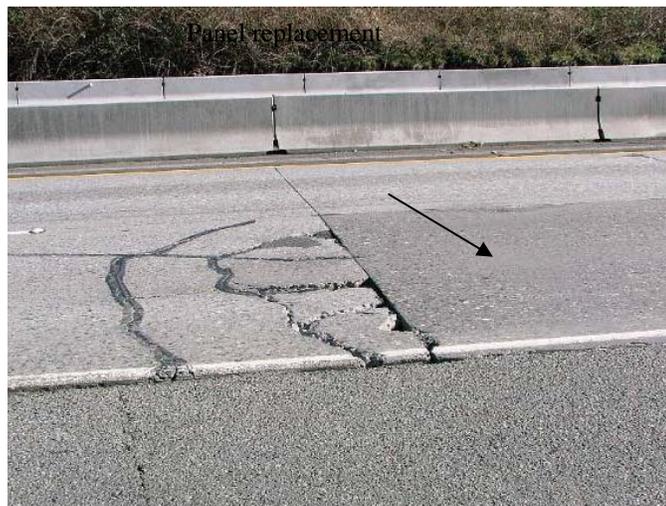
Within 2 weeks of project completion, severe panel cracking was observed in the concrete panels adjacent to the panel replacements. Within 5 months of project completion, WSDOT Maintenance forces were required to conduct temporary panel repairs at six locations of severely distressed panels (Figure 12). For the temporary fixes, maintenance forces chipped out the distressed concrete (sawcutting, inserting dowel or tie bars, and base preparation were not conducted) and backfilled using Five Star Hwy Patch. The total number of panels requiring temporary repairs increased to 16 by early 2007.

Figure 12. Severely distressed panel.

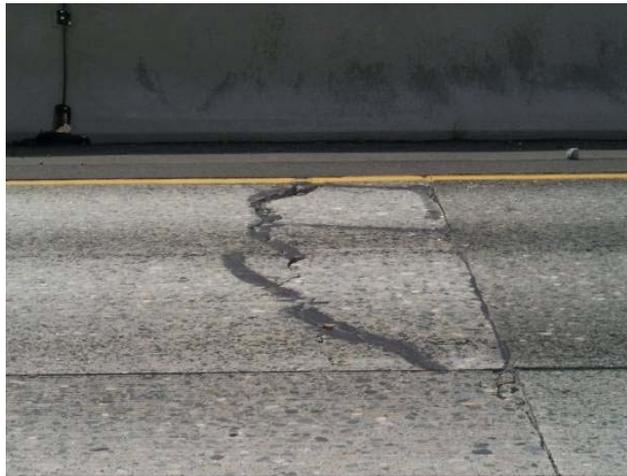
The first step of the forensic investigation was to conduct a field visit to quantify the amount and extent of the panel distress. The field visit identified a total of 38 panels that required replacement and 26 additional panels that contained some form of corner cracking or other distress that require repair. The field visit also identified (confirmed by WSDOT Maintenance forces) that the typical observed distress is transverse cracking, located 2 to 4 ft (0.6 to 1.2 m) from the transverse joint (Figure 13) on existing concrete panels adjacent to panel replacements.

Figure 13. Typical panel distress.

The cause of the panel cracking is most likely due to the use of a guillotine pavement breaker to break the panels to be removed. Since relief cuts were not used on this project, excessive forces were transmitted to adjacent panels during the breaking process. While cracking was not evident during construction, cracking became evident after continued loading from traffic.

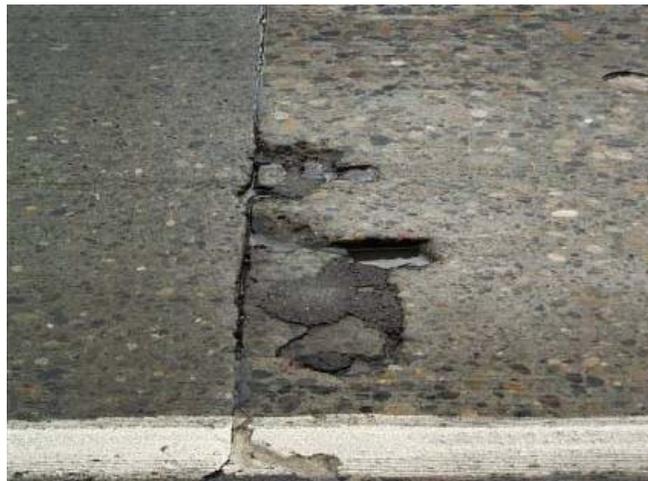
- Dowels deleted during construction likely contributed to the smaller localized failures (Figure 14). Smaller localized failures are occurring within wheelpath locations where the pavement section was reduced as a result of spalling.

Figure 14. Localized cracking and spalling.

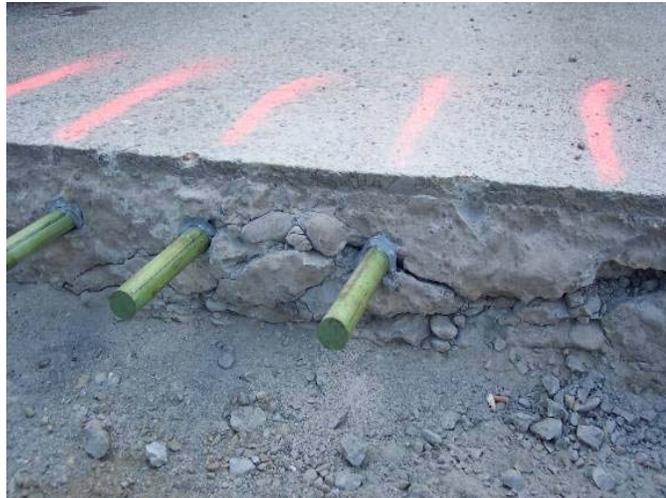
- Though it is difficult to prove that lane rental bidding incentives contributed to the panel cracking, the use of this incentive may have caused hesitancy on the part of the project inspectors to add additional work or change orders to the contract. For example, additional excavation and placement of backfill materials was needed in areas of poor base or subgrade materials, however, project plans did not clearly define these excavation areas. More than likely some panel replacements were placed over poor soil conditions, however, not all cracked slabs occurred in the areas of weak subgrade.
- The sawcutting operation did not extend to the full depth of the concrete slab (Figure 15), placing undue stresses within the concrete pavement during removal (impact breaking).

Figure 15. Inadequate sawcut depth.

- Relief cuts were not used on this project, and in conjunction with insufficient sawcut depth, the force of the impact demolition using a guillotine hammer was transmitted to the existing panels and likely caused the panel cracking.
- During construction, concrete trucks backed off the existing concrete into the excavated area for the panel replacement. The subgrade may have been too weak to restrict excessive deflections at panel edges, which could have led to panel cracking.

Panel Excavation Techniques. If pavement breaking using a guillotine hammer is performed, project inspectors must ensure that full-depth perimeter sawcuts are provided. Additionally, full-depth relief cuts should be placed around all abutting concrete 12 to 18 in. (305 to 457 mm) inward of the full-depth perimeter sawcut edge. WSDOT inspectors need to enforce Section 5-01.3(4) of the Standard Specifications, which specifies that the removal process shall not damage adjacent slabs that will remain in place.

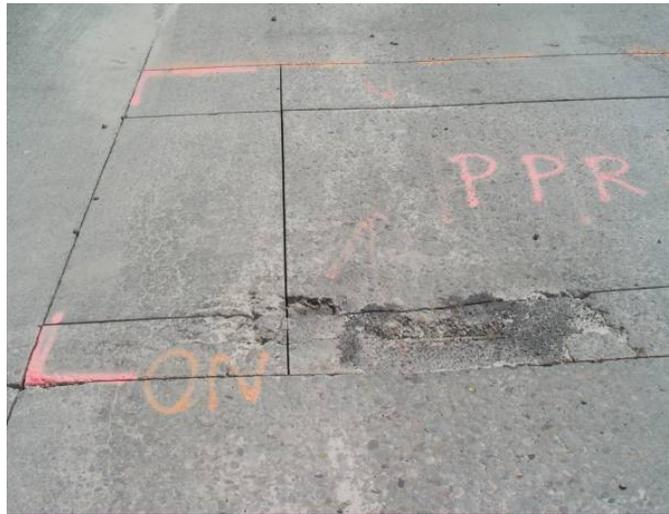
WSDOT Standard Specifications (2) did not require full depth relief cuts (Figure 16) prior to panel demolition. Based on the experiences of northwest Washington concrete contractors, full-depth relief cuts should be made parallel to the perimeter of the panel replacement, 18 in. (457 mm) inside the longitudinal and transverse joints. Pavement removal, either by breaking concrete or lifting concrete sections, should first be restricted to the interior of the panel provided by the relief cuts. This provides a “buffer zone” that attenuates resulting forces used for pavement removal, so that damage to the adjacent panels, such as spalling, is avoided.

Figure 16. Typical relief cut layout used on other WSDOT projects.

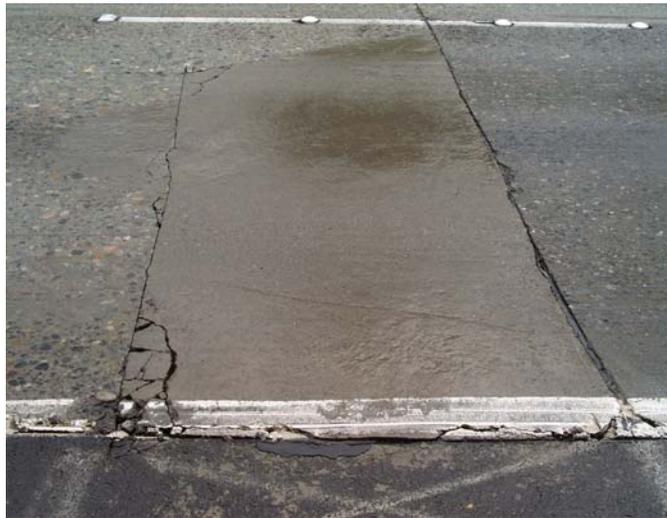
Since October 2003, WSDOT Maintenance has spent nearly \$70,000 to repair the growing number of cracked panels. By 2007, approximately 16 panels had been repaired. Initially, both WSDOT Maintenance and the Pavement Division estimated that these repairs would be temporary and last maybe a year, but the resulting performance of these repairs has been very good (Figure 17). With each repair, expertise has been gained, and it appears the repairs will last much longer, perhaps 5 years. WSDOT Maintenance estimated that within the next year, eight panels will need repair at a cost of \$40,000. Repairs to smaller areas (cracking over dowel, spalls, etc.) will increase this cost to \$50,000.

Figure 17. Performance of Maintenance repair.

Due to restricted budgets, the repair scenario that makes the most sense, at this time, is to have WSDOT Maintenance continue to repair the cracked panels on an as-needed basis. Recently, there has been discussion that additional work will likely occur in this corridor, possibly within the next 5 years. It may be more economical to program additional panel replacement work on these future contracts. In 2006, construction estimates to correct the deficient panels throughout the project limits were estimated and included two options: (1) Replace severely distressed panels (estimated to be 210 panels) at a cost of \$3.5 million, or (2) replace all cracked panels (estimated to be 510 panels) at a cost of \$7.6 million.
