Restoration of New PCC Pavement With Uncontrolled Cracking in Missouri

John P. Donahue¹

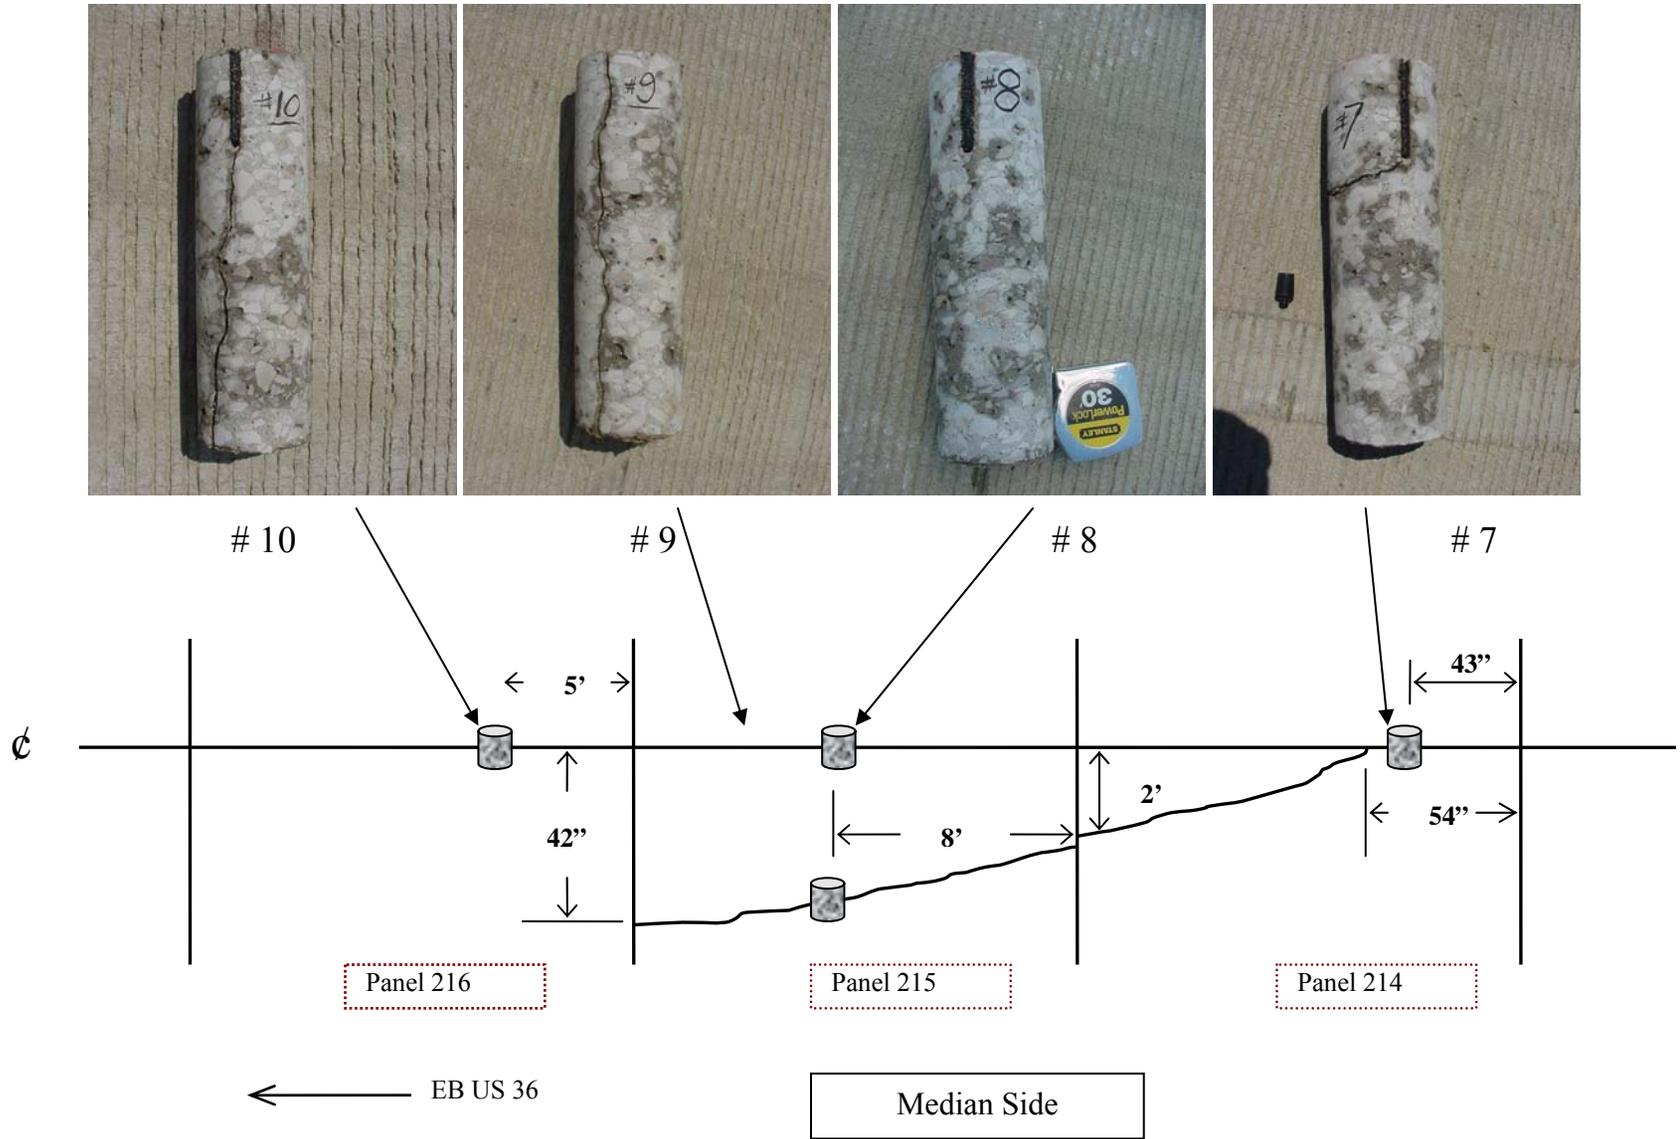
Figure 1. Core locations on US-36.

The thickness and sawcut depths of four consecutive cores are summarized in Table 1. Pictures of the cores and a diagram of their locations are shown in Figure 1.

The trend observed in the crack and cores in Figure 1 typified what was seen in the others. The sawed centerline joint would crack through (Core No. 10) at a point parallel to the start of the uncontrolled crack, but farther along it would not crack (Core No. 8). Meanwhile, the uncontrolled crack would usually, but not always, veer into the sawed joint. The uncontrolled crack's influence would still be felt beyond this point, however; as evidenced by the shallow angular fracture planes under the sawed joint in Core No. 7, which were believed to be prone to spalling or breaking off.

Finally, the ratio of the average sawed depth to field core thickness was 26 percent, very close to the T/4 (one-quarter the thickness) specification.

In the other area of the project, where uncontrolled cracks ran parallel to the centerline joint in both eastbound and westbound lanes, panels with continuous cracks were cross-stitched with No. 8 bars on 2-ft (0.61-m) centers. Panels with a confluence between a sawed joint and an uncontrolled crack were replaced because of concern over the shallow angular fractures eventually spalling.

As a result of the uncontrolled cracking on this project, the standard specification for longitudinal sawcut depth on all other projects was increased from T/4 to T/3.

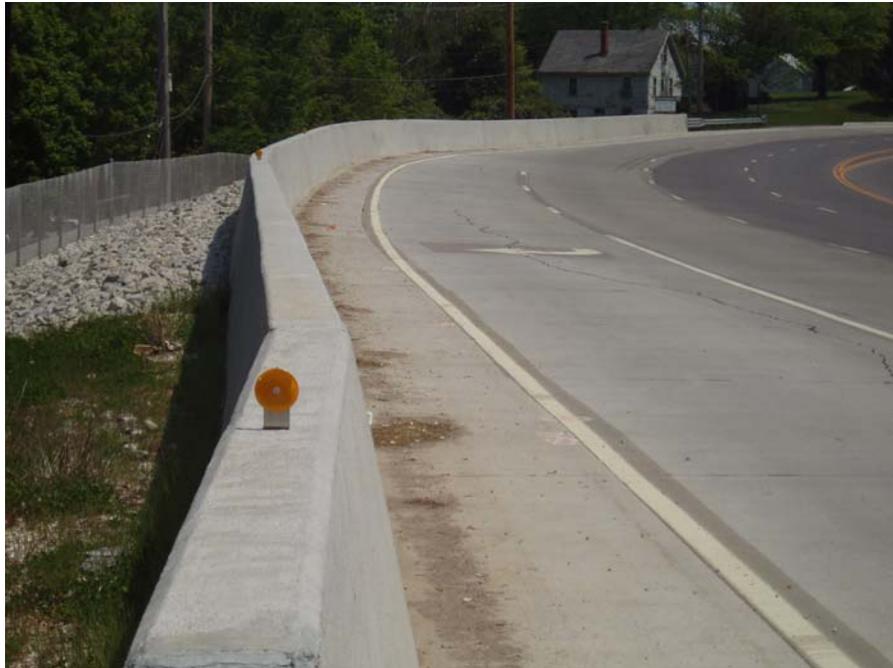
Figure 2. Right turn lane with pinned concrete barrier on retaining wall.

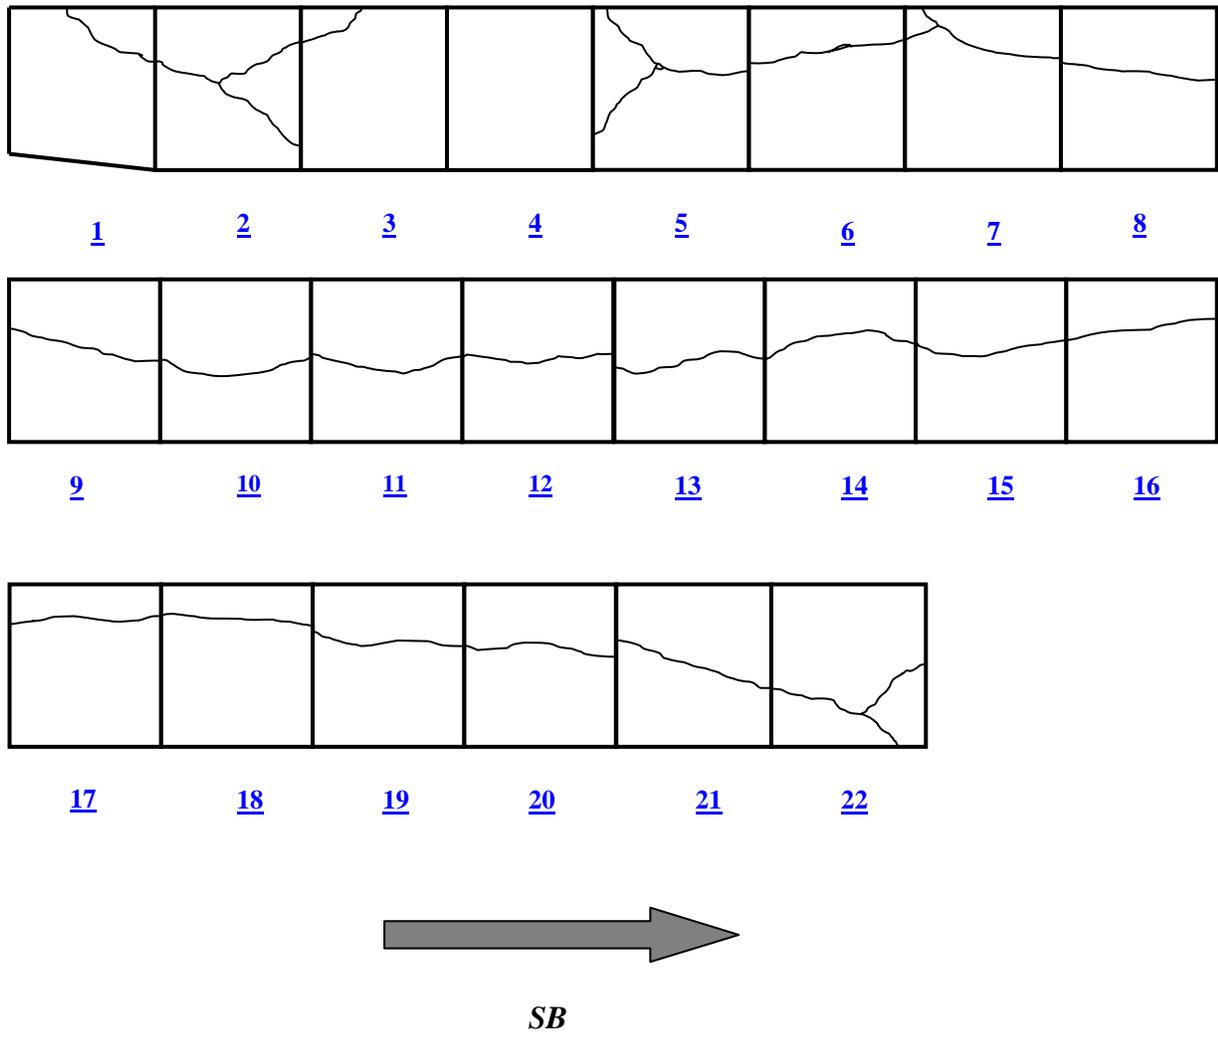
Figure 3. Route 94 turn-lane cracked panel diagram.

Twenty-one of 22 panels in the turning lane developed some form of cracking. The cracking pattern is detailed in Figure 3: 15 panels had a single longitudinal crack running from transverse joint to transverse joint; 4 panels had multiple cracks emanating in a Y-shape; 2 panels had corner cracks. The crack widths remained fairly tight, yet some displayed obvious faulting, which became the primary concern of the field investigation. Project office personnel said that the crack initiated at the southern end and propagated northward along the entire length.

Differential settlement in the widened fill was the only probable explanation for the slabs cracking and faulting. This problem was not unlike the settlement occurring at many bridge approaches where the high fill continues to consolidate and lose volume, while the adjacent structure on one side and the pavement on shallow fill on the other side have virtually no relative settlement. A thorough geotechnical investigation would have been required to substantiate this hypothesis and verify the exact nature and location of the settlement, but the low overall importance of this piece of pavement precluded that level of activity.

paired in a way that corresponded to the significance of this particular lane. Since most of the longitudinal cracks appeared to maintain tight aggregate interlock, cross-stitching with No. 6 bars was employed on 17 of the panels. Only panels 2, 5, 7, and 22 were deemed damaged beyond conventional restoration techniques and were replaced. Three years later, the cross-stitched panels have not shown any visible increase in distress, and the roadway is functioning normally under traffic.

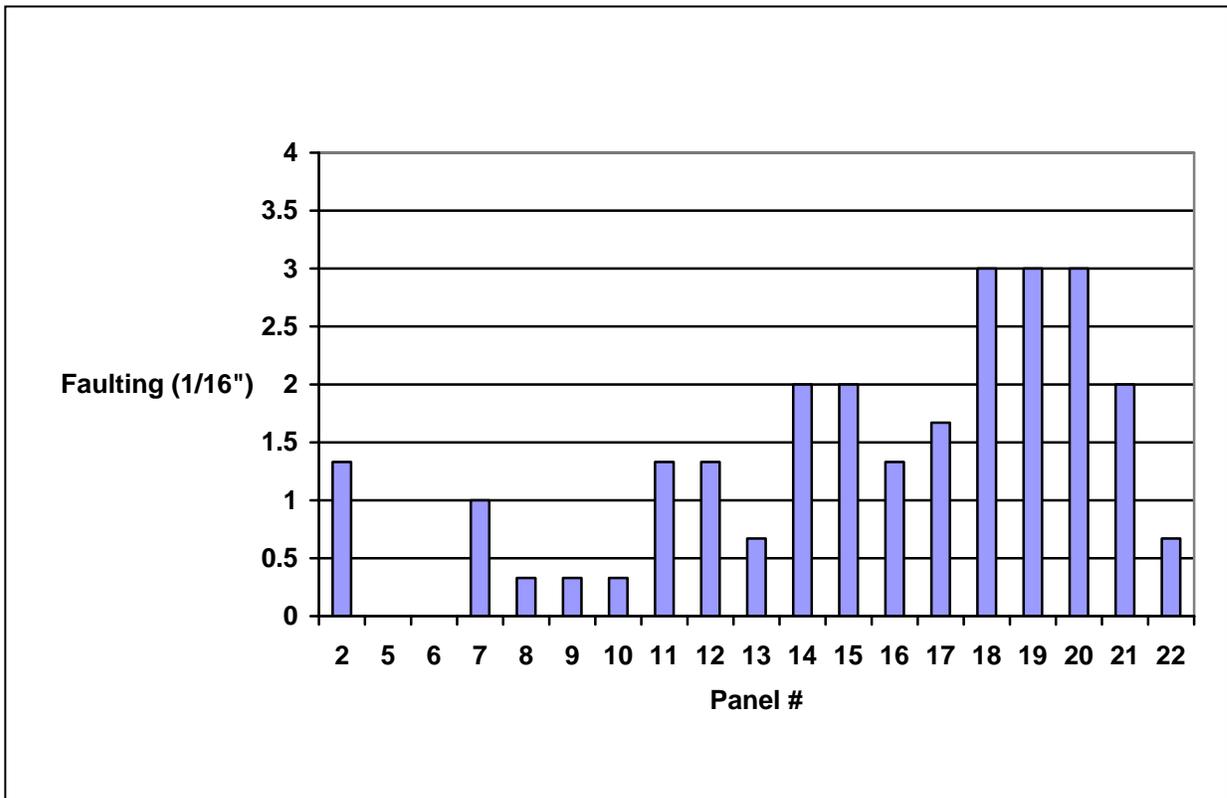
Faulting was measured across the cracks in 1/16-in. (1.6-mm) increments. Three evenly distributed measurements were made in each full-length panel crack. Faulting in this case is the drop in elevation of the outside (barrier side) cracked slab panel with respect to the inside (traffic side) one. The average faulting of each panel is shown in Figure 4. The greatest faulting occurred at the southern end of the turn lane. The depth of faulting in a longitudinal crack on a new pavement, particularly one that had experienced very light traffic, strongly suggested settlement problems. A half-year after the initial field investigation, faulting increased by an average 1/16-in. (1.6 mm), indicating further settlement of the outside pavement.

Figure 4. Faulting across longitudinal cracks.

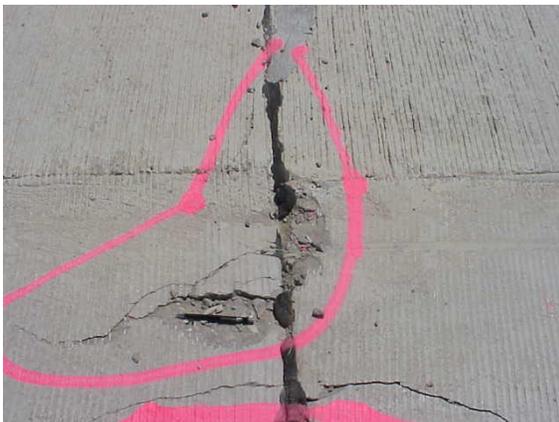
Figure 5. Corner cracking and spalling.

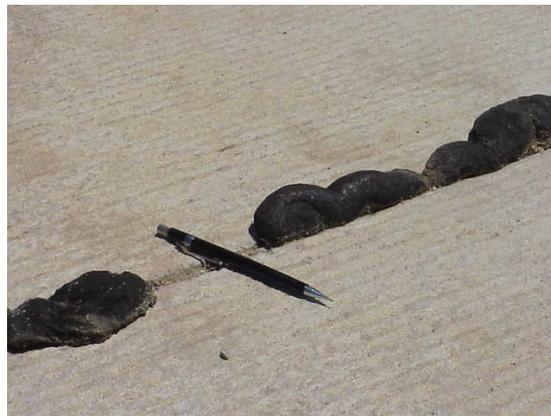
Figure 6. Joint sealant extrusion.

The results clearly show that the sealant failed to meet ASTM 6690 criteria by a wide margin and fell even farther below the manufacturer’s standards. This led to an early hypothesis that the uncontrolled pavement cracking and corner heaving could be attributed to sealant infiltration. The circumstances that would have allowed this to happen included the combination of several factors: a difference between ambient and concrete temperature during paving of 30 °F to 40 °F (1 °C to 4 °C), causing cracks to develop every five to seven slabs; late and insufficient saw depth at the other joints necessary to initiate cracking at interim panel joints; hot pour mixed with fine aggregate and cement slurry infiltrating the deep crack openings; and finally, hot summer temperatures the following year, causing expansion and subsequent shear failures.

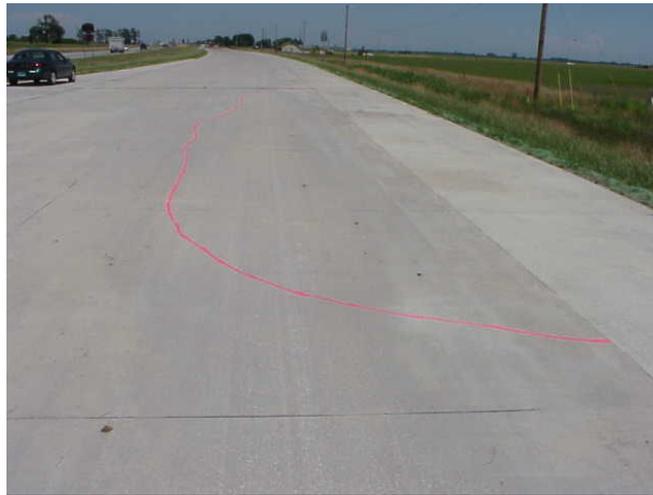
Figure 7. Crack across multiple panels.

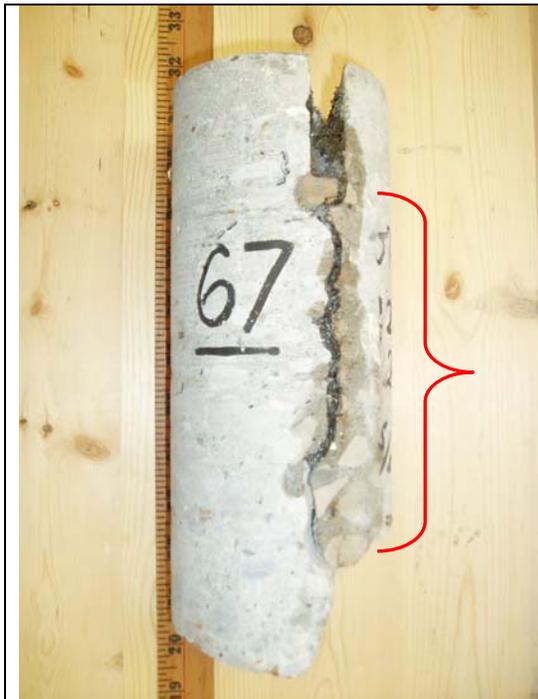
Figure 8. Joint 67.

Coring revealed a pattern. Corner cracking and/or spalling occurred every five to seven slabs where full-depth cracks formed through the sawed joints, as at Joints 67, 72, and 77. In addition to the extreme surface extrusion, these joints also had moderate to severe sealant infiltration, in some cases through nearly the full thickness of the core (figures 8 and 9). Sealant-filled cracks were up to 0.2 in. (5 mm) wide. Interim transverse joints between the cracked joints had either no or light partial-depth cracking, therefore no sealant was able to penetrate into these joints.

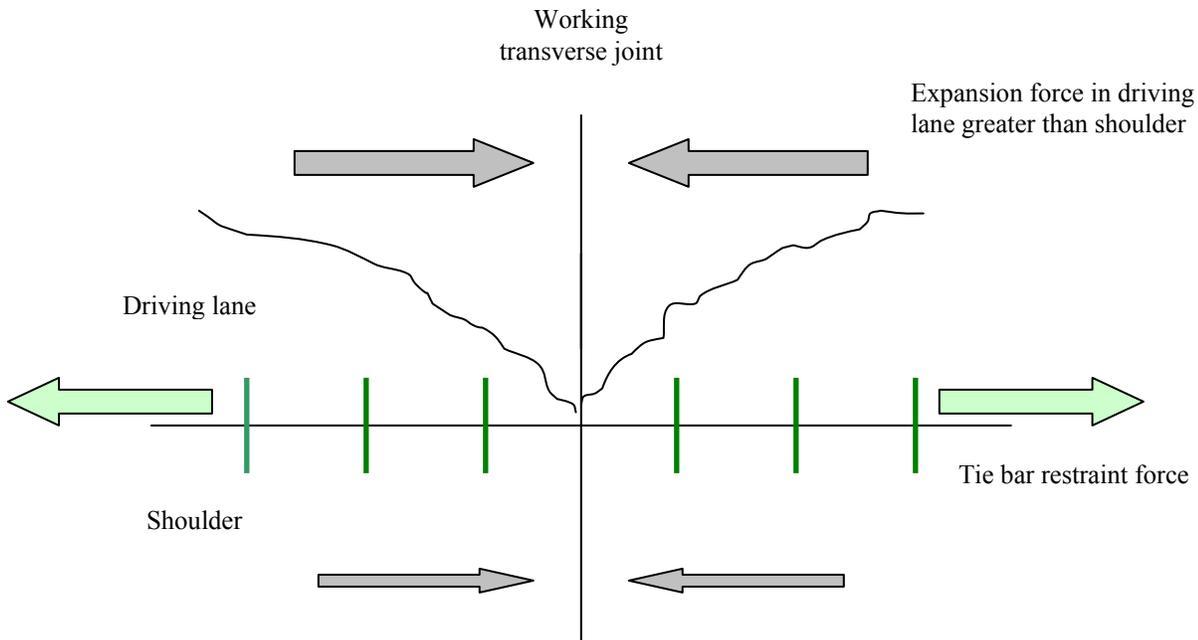
However, since it is doubtful that the sealant / slurry mixture could have had enough viscosity to act as an incompressible, the more logical explanation, or at least the apparent major contributor, was tie bar restraint. The 8-ft (2.4 m) shoulder was paved at a later date during significantly colder temperatures than the adjacent monolith, therefore it experienced less thermal contraction in the winter months. In June, as temperatures approached 100° F (38° C), the effective “super slabs” in the driving lanes had much farther to expand at the working joints than did the adjacent outside shoulders. The difference in expansion forces activated a shear stress by the No. 6 tie bars, embedded 15 in. (381 mm) on either side, which in turn caused a shear failure near the corners (Figure 10). Had the shoulder expanded as much as the driving lane, the joint interface would have experienced uniformly high compressive stresses and the tie bars could not have been in shear. This theory was verified by thinner joint crack openings measured in the portion of driving lane that had been “freed from bondage” to the remaining section still attached to the shoulder.

Figure 10. Joint restraint failure.

- Tie bars were severed (with a saw) along the length of two panels on either side of “super slab” working joints. This eliminated the tie bars’ ability to restrain the differential thermal movement of the driving lane and shoulder and propagate more cracking.
- Partial-depth repairs were performed at corner crack locations where the cracks had not grown more than a few feet.
- Cracks that extended across multiple panels were cross-stitched in the interim panels where the crack did not compromise corners with potential spalls.

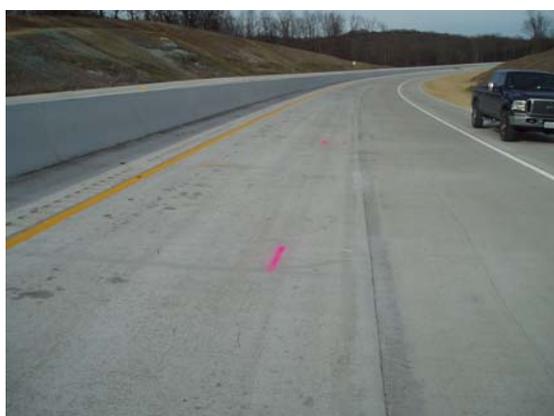
Within a week of its scheduled opening, a series of unexplained cracks were suddenly appearing in the pavement. The cracks, varying in length from less than a foot to several feet, ran roughly parallel to and within several inches of the transverse joints near the centerline (figures 11 and 12).

Figure 11. MO-21 cracking.

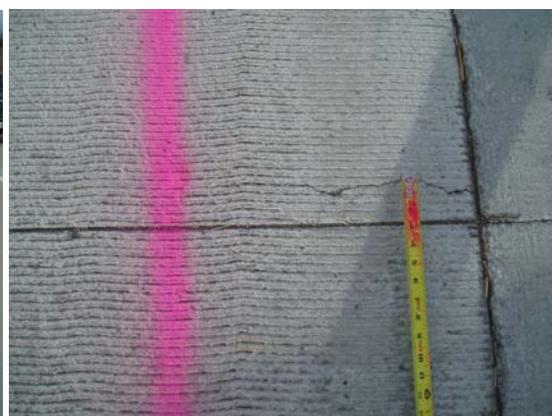
Figure 12. Crack close-up.

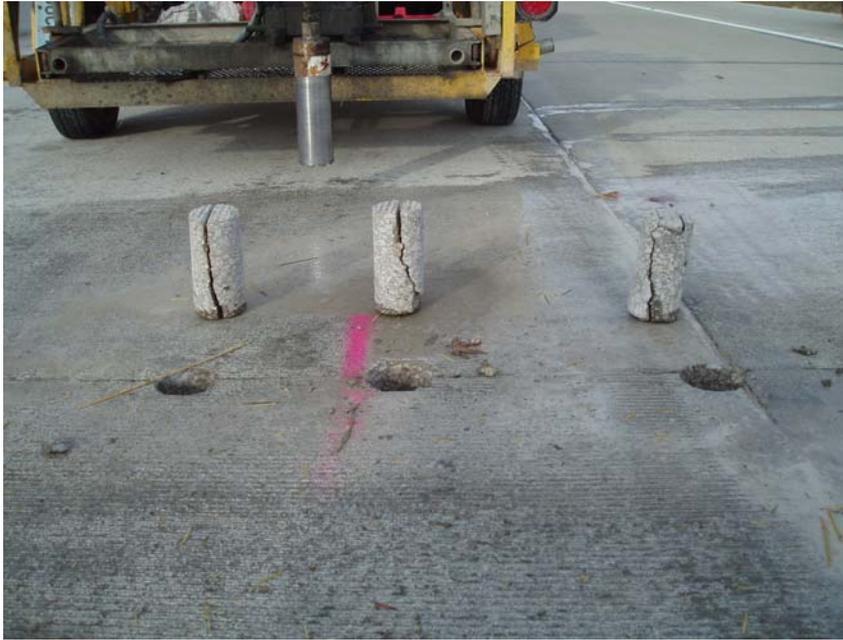
Cores were drilled at locations centered on and slightly beyond cracks as well as on adjacent sawed transverse joints. The intent was to determine the extent and shape of the crack and whether or not a crack had also formed through the sawed joint (Figure 13). The cores revealed that the cracks were uncontrolled nearest the centerline (Figure 14), but eventually worked their way back into the sawed transverse joints (Figure 15).

Figure 13. Cores at transverse joint.

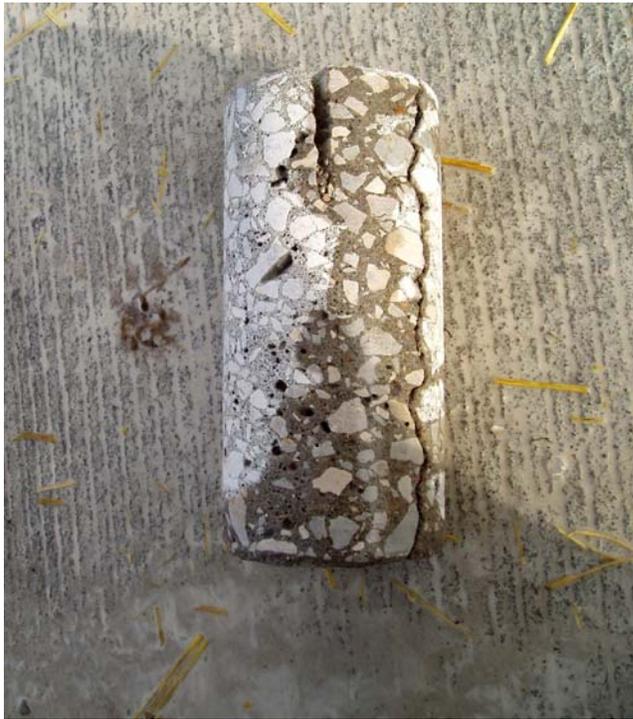
Figure 14. Uncontrolled transverse crack.

The cores also clearly showed that the joint saw depth tapered to nothing at the centerline joint. The sawing subcontractor, somewhat inexperienced, had apparently tried to avoid overcutting into the adjacent paved lane. By doing so, however; uncontrolled cracks developed and continued parallel to the sawed joint until its depth (and influence) forced the crack into a confluence with the sawed joint some distance away from the centerline.

Since the majority of the uncontrolled cracks had not resulted in corner spalling and were well within the influence of the 18-in. (457-mm) dowel bars, the sawed joints next to the working cracks were sealed with an epoxy, thus reducing the possibility of future spalling. Compressible board blockouts were inserted near the joint / uncontrolled crack confluence to prevent the epoxy from infiltrating the working sawed joint. The few locations where spalls had already occurred were corrected with partial-depth repairs.

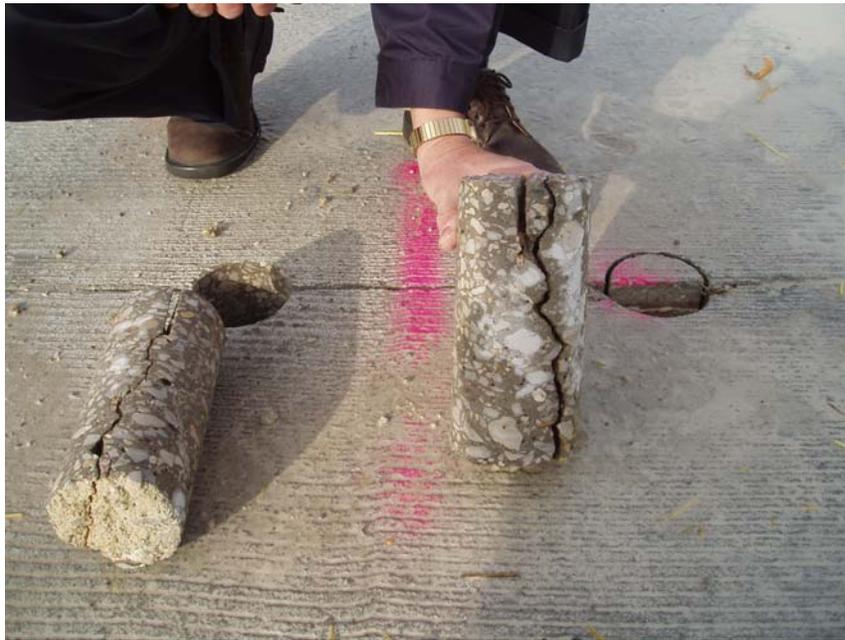
Figure 15. Crack merging with sawed joint.
