Retrofit Dowel Bars in Jointed Concrete Pavement— Long-Term Performance and Best Practices

Thomas Burnham¹ and Bernard Izevbekhai²

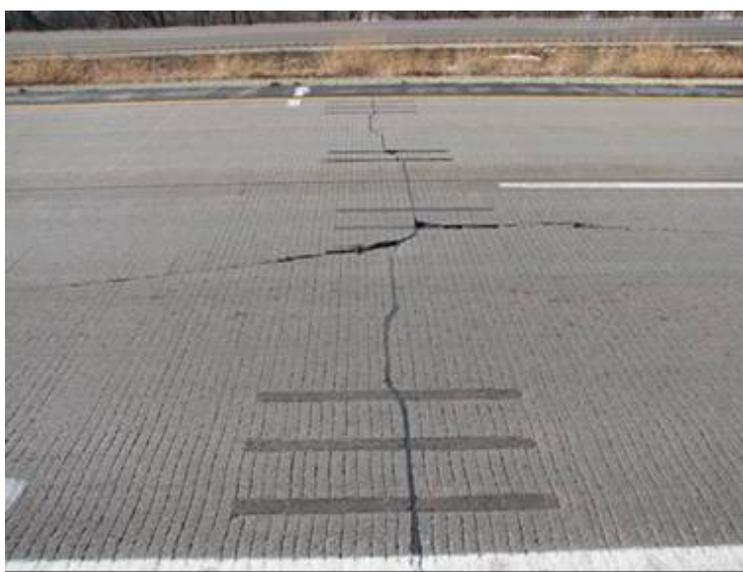
Photo 1. Distress in TH 52 retrofit dowel bars caused by longitudinal panel cracks.

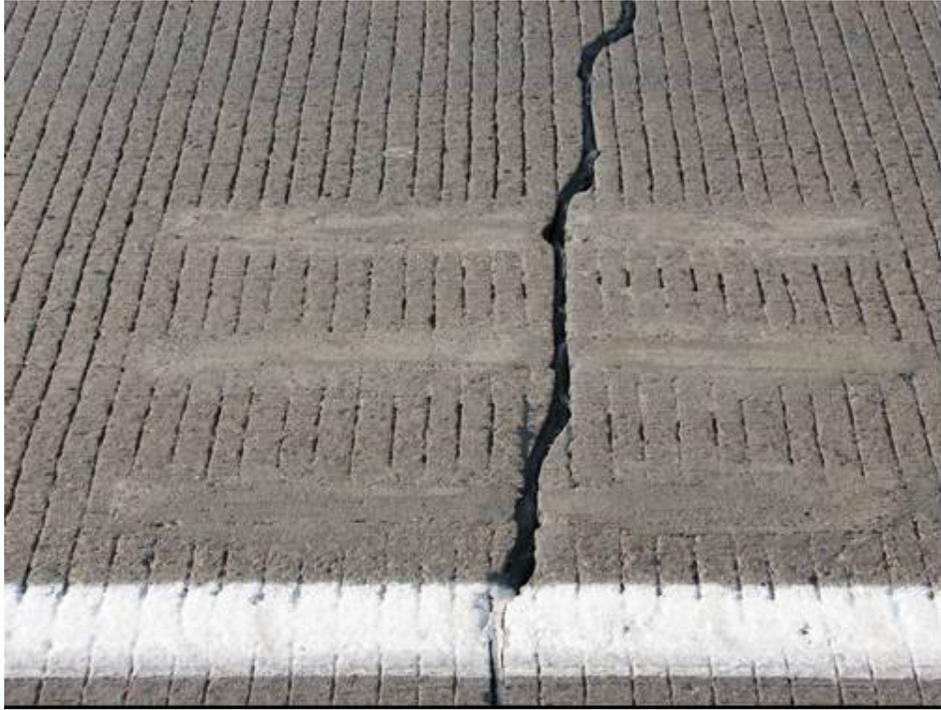
Photo 2. TH 52 slots with Mn/DOT 3U18 backfill mortar after 13 years.

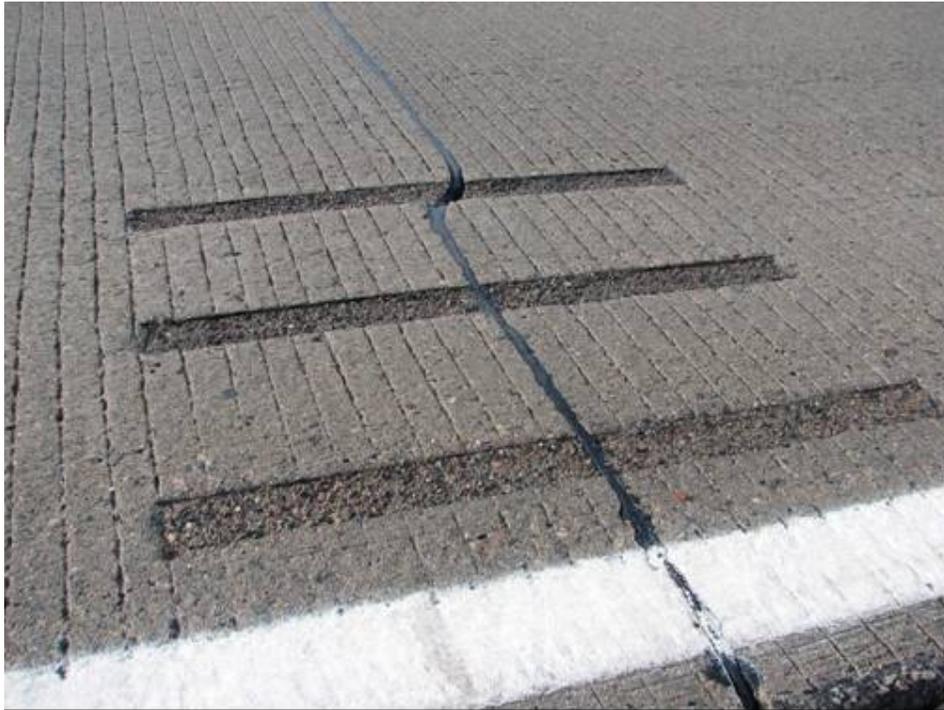
Photo 3. Loss of PMQP mortar near surface of slots on TH 52.

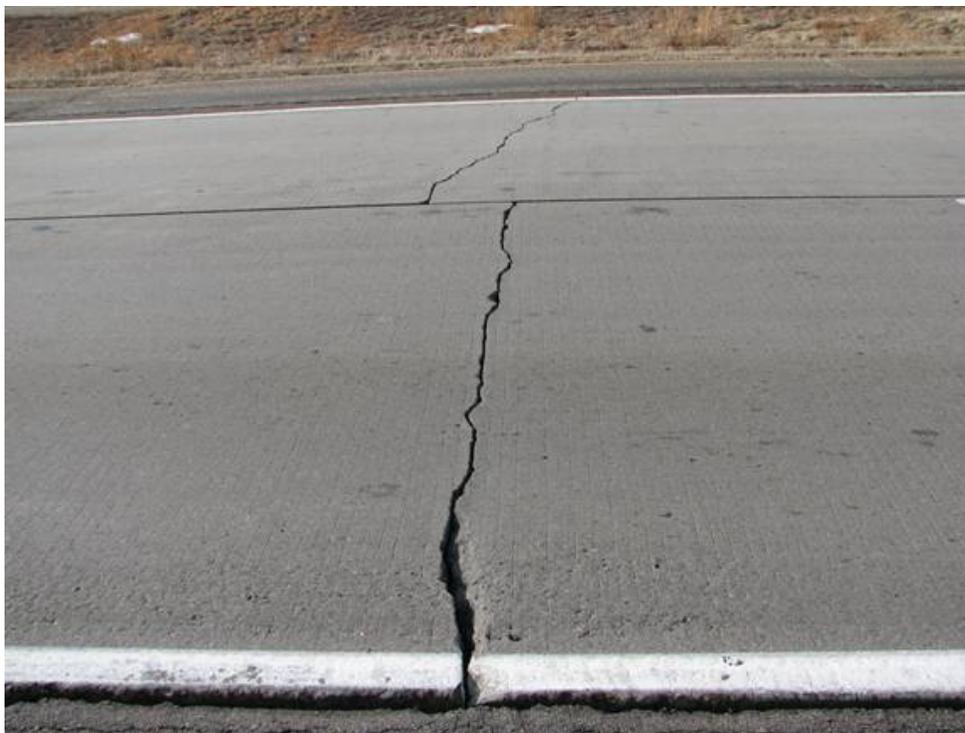
With regards to the various dowel patterns, it seems the performance in terms of ride quality at year 13 is insensitive to the number and length of the retrofit dowel bars as they were designed in this project. The benefit of retrofitting dowels across mid-panel cracks on TH 52 can clearly be seen by observing the faulting that occurred on a number of nearby unsealed mid-panel cracks that had not received retrofit dowel bars (see Photo 4).

Photo 4. Faulted mid-panel cracks without retrofit dowels on TH 52.

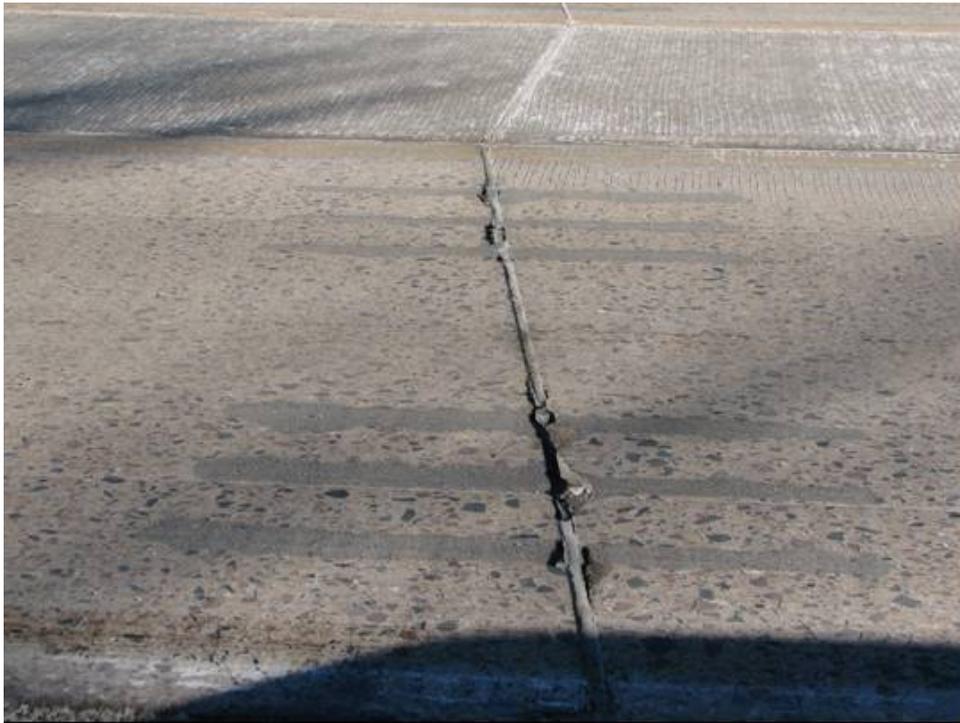
The retrofit dowel bars on TH 12 were installed in 1996, and therefore have been exposed to over 12 years of traffic (HCADT = approximately 600)(6) and weather. Recent site visits took place in October 2006 and February 2007. During those visits, minor surface distress on the retrofit dowel bar slots was noted to occur predominantly near the joints (see Photo 5). The distresses might be linked to the slot milling process, when material near the joint

was weakened. Otherwise, there was little deterioration of the Mn/DOT 3U18 backfill mortar after 10 years of service.

Photo 5. Backfill mortar distress near joints on TH 12.

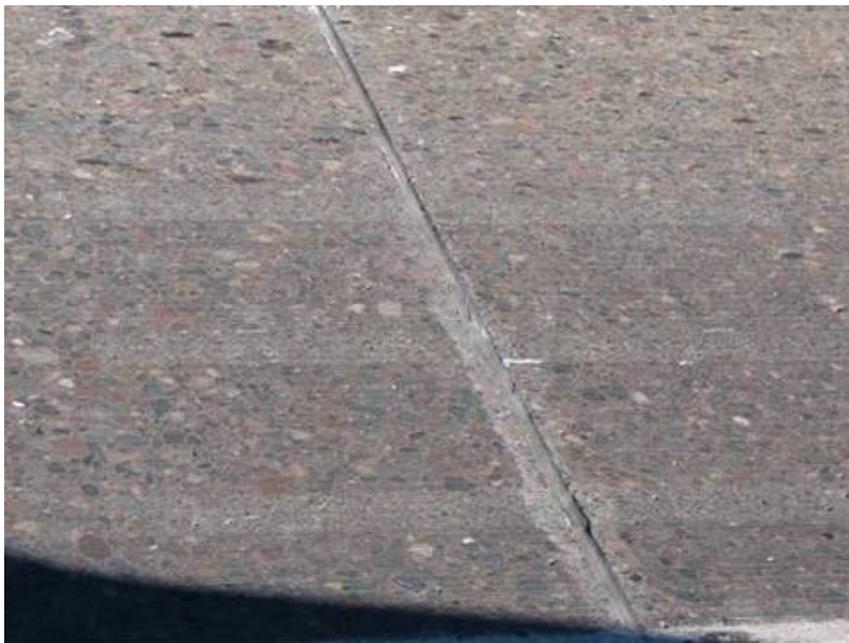
Photo 6. TH 23 slots with Mn/DOT 3U18 backfill mortar after 8 years.

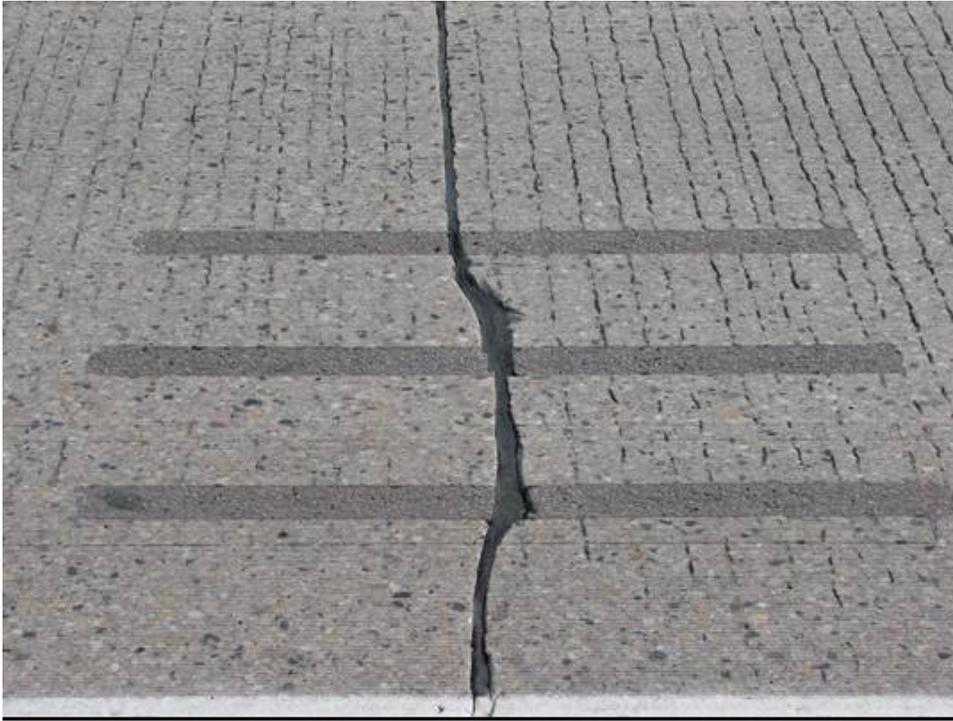
Photo 7. Typical condition of I-90 slots with PMQP backfill mortar after 7 years.

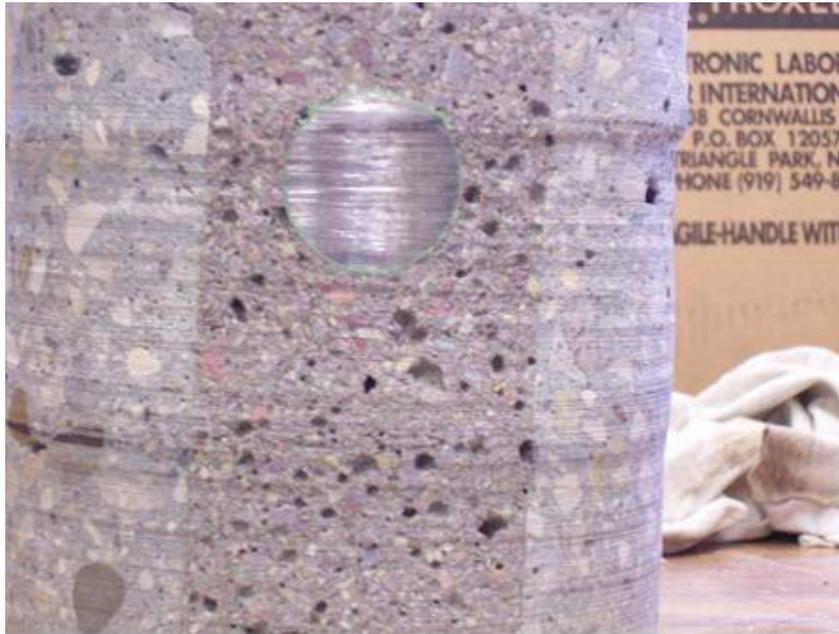
A retrofit dowel bar project was constructed in 1994 on Minnesota TH 59. A contractor test site was constructed and the specified cores were taken and tested. Many of the core samples did not attain the required ASTM 928 prescribed strength. The cores also revealed severe honeycombing. This is shown in Photo 9. These results necessitated a switch from one approved backfill product to another.

Photo 9. Core from TH 59 test site showing honeycombed retrofit mortar.
