# **Retrofit Dowel Bars In Jointed Concrete Pavement - Long Term Performance and Best Practices**

Office of Materials and Road Research  
Minnesota Department of Transportation

**NATIONAL CONFERENCE ON PRESERVATION, REPAIR, AND  
REHABILITATION OF CONCRETE PAVEMENTS**

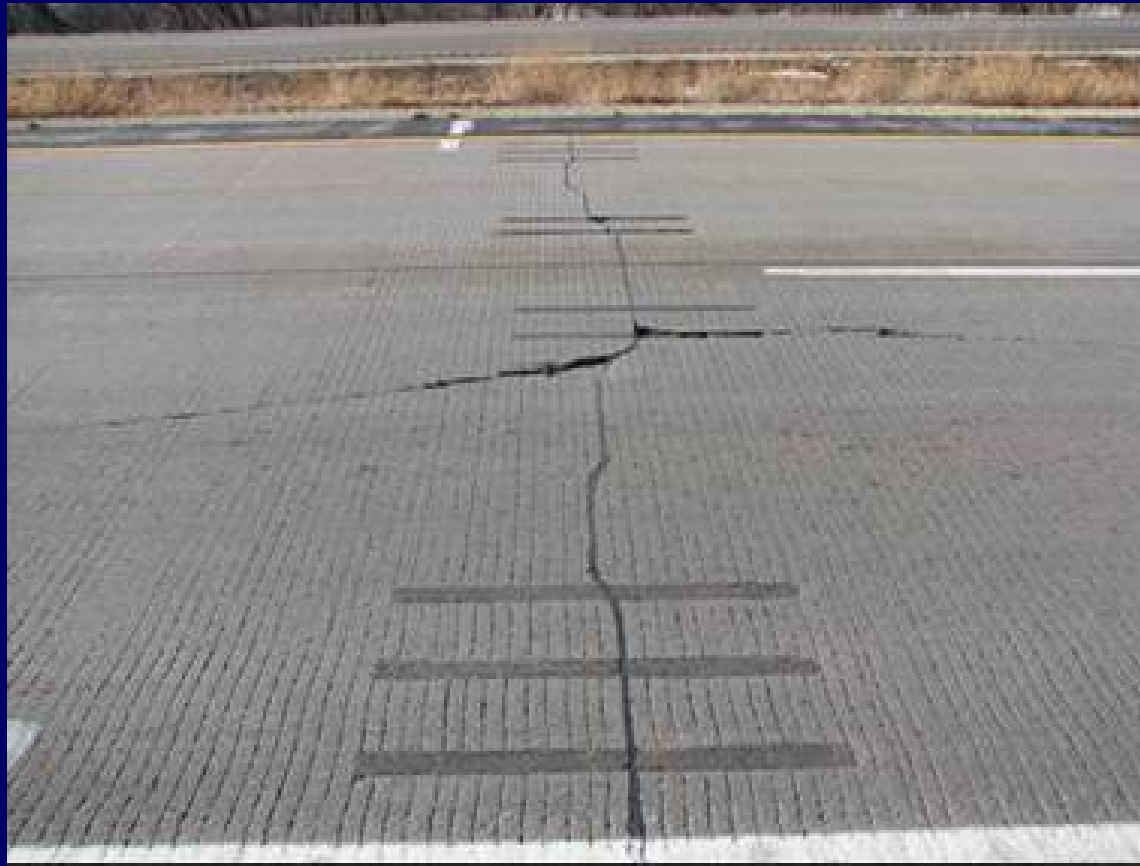
- Observed Performance (14 years after retrofit)
  - Faulting of mid-panel cracks minimal (avg = 1.7 mm)
  - Small number of distressed retrofit dowel bar slots caused by longitudinal cracking
  - Backfill material performance very good
    - PMQP had some loss of material near surface
    - Mn/DOT 3U18 patch mix good despite early shrinkage cracking around slots
  - LTE (2006)
    - 60 to 80 percent

Longitudinal panel crack

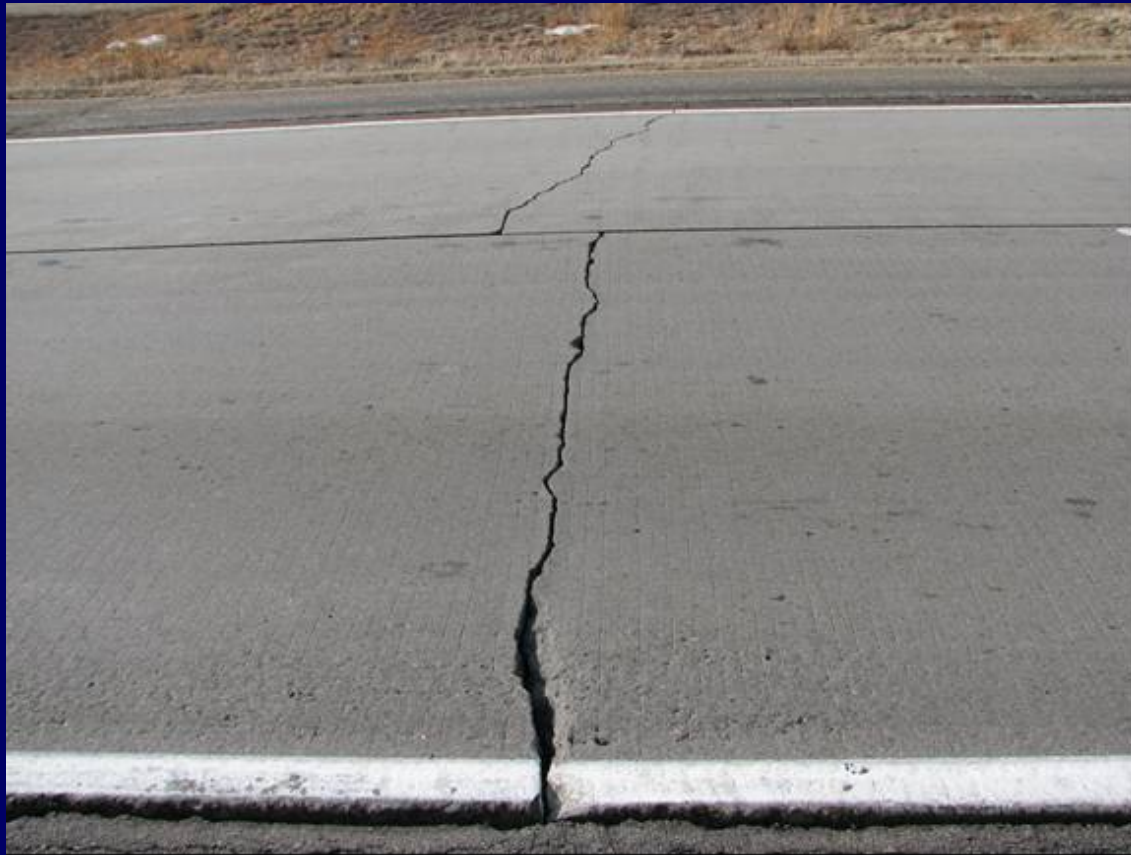
Faulted mid-panel crack

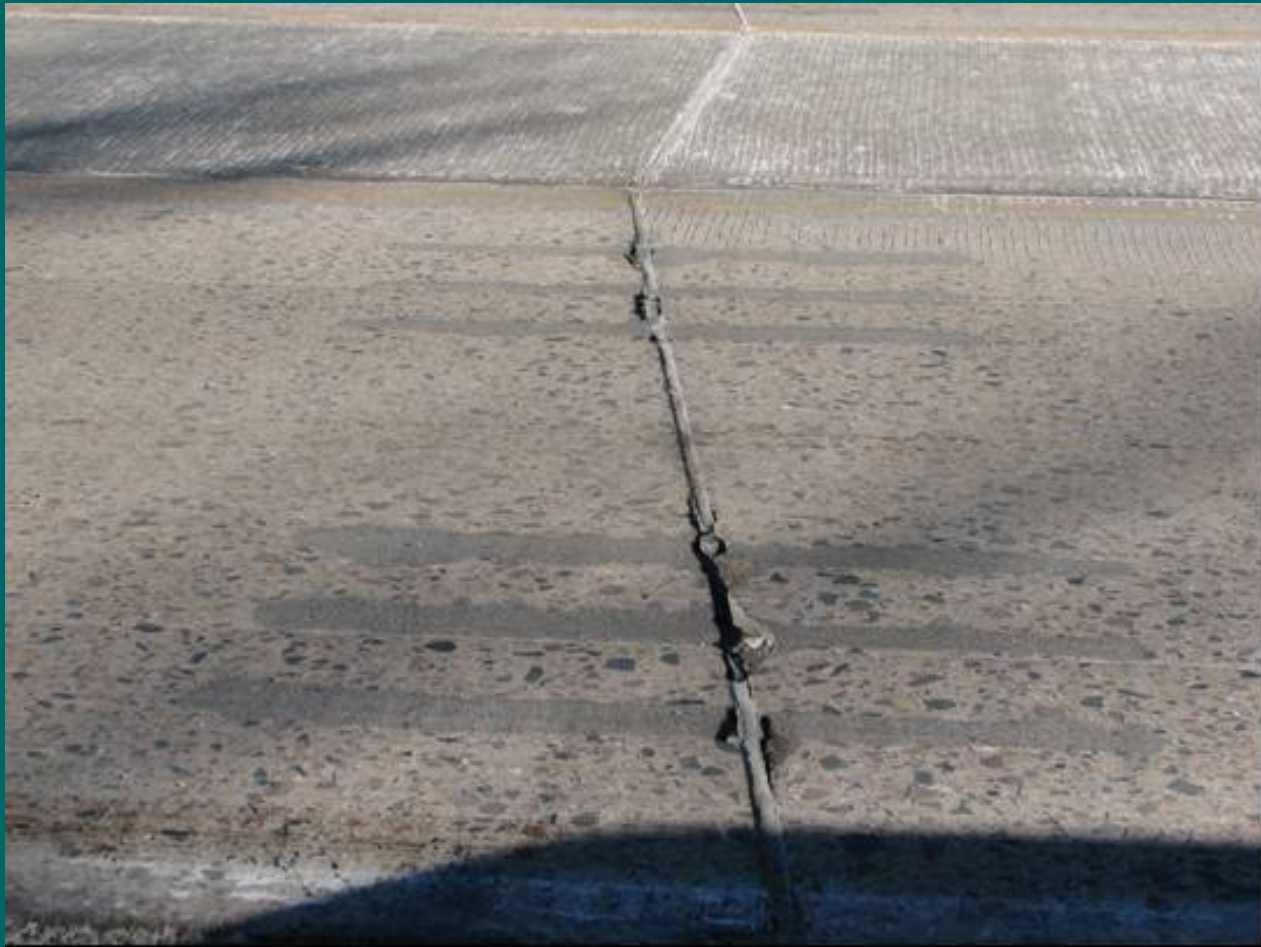
- Observed Performance (12 years after retrofit)
  - Faulting of transverse joints minimal (avg = 1.5 mm)
  - Backfill material performance good
    - Minor surface distress in slots near joint
    - May be linked to milling process
  - LTE (2006)
    - 51 to 65 percent

Backfill mortar distress near joint

- Effective in preventing faulting of mid-panel cracks
- Effective in extending service life of previously undoweled joints
- Surface grinding critical to performance of retrofit dowel bars
- Fairly insensitive to various dowel patterns and bar length
- Good performance from most backfill materials
- Milling not recommended for slot formation

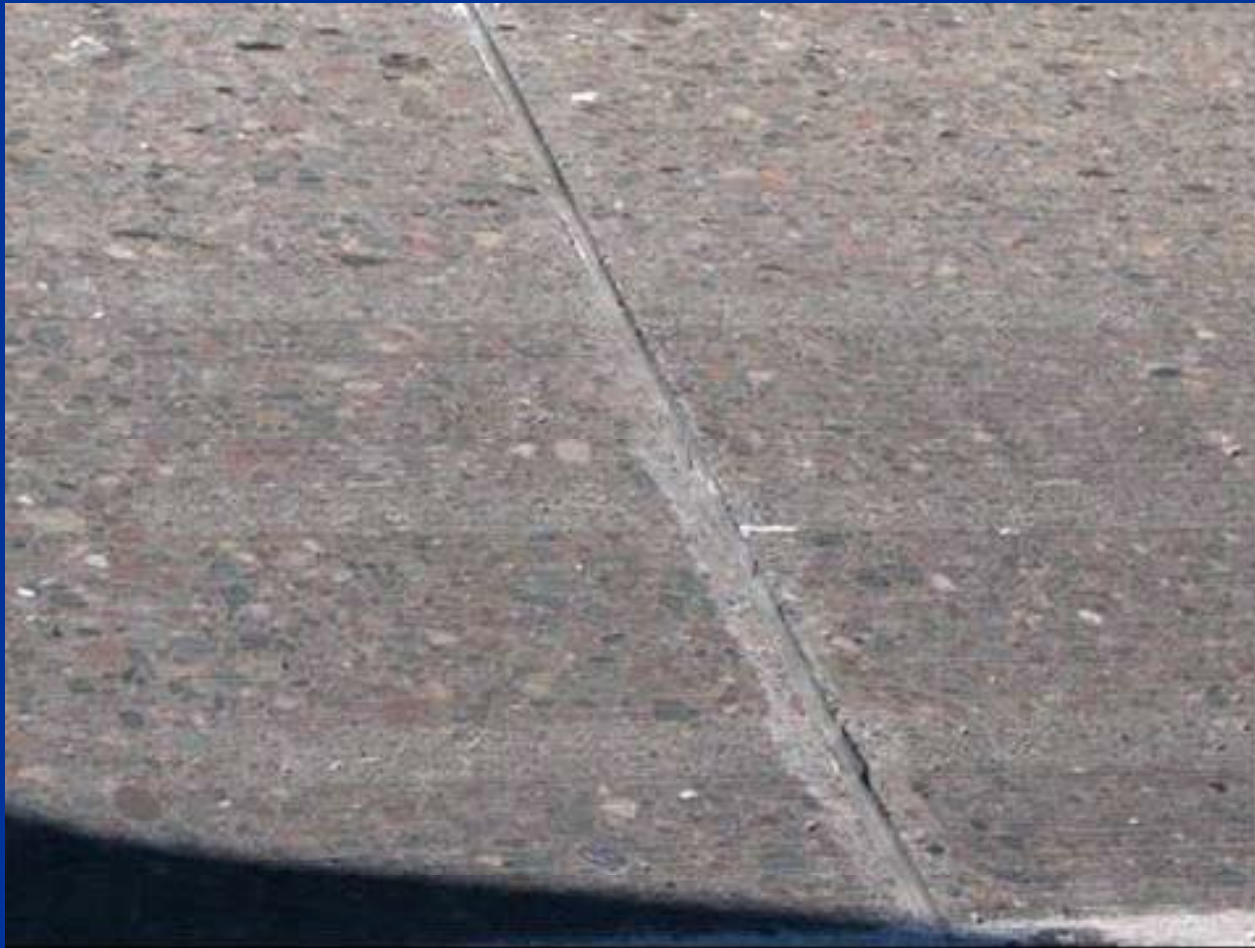
Mn/DOT 3U18 backfill mortar

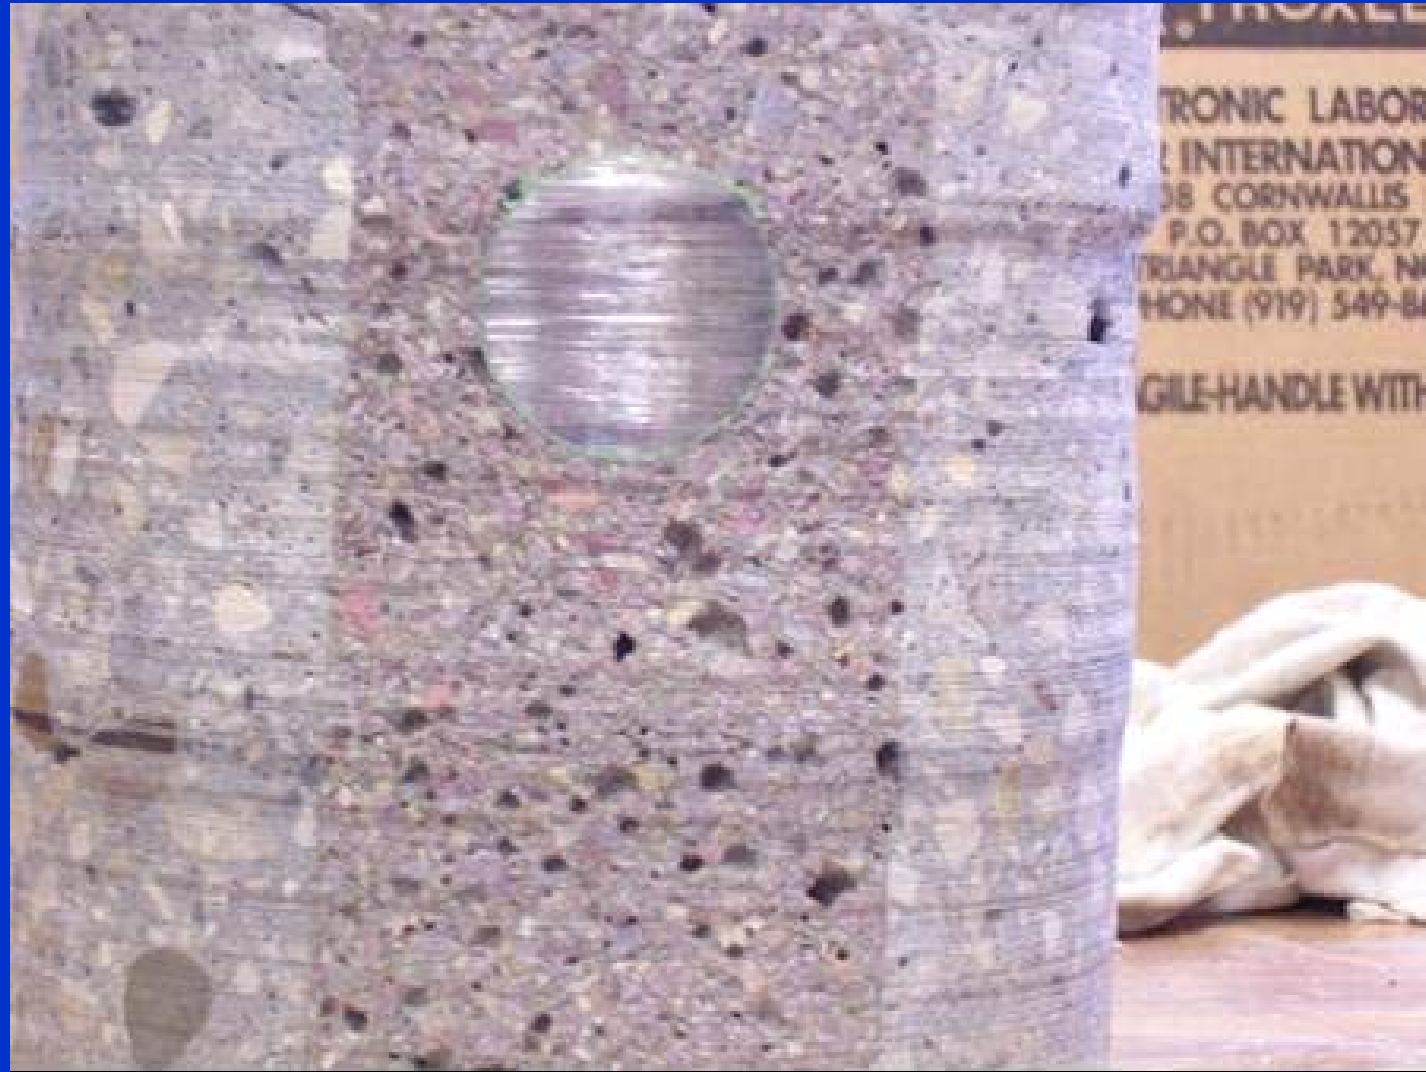
Honeycombing of backfill mortar ► Switched mortar type

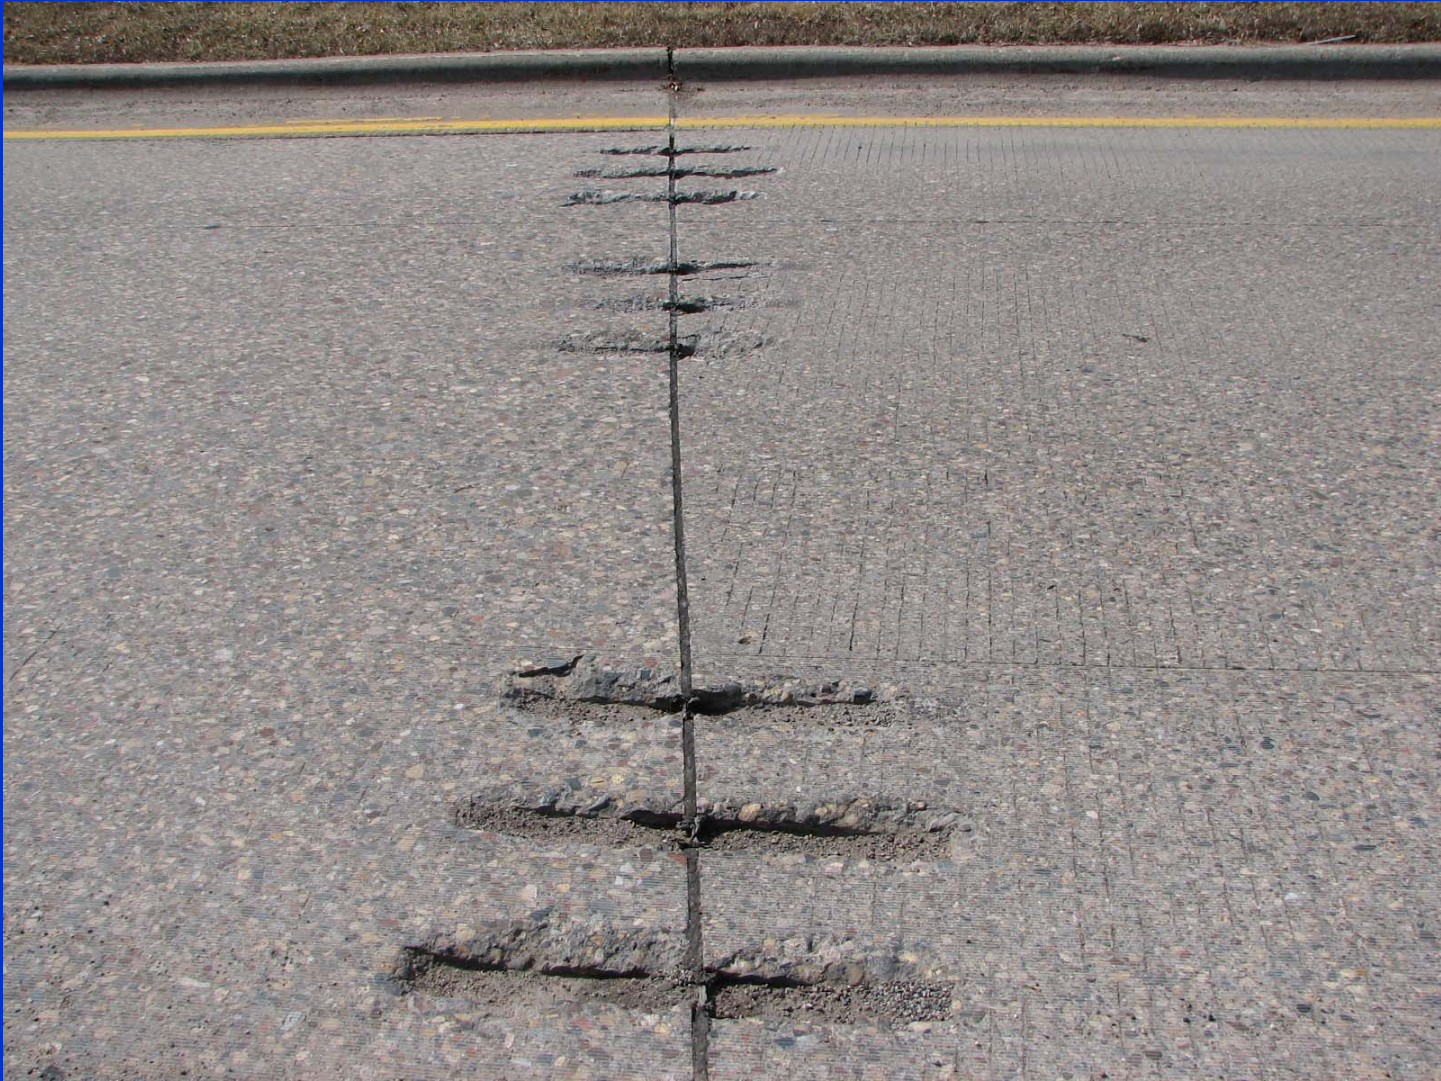
Age = Approximately 5years

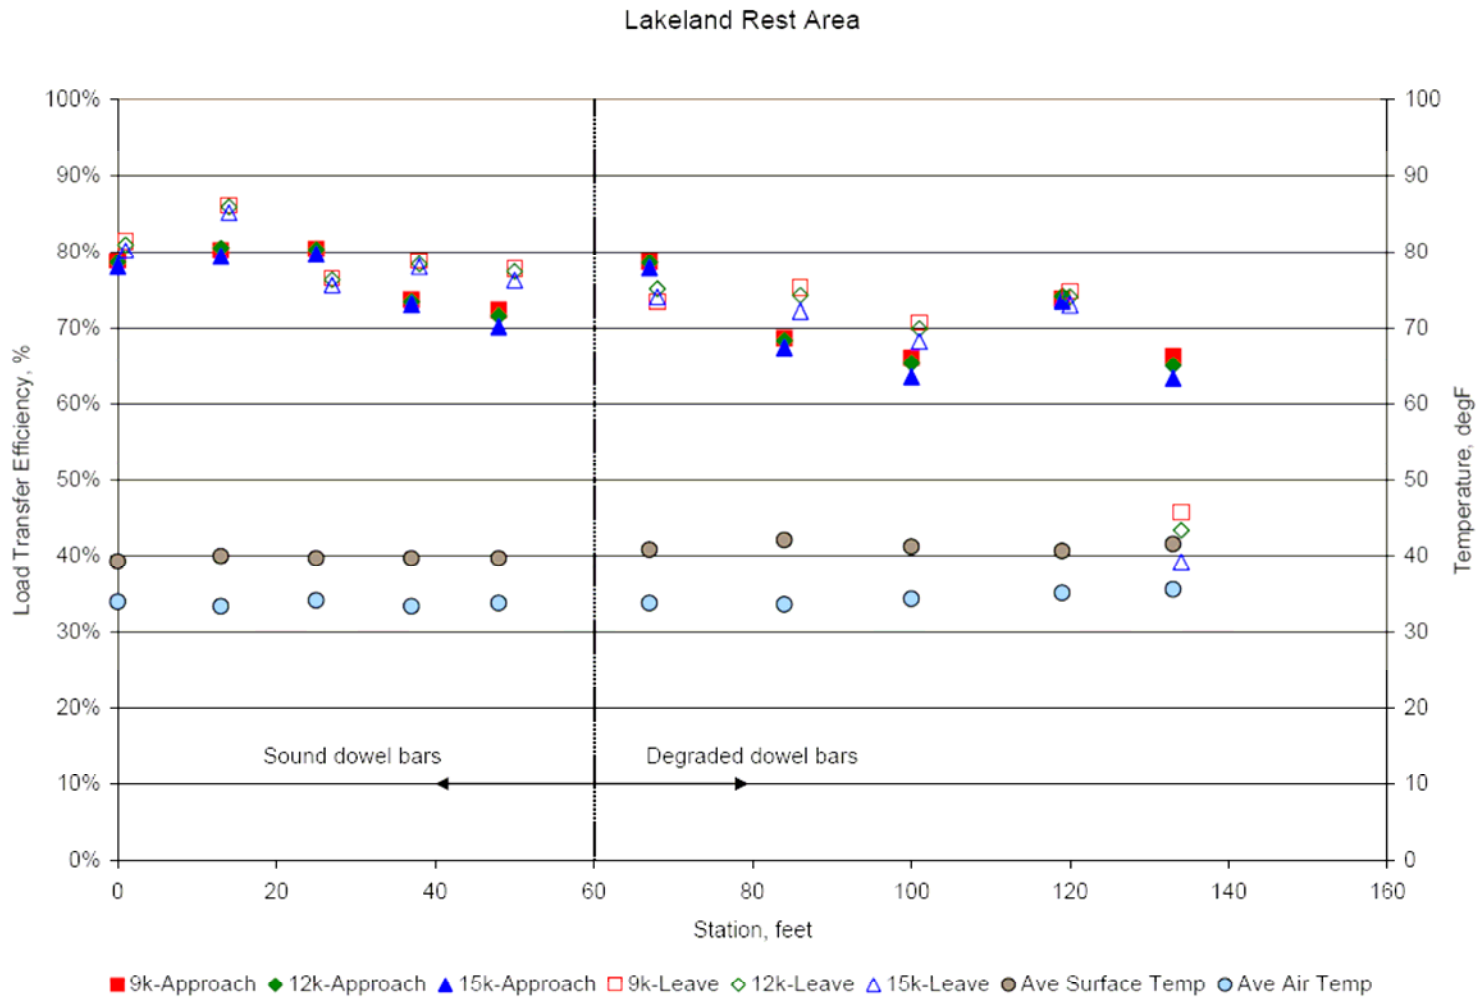
Age = Approximately 5years
