SLOPE STABILITY ANALYSIS OF A SMALL
INTERMITTENT FAILURE

A Thesis
Presented
to the Faculty of
California State University, Chico

In Partial Fulfillment
of the Requirement for the Degree
Master of Science
in
Geosciences
Hydrology/Hydrogeology Option

by
Chloe Adams
Spring 2015

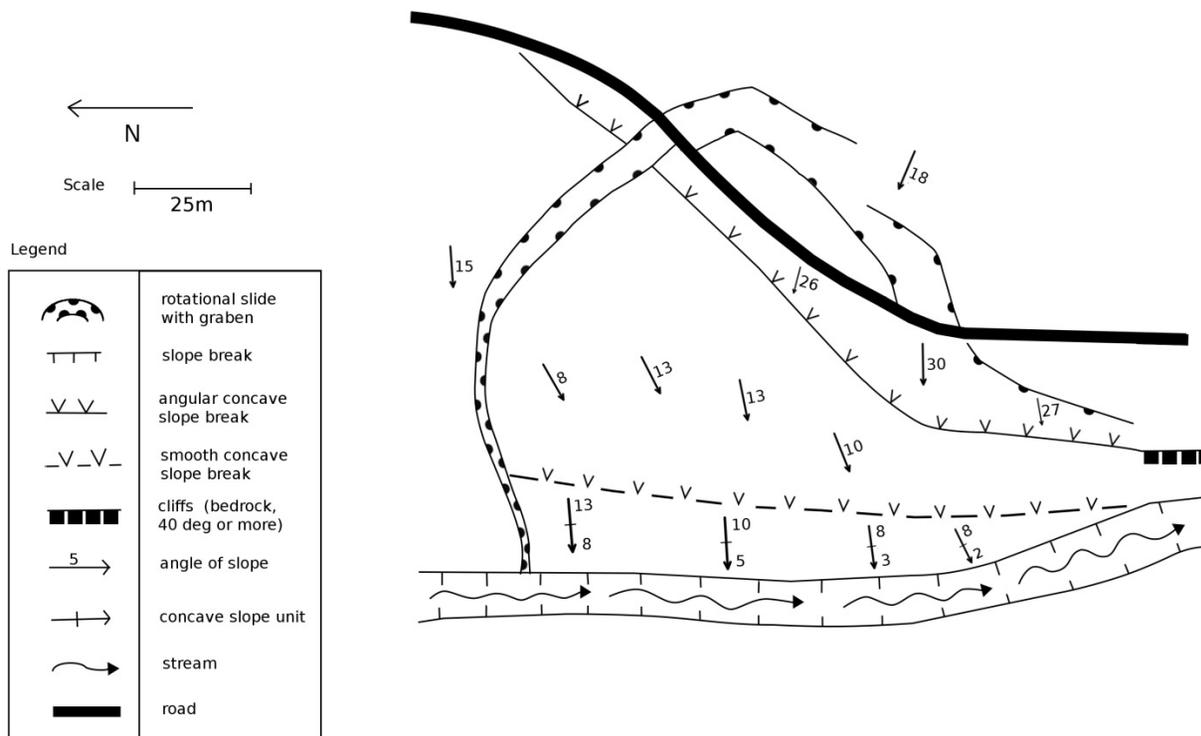
Figure 2. Slope map of the study area depicting a landslide, graben, road and slope features.

The rotational failure occupies approximately $1.25 \times 10^4 \text{ m}^2$ on the west side of the study area and exhibits a variety of slopes and surface features. Slopes directly above the failure headwall and graben (trench) range between 15° and 18° (Figure 2). Just west of the road slopes increase to 26° - 30° , and further west an angular concave slope break gives way to gentile 8° - 13° slopes. A smooth concave slope break parallel to the creek results in slopes between 2° - 8° from the break to the drop off into the creek. The edge of the creek is a steep (greater than 40°) slope composed of soil and rock. The graben is well defined on the north and east sides but is broken and begins to dissipate to the southeast. The northern section of the graben, on the west side of the road, varies in depth and width from 0.2 m deep and 1.0 m wide near Big Chico Creek to 2.0 m deep and 6.0 m wide near the road. This section is situated in thinner sandy soils that form 0.25 to 0.50 m terracettes lining the interior walls of the graben. The eastern section of the graben has an arcuate shape and is not continuous on the upper central side of the slope. Width of the graben is approximately 8 m on the east side of the road excluding the

fragmented portion. The depth varies greatly from 2.5 m on the northeast side to 1.0 m to the southeast.

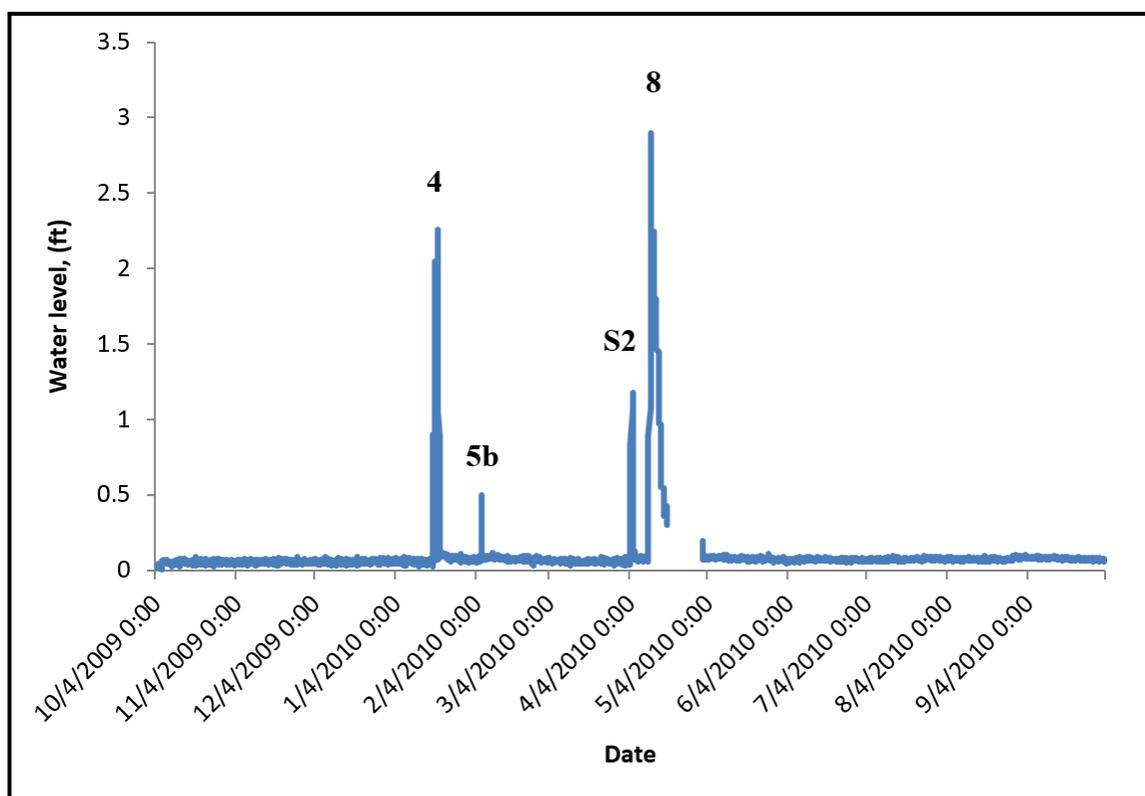
Figure 5. Water levels in piezometer 1 and corresponding precipitation events.

Piezometer 1, located in the toe of the failure on a small hummock (Figure 4) was the least responsive of the sensors; water levels in the piezometer ranged from 0.0 to 2.9 feet with high levels corresponding to three of the nine events. The piezometer also exhibited a high water level during a storm not considered a significant event according to the criteria set forth earlier. A water level of 2.6 feet corresponded to the period of greatest rainfall intensity during precipitation event 4 (Figure 5); the piezometer then

drained rapidly before the event finished. A water level of 0.5 feet was exhibited during event 5b. High antecedent moisture conditions produced by event 5a and maximum rainfall intensity for the 5b event likely contributed to this increase in water level. A

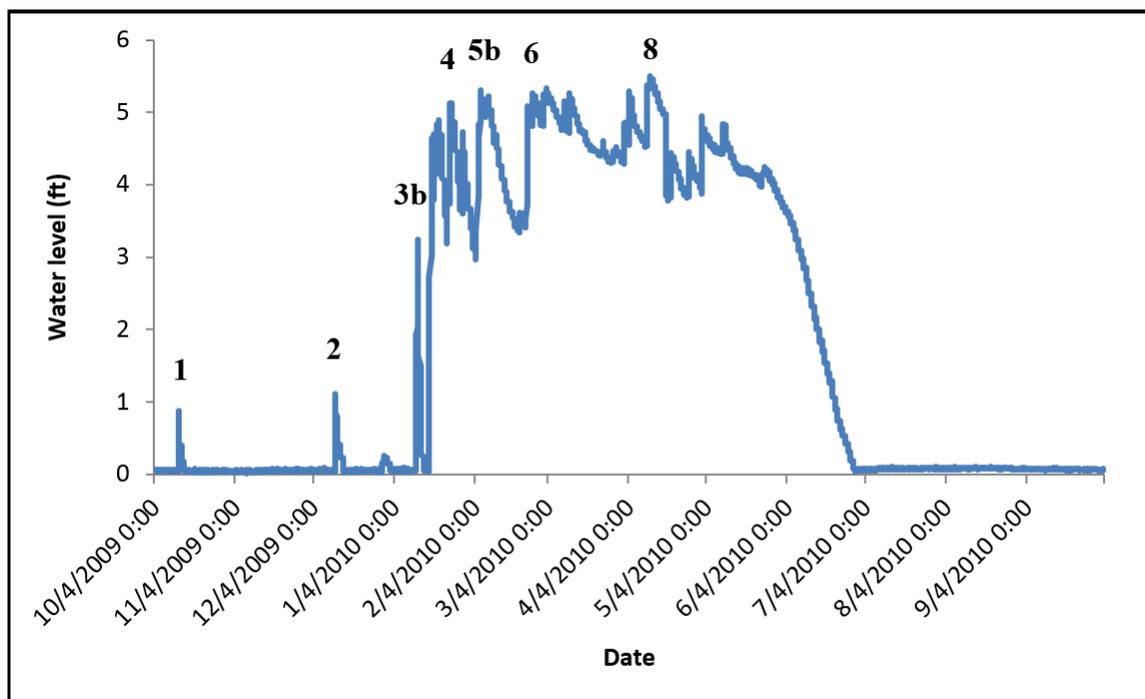
Figure 6. Water levels in piezometer 2 and corresponding precipitation events.

Piezometer 2, located in a swale on the west side of the failure near Big Chico Creek (Figure 4), exhibited a response to all of the precipitation events and maintained water from January 12, 2010 to July 1, 2010. A water level of 0.9 feet corresponded to precipitation event 1 (Figure 6); Piezometer 2 was the only piezometer to register the event. A water level of 1.1 feet corresponded to the highest rainfall intensities for precipitation event 2 and a water level of 3.2 feet corresponded to the peak rainfall intensity for event 3b. After this event a permanent perched water table was formed. High water tables were recorded for events 4, 5b, and 6 with a peak water level of 5.3 feet corresponding to precipitation event 8. The response of Piezometer 2 to precipitation

events can be attributed to its location in a swale near the edge of Big Chico Creek that collected and infiltrated precipitation.

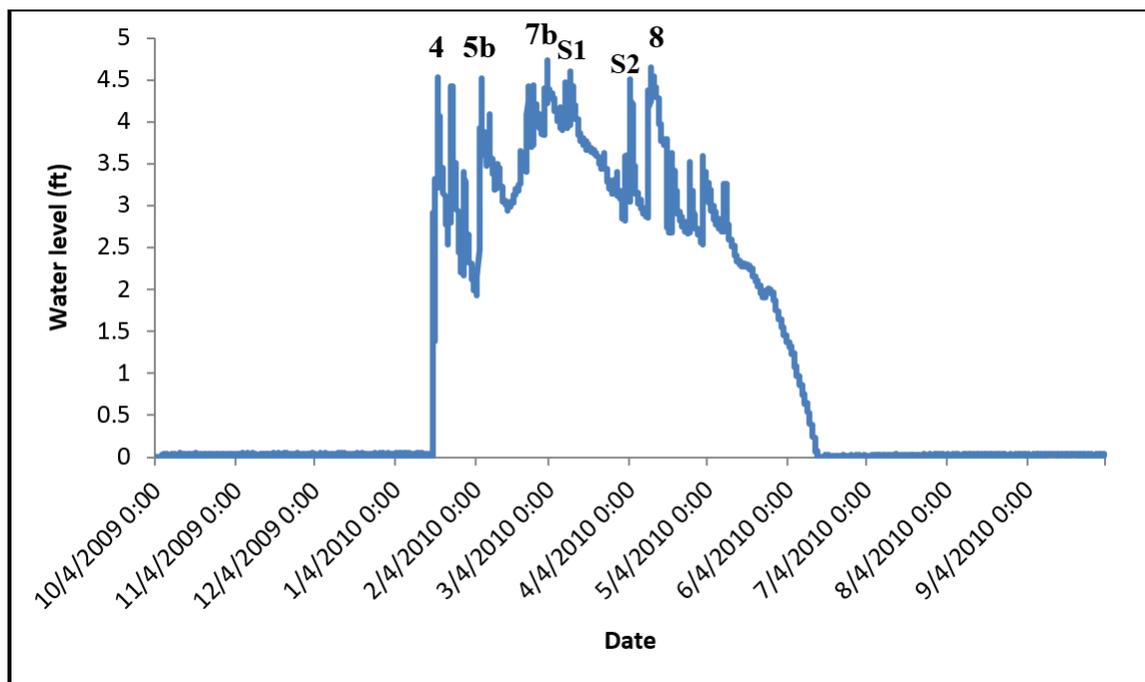
Figure 7. Water levels in piezometer 3 and corresponding precipitation events.

Piezometer 3, located in the northern third of the slide between the road and the creek on a mild 13° slope (Figure 4), maintained water from January 18, 2010 to June 15, 2010. Water levels ranging from 0 feet to 4.7 feet in Piezometer 3 corresponded to precipitation intensity peaks for events 4, 5b, 7b, and 8 (Figure 7) with the highest peak of 4.7 feet occurring on March 3, 2010 during precipitation event 7b. High water levels also occurred during precipitation events on March 10, 2010 (S1) and April 4, 2010 (S2), although the storms occurring on those dates did not produce enough precipitation to be considered significant events, producing 0.8 inches in 5 hours and 0.9 inches in 7 hours, respectively. High water levels and the formation of a more permanent perched water

table were probably the result of Piezometer 3 being located near a slope break where surface water could accumulate and aid infiltration.

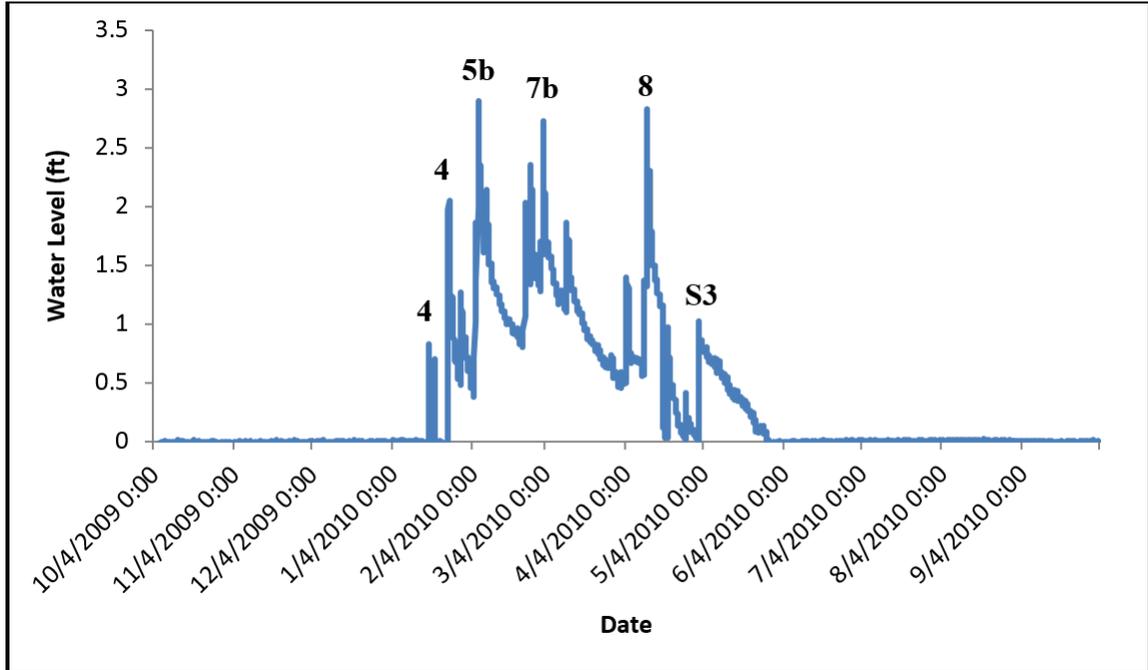
Figure 8. Water level in piezometer 4 and corresponding precipitation event.

Piezometer 4, situated in shallow soils just outside of the north end of the landslide (Figure 4), exhibited a perched water table from January 20, 2010 to April 26, 2010 and then again from April 27, 2010 to May 27, 2010. High water levels of 0.8 and 2.0 feet occurred during precipitation event 4, a series of storms lasting 9.5 days (Figure 8). These storms produced enough precipitation to create a sustained perched water table. The high water level of 2.9 feet during precipitation event 5b did not correspond to peaks in rainfall intensity, unlike water levels of 2.7 and 2.8 feet during events 7b and 8, which did correspond to increases in rainfall intensity. The high water level recorded on May 2, 2010 corresponded to a brief 2 hour storm (S3) that occurred 4 days earlier. The

piezometer was located in thin soils just outside the failure on a slope dipping 15° west toward the creek. This allowed for more runoff and less infiltration due to its placement on the slope.

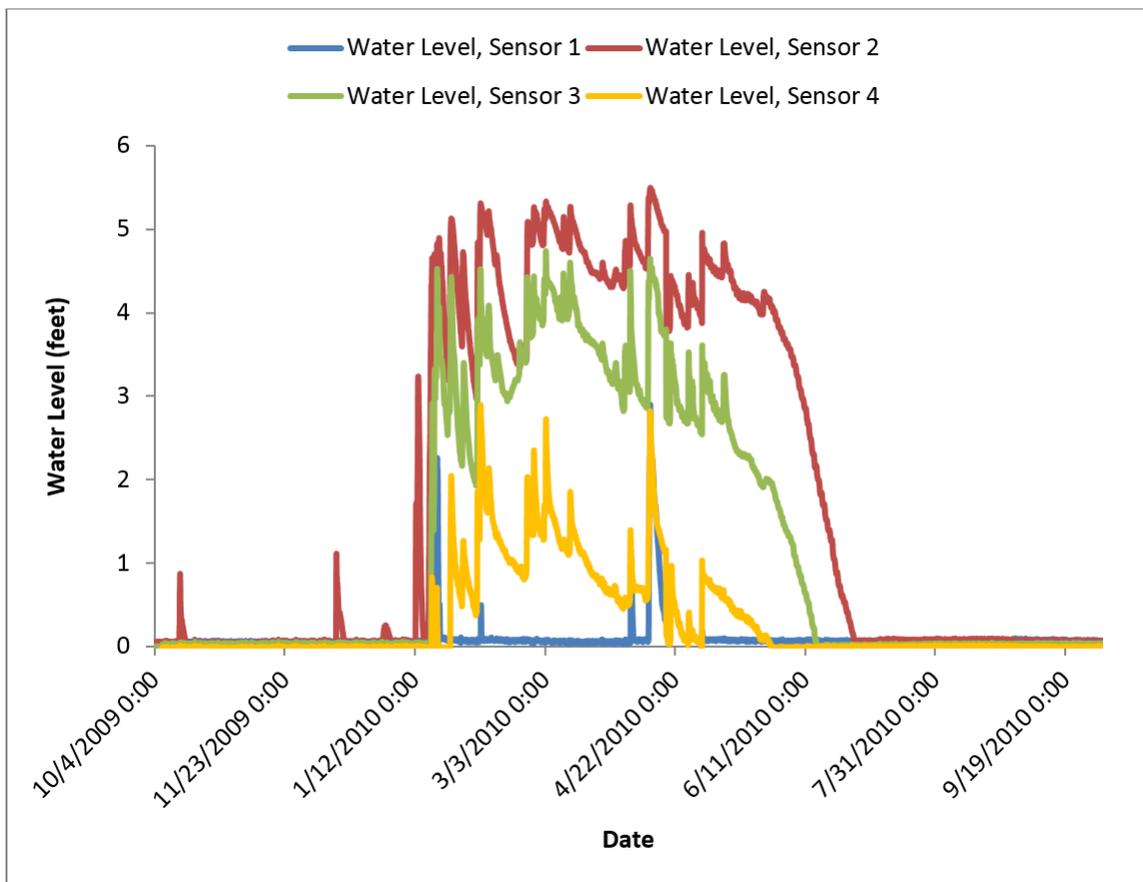
Figure 9. Water levels in piezometers 1-4.

When examining the piezometer data some similarities and differences became evident (Figure 9). Located near the creek on the south side of the study area, Piezometer 1 was the least responsive of all the piezometers and drained quickly. Piezometer 4 was the second least responsive of the piezometers but was able to maintain a water level from January 20, 2010 to April 26, 2010 but drained more quickly than Piezometers 2 and 3. Both Piezometers 1 and 4 were at similar depths, 49 and 48 inches respectively, and were placed in fine sandy loam; however, Piezometer 1 was located on a small hummock near the creek and Piezometer 4 was on a 15° slope just outside of the failure to the north. Piezometers 2 and 3 were 65 and 67 inches deep respectively and

responded similarly to precipitation events with Piezometer 2 being the most responsive of the all the piezometers. Piezometer 2 was located near Big Chico Creek in a swale and had a perched water table for the longest period of time while Piezometer 3 was located in the northern third of the slide between the road and the creek on mild 13° slopes.

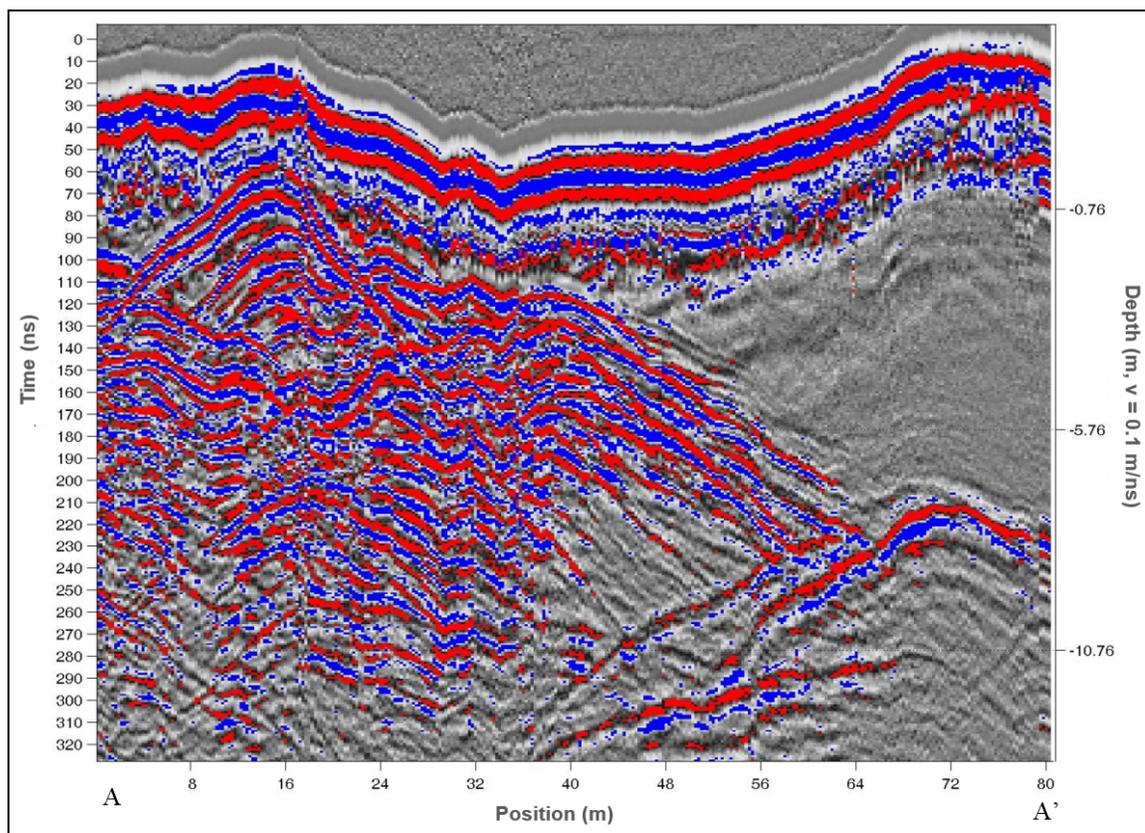
Figure 11. GPR profile of line 1.

Line 1, located along the road and running northeast to southwest, was 80 m long and penetrated to a depth of approximately 13 m (Figure 11). All three types of reflectors were visible in this line. The first reflector was strong and encompassed more than half of the GPR line, beginning at the start of the line and pinching out at 64 m distance at a depth of 7 m (Figure 12). The associated reflections were stronger and more chaotic near the surface, gradually weakening with the depth. Because there were several jumbled interbedded reflections within this section, separation of the surfaces was difficult. The second type was weak reflector beginning at 36 m, near the surface, and gradually thickens from 0.5 m to a maximum of 7 m. It was smoothly textured, with only minor reflections. The third reflector began 35 m along the line at a depth of 13 m increasing to a maximum thickness of 6 m at 70 m and declining to 4 m at the end of the line. There were two distinct reflections within this section with smaller parallel medium-strength reflections beneath them.

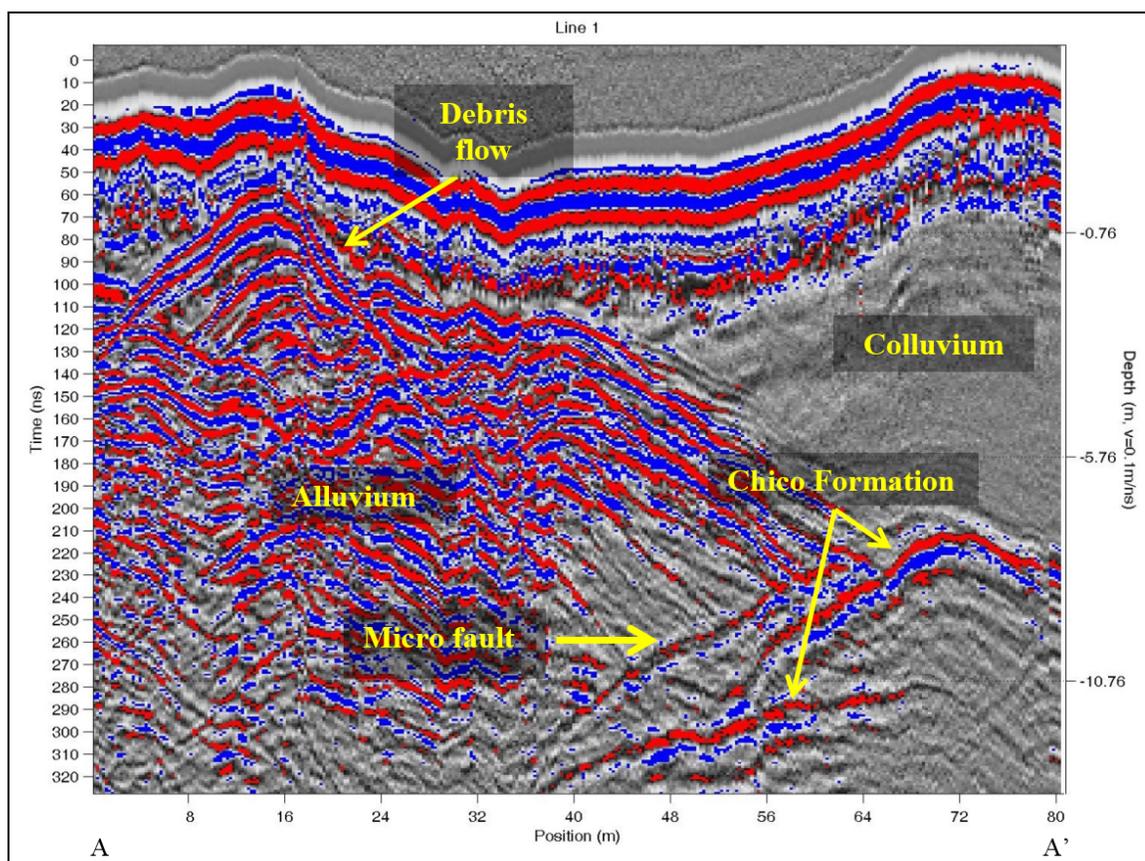
Figure 17. GPR profile of line 1 with interpreted features.

According to these guidelines, Line 1 showed the strong parabolic signature of the debris flow and alluvium (Figure 17). The debris flow is approximately 18 m wide and sits upon the alluvial deposits. The contact between the colluvium and the Chico Formation can be seen between 38 and 80 m. Because some faults in ground penetrating radar surveys are seen as one-sided diffractions (Bano et al., 2000). A single dipping parabolic arm visible in the survey could suggest the presence of a micro-fault. Although near the contact, the reflection cuts across reflections parallel with the alluvial deposits.

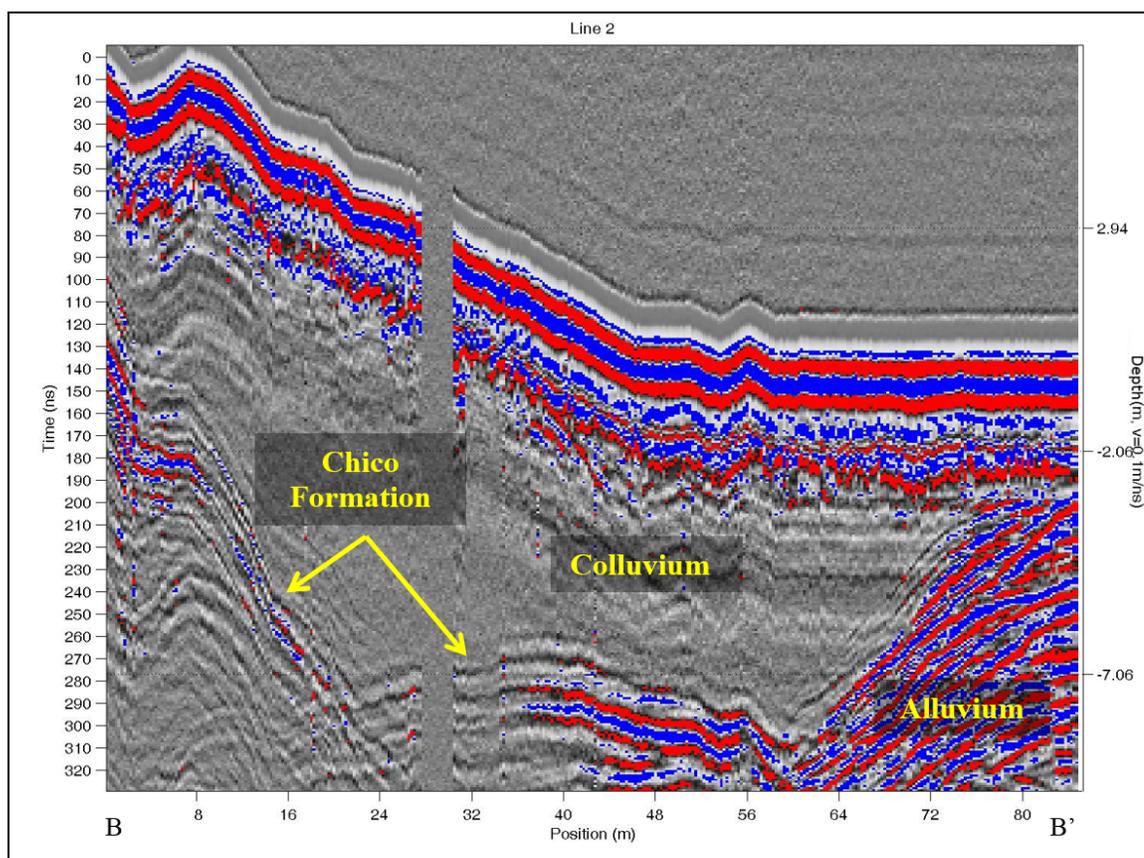
Figure 18. GPR profile line 2 showing interpreted features.

The GPR survey suggests Line 2 is composed of mostly colluvium. A 10-meter thick section of Chico Formation can be seen thinning to 2 m when it contacts another section of Chico Formation at 20 m. These both exhibit medium parallel reflections consistent with the other lines. At 60 m alluvial deposits can be seen (Figure 18).

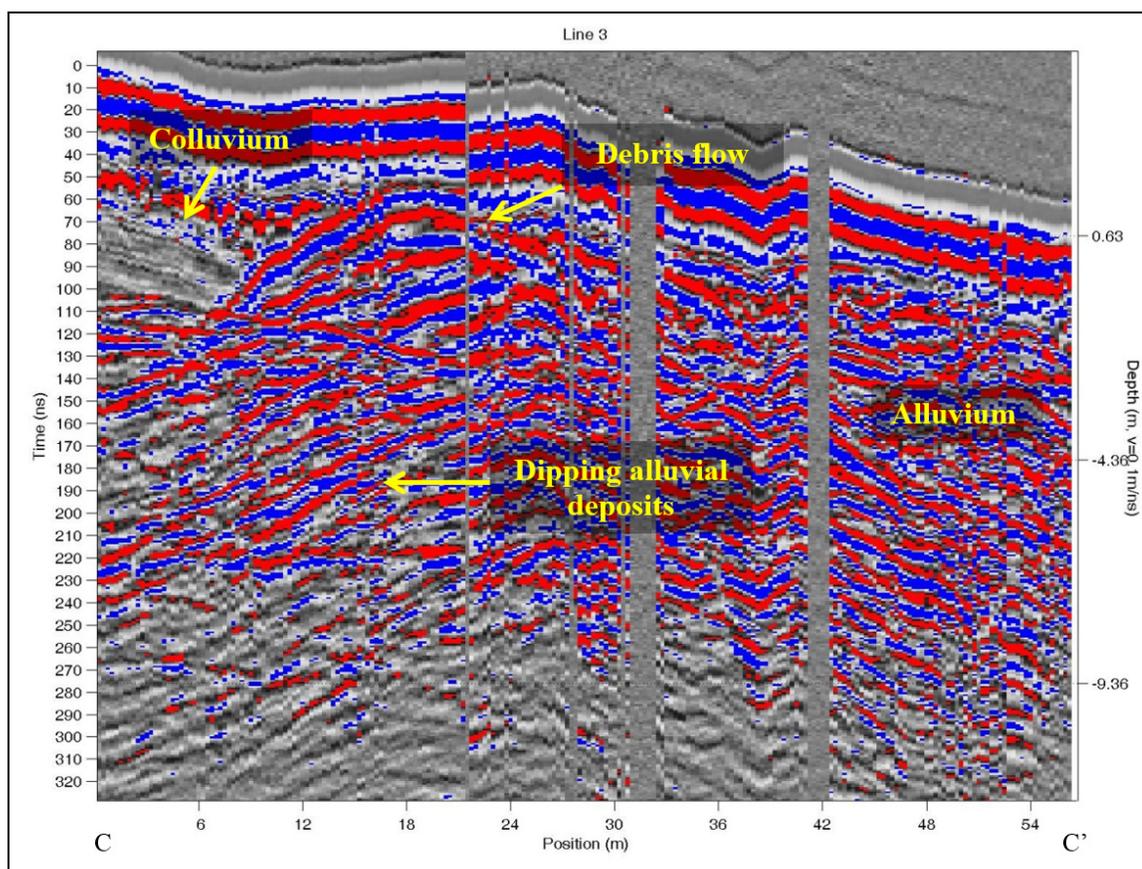
Figure 19. GPR profile line 3 showing interpreted features.

Reflectors along Line 3 suggest the presence of alluvium with the debris flow from line 1 evident between 8 m and 26 m and a small amount of colluvium (Figure 19). There is evidence of alluvial deposits dipping to the north east between 0 m and 28 m

indicating possible channel migration. Beyond 26 m distortion in the line makes interpretation difficult. Thick grass along the line reduced contact with the ground surface and multiple terracettes in the graben may have contributed to uneven antenna spacing causing a poor quality reflection.

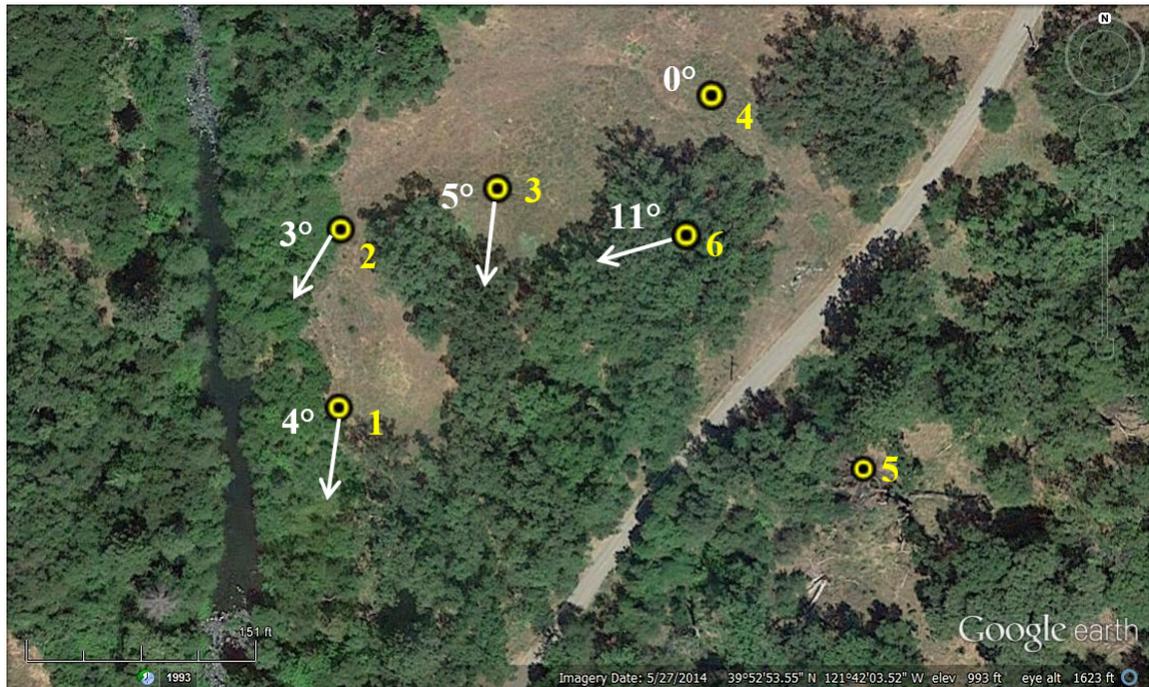
Figure 21. Satellite photo showing piezometer locations (yellow) with tilt measurements (white).

Piezometer #	Tilt	Direction of Tilt
1	4°	S10°W
2	3°	S35°W
3	5°	S5°W
4	0°	0
6	11°	S75°W

the steeper slopes was downslope toward Big Chico Creek. On the more gentle slopes, tilt measurements indicated movement downslope but somewhat parallel to Big Chico Creek (Figure 21). Piezometers 1 and 2 were tilted at an angle similar to the slope of the surrounding area. Piezometer 3 exhibited a tilt similar to that of the slope; however, the direction of tilt differed from the direction of slope by 55°. Piezometer 4, which is just outside the slide area to the north, was still level despite being on a 15° slope. Piezometer 5 could not be measured as it had been buried by debris from a fallen oak tree.

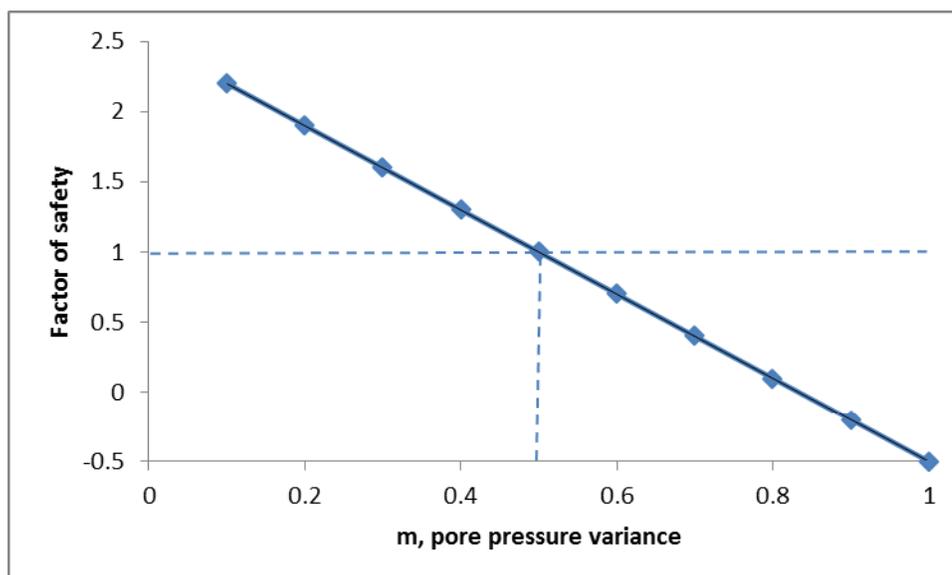
Figure 26. Variation in factor of safety as height of water table above the slide plane (m).

The model was run several times to determine how high the perched water table needed to be to instigate slope instability. The results suggest that when the pore pressure variance, m , is equal to 0.5, the factor of safety, F , is equal to 1 (Figure 26). Perched water tables that sat at levels greater than half the distance up from the failure surface in the soil column would cause the slope to be unstable, while those sitting at less than half the distance would allow the slope to remain stable. Field measurements indicate that two of the piezometers in the lower section of the slide consistently showed the water table to be within 1 meter of the surface during and after precipitation events. For example, Piezometer 2, located near the creek, was within six inches of the ground

surface on several occasions and was within 1 m of the surface from January 13, 2010 to June 14, 2010 (Figure 6). Piezometer 3, located in the center of the failure, indicated that the water table was within 1 m of the ground surface from January 18, 2010 to May 22, 2010 (Figure 7) giving Piezometers 2 and 3 an m value of 0.9. Pore pressure variances greater than 0.5 were likely to result in slope instability, a condition common throughout the measured period.
