UAV-based Thermal Imaging for Detecting Near-Surface Voids on Roadway Pavements

using Computer Vision and Deep Learning Algorithms

Georgia Institute of Technology

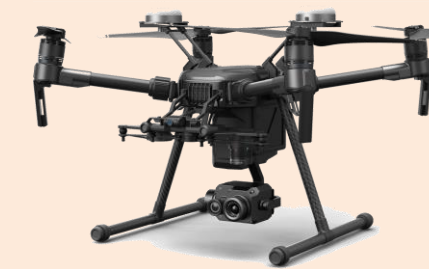
Location: NCAT Facility in Opelika AL.
Drone model: DJI Matrice 200
Camera model: Zenmuse XT2
IR Resolution: 640 × 512

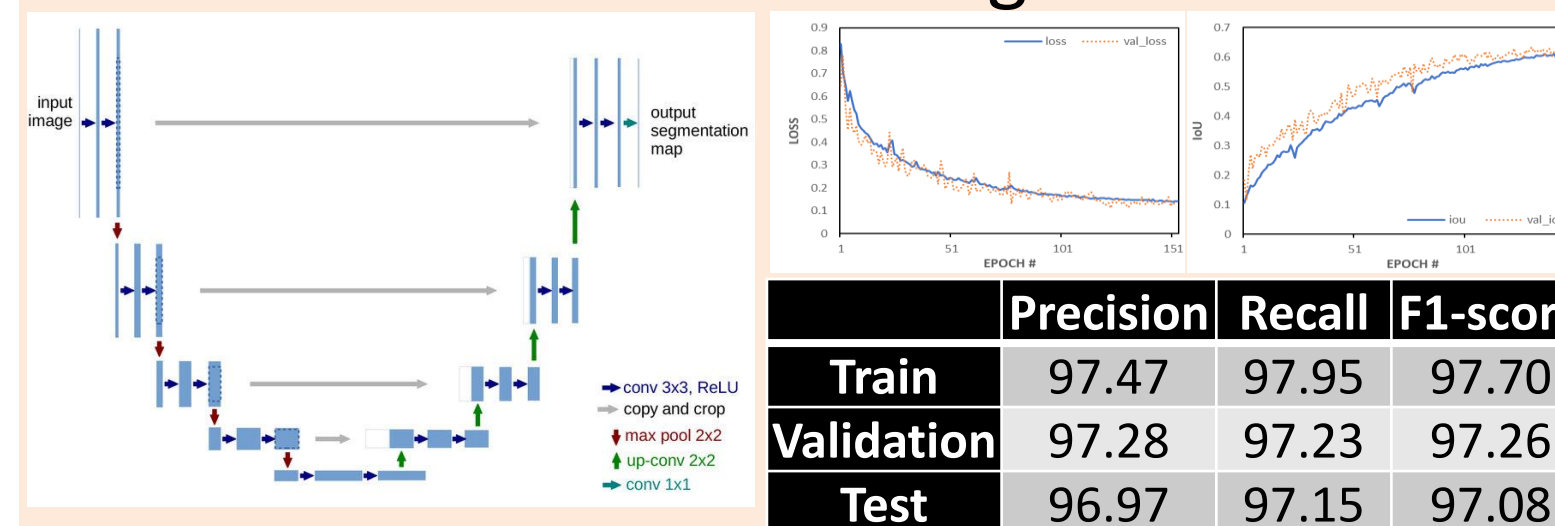
- UNet model for crack segmentation

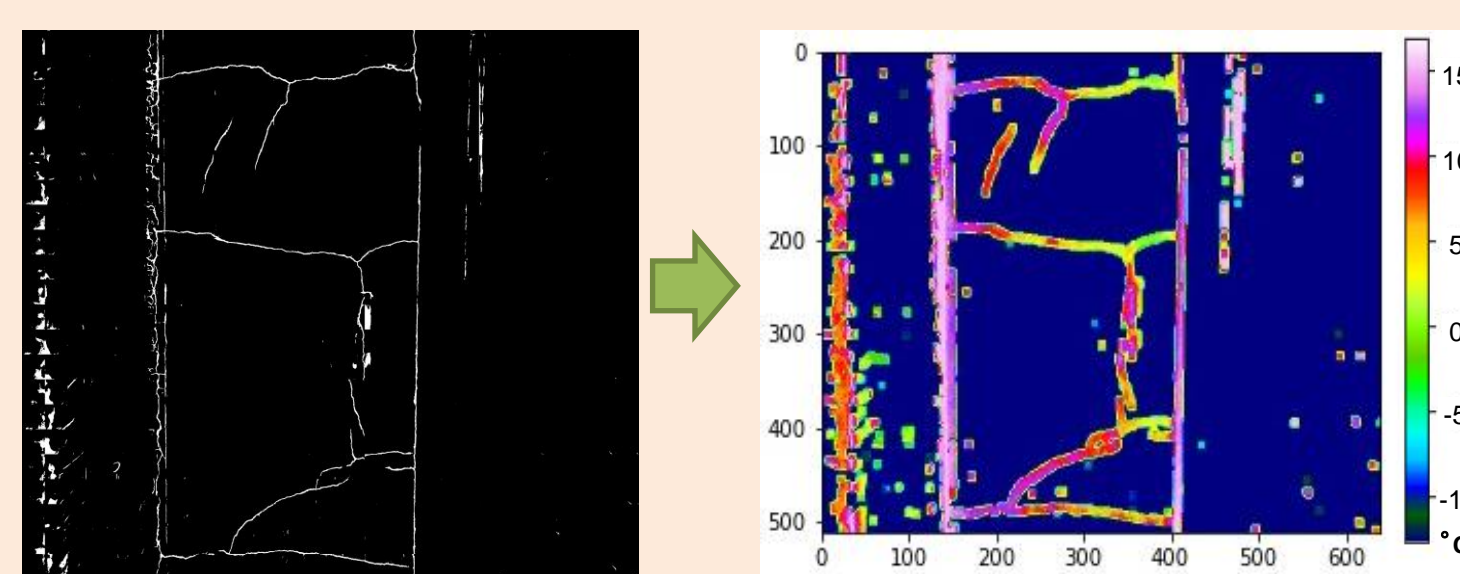
- Crack with Thermal Information

- Thermal anomalies → Near-surface voids
 - Potential voids beneath surface
 - Voids containing air, moisture

- Binary crack segmentation
- Dilate crack regions
- Multiply with IR temp data
- Normalize temperature colormap
