Minimizing Reflective Cracking With Applications of the Rolling Dynamic Deflectometer and Overlay Tester

ABSTRACT

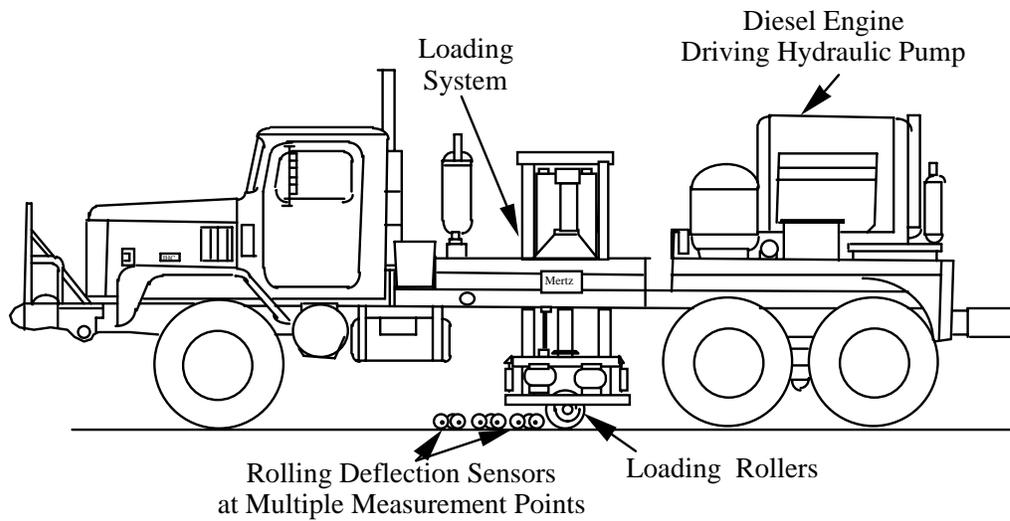
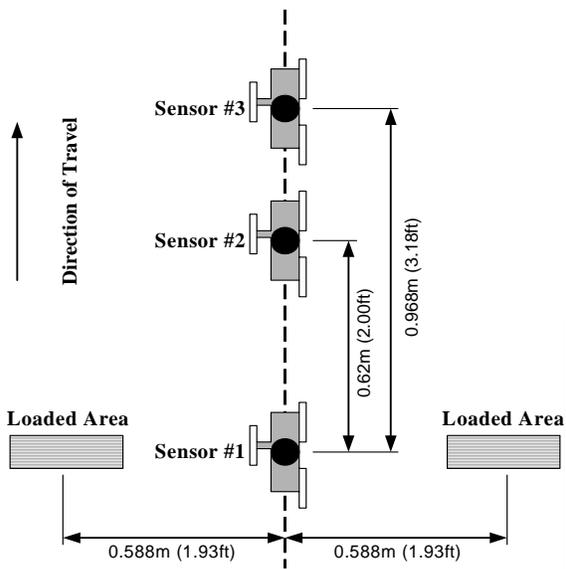
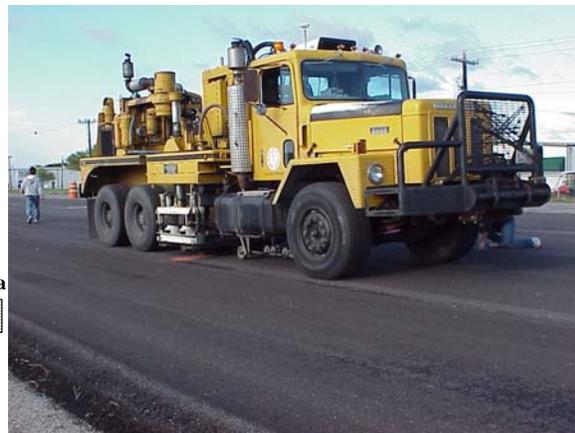
Figure 1. Schematic and general rolling dynamic deflectometer arrangement with typical rolling sensor configuration.

Continuous deflection measurement provides valuable information for determining joint and crack conditions of an existing roadway. Research results (Scullion 2005; Chen et al. 2007; Chen 2008) have clearly demonstrated the capabilities and benefits of the rolling dynamic deflectometer (RDD) in providing continuous deflection data over entire projects. Figure 1 shows a schematic view of the RDD and sensor arrangement.

With reference to the RDD deflection sensors shown in Figure 1, research results (Chen et al. 2007; Chen 2008) have demonstrated that $W1-W3$ is a good indicator for reflective cracking potential, especially in areas where $W1-W3$ exceeds 6.5 mils on an AC surface without milling. $W1-W3$ is usually at a maximum when sensors 1 and 3 are on either side of a joint. A higher $W1-W3$ value is interpreted as a poorer load transfer across a joint or crack. $W1-W3$ deflections for IH-20 (eastbound lane, before milling) are presented in Figure 3. The unit used on the Y-axis (and hereafter) is mils/10 kips, which represents the measured deflection in mils under 10 kips of peak dynamic force. As shown in Figure 3, numerous locations have significant spikes where the $W1-W3$ deflection exceeds 6.5 mils. These spikes indicate locations with poor load transfer or significant relative vertical movements.

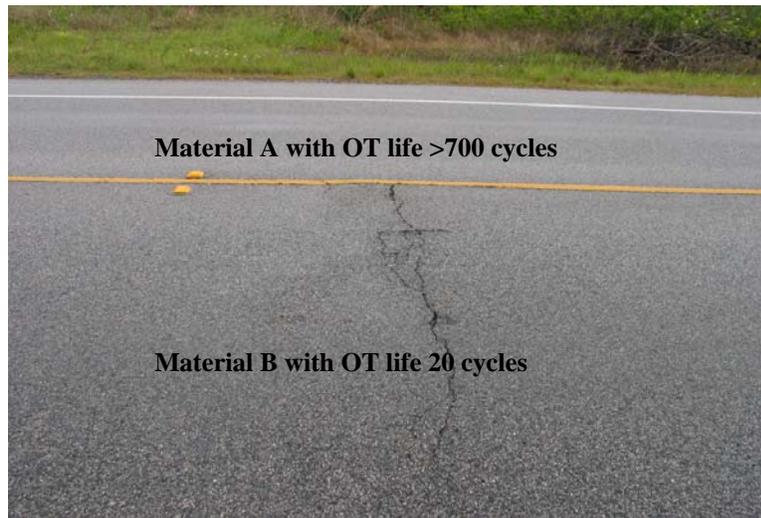
OT = overlay tester

Figure 2. Comparison of ability to resist reflective cracking for materials A and B after 2 years of traffic.

The overlay tester (OT) has been applied with success to characterize asphalt mixes' ability to resist reflective and fatigue cracking (Zhou and Scullion 2005; Zhou et al. 2007). Based on extensive laboratory and field performance observation, Zhou and Scullion (2005) found that the OT results matched very well with field cracking. When an asphalt mix lasts more than 700 cycles in the OT, it is thought to have good fatigue resistance (Zhou et al. 2007). Figure 2 shows a comparison of ability to resist reflective cracking for materials A and B after 2 years of tracking. While materials A and B were placed at the same time above the same JCP pavement structure, material A (with OT life exceeding 700 cycles) does not have reflective cracks. There are reflective cracks in the lane with material B because the mix is brittle. The OT life of material B was only 20 cycles. This example clearly demonstrates the importance of mix properties in preventing reflective cracks.

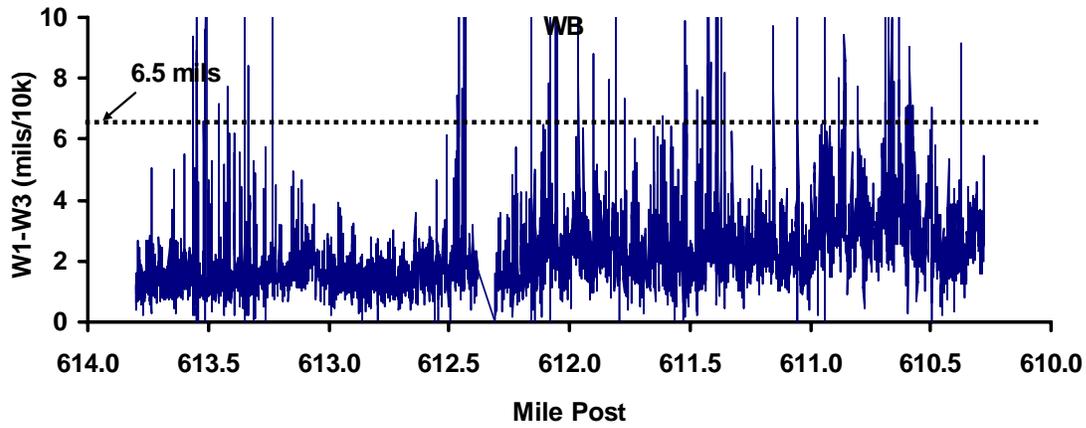
Figure 3. W1–W3 continuous deflections before milling for IH-20. Spikes indicate poor load transfer or significant vertical movements that indicate a high potential for reflective cracking.

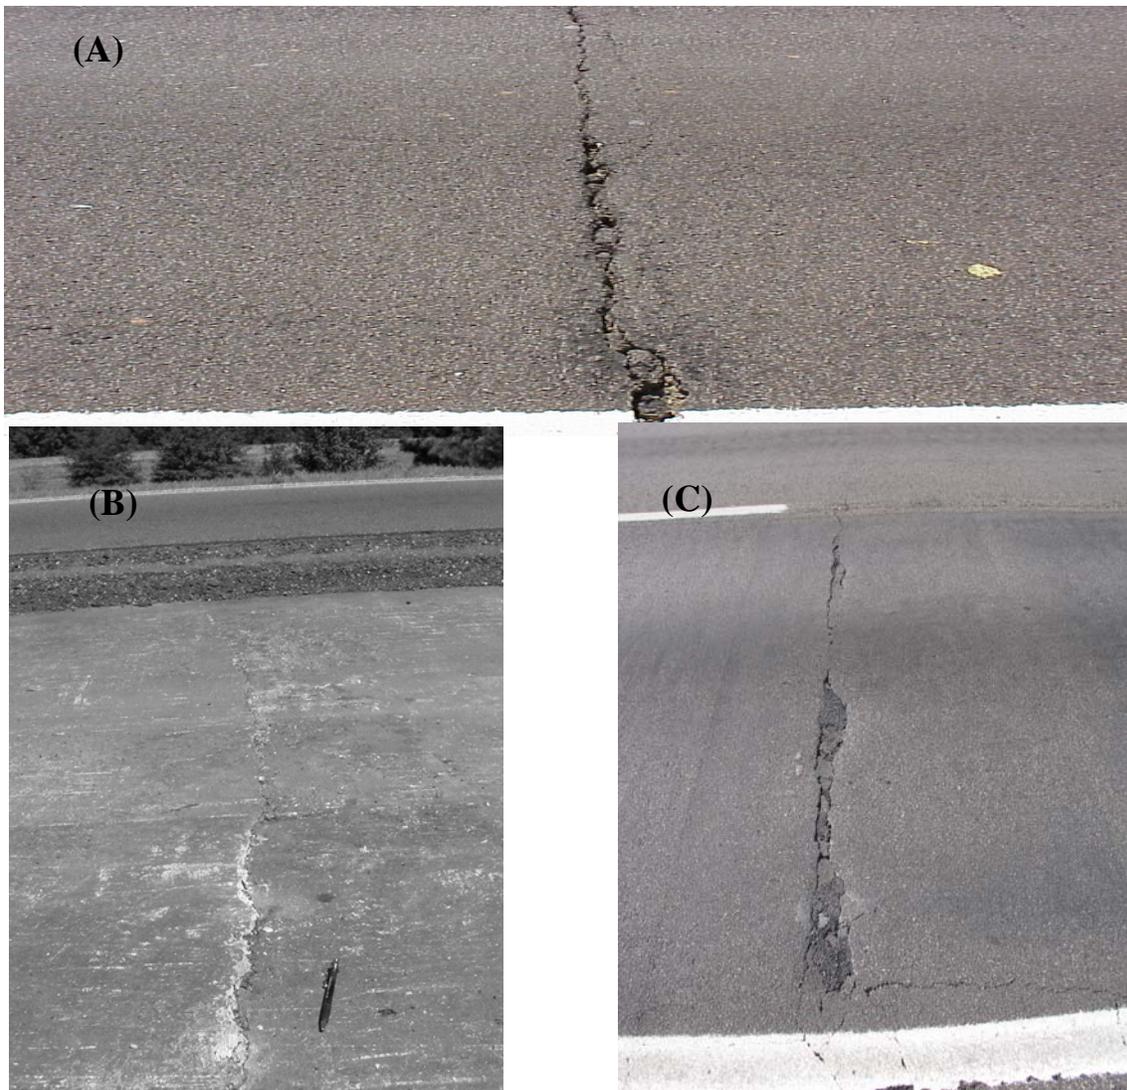
Figure 4. Pavement conditions along IH-20 (A) before milling, (B) after milling and before overlay, and (C) with reflected cracks 1 year after overlay.

Figure 4 illustrates the pavement condition before milling, after milling, and 1 year after the 100-mm AC overlay. Even though there were significant vertical movements, no full-depth repairs were performed at this location, and cracks reflected through within 1 year. In fact, numerous reflective cracks were observed on IH-20 after only a few days. The lab results on the cores taken from IH-20 indicated that the 100-mm AC overlay was stiff and rut resistant, but had relatively poor crack resistance. Under the Hamburg Wheel test, the AC overlay had rutting of less than 12.5 mm after 20,000 cycles at 50C. The AC cores were tested with the OT, and it only took 2 cycles to fail the specimens. This means the AC overlay is very brittle and prone to crack. After traffic resumed, numerous locations like those shown in Figure 4 were observed, and many patches had to be placed in 25 months or less. The distress condition survey indicated that there were 90 locations (63 reflected cracks plus 27 patches) with distress after 25 months.

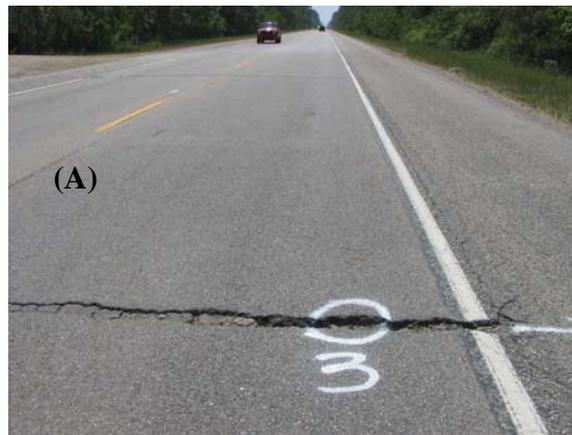
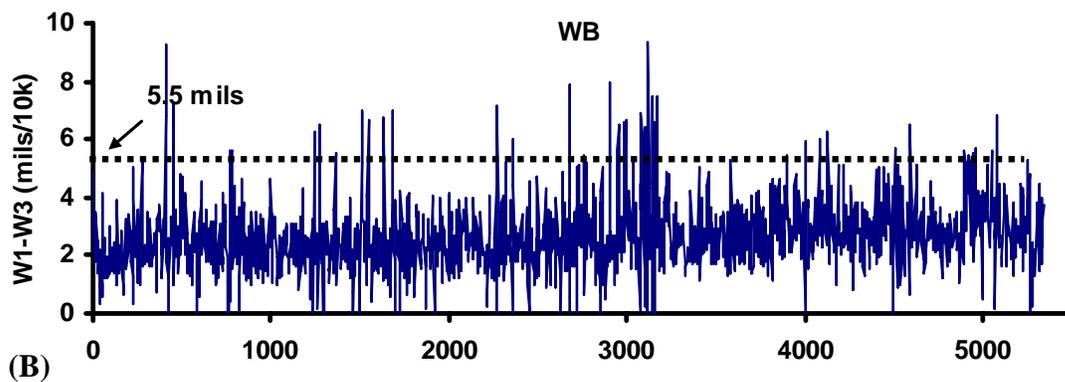
Figure 5. Pavement conditions and rolling dynamic deflectometer (RDD) measurements on SH-12: (A) pavement conditions before milling; (B) RDD continuous profiles after milling.

A typical continuous deflection profile collected on SH-12 is shown in Figure 5. RDD tests were performed on the milled JCP surface. Research results (Chen et al. 2007; Chen 2008) indicated that exposed concrete surfaces with a *W1–W3* deflection exceeding 5.5 mils indicates a high potential for reflective cracking.

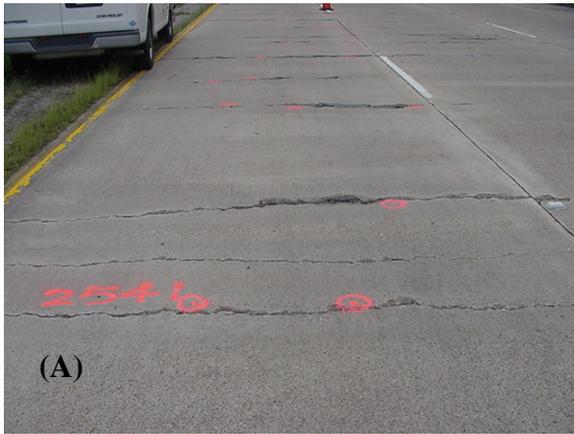
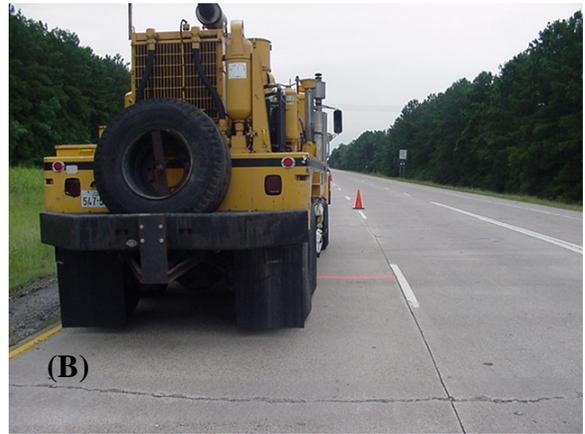
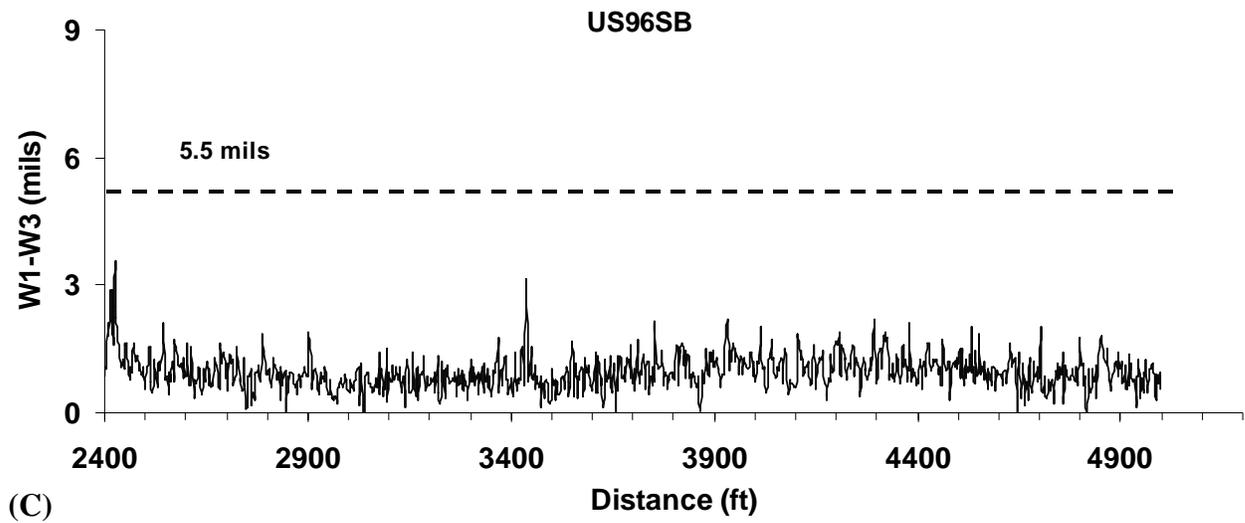
Figure 6. (A) Pavement condition of US-96 before rehabilitation with severe cracking and spalling; (B) rolling dynamic deflectometer testing (RDD); (C) RDD continuous deflection profile (on top of exposed concrete surface) for southbound direction.

A 40-year-old CRCP on US-96 was being considered for major rehabilitation for the first time. Extensive spalling of the original CRCP near the transverse cracks was evident. The spalling was found to be limited to the top 50 mm. The pavement consists of 8 in. (203 mm) of CRCP and 4 in. (102 mm) of CTB. The roadway condition before rehabilitation is shown in Figure 6A. A candidate rehabilitation strategy proposed by the District consisted of placing an SMA overlay, 3 in. (76 mm) thick. The main concern with the placement of the overlay was the potential for reflective cracking. Since the reflective cracking is highly related to movement of the slabs at the cracks, the District requested an RDD survey to assess the support under the slabs at the cracks, as shown in Figure 6B. The continuous deflection profile collected by the RDD at this site is shown in Figure 6C. In view of Figure 6C, it was found that no cracks had *W1–W3* deflection exceeding 5.5 mils, indicating good load transfer and little reflective cracking potential.
