Optimization of Concrete Maintenance to Extend Pavement Service Life

Craig White¹ and David K. Hein²

ABSTRACT

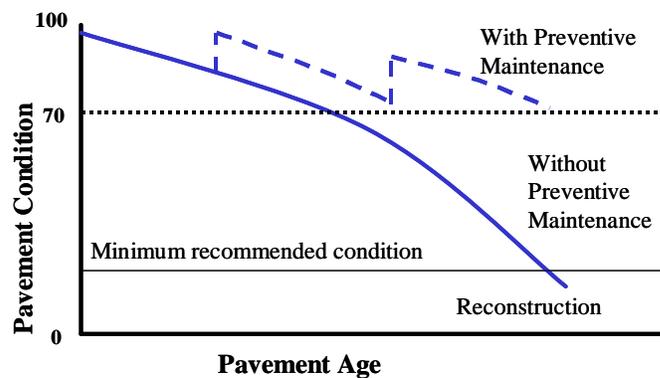
Figure 1. Pavement deterioration with and without preventive maintenance.

The key to cost-effective preservation of pavements is to have a toolbox that includes a variety of effective preventive maintenance techniques that can be effectively used to extend the service life of the pavement. Preventive maintenance treatments are applied to prevent premature deterioration of the pavement or to retard the progression of pavement defects. As a result, the pavement is maintained at a relatively high level of service. This type of approach is illustrated in Figure 1.

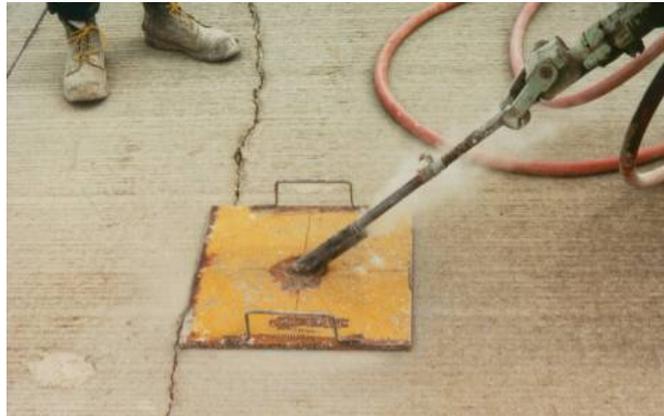
Figure 2. Drilling holes for cross stitching.

- Drilling holes at a 35-to-45° angle so that they intersect the crack at about the slab middepth (Figure 2).
- Cleaning of holes by air blasting.
- Injecting epoxy into the hole (in sufficient volume to fill all the available space after a tie bar is inserted).

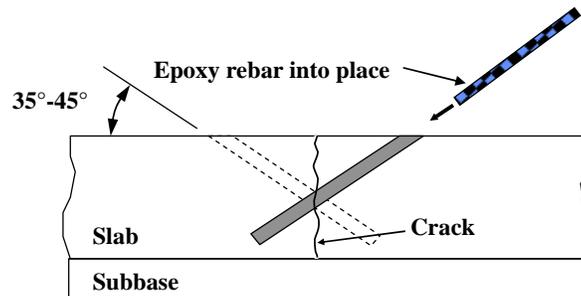
Figure 3. Stitched longitudinal crack.

- Inserting a deformed tie bar into the hole, leaving about 25 mm (1 in.) between the pavement surface and the end of the tie bar (Figure 3).
- Removing excess epoxy and finishing it flush with the pavement.
- Sealing of the crack (Figure 4).

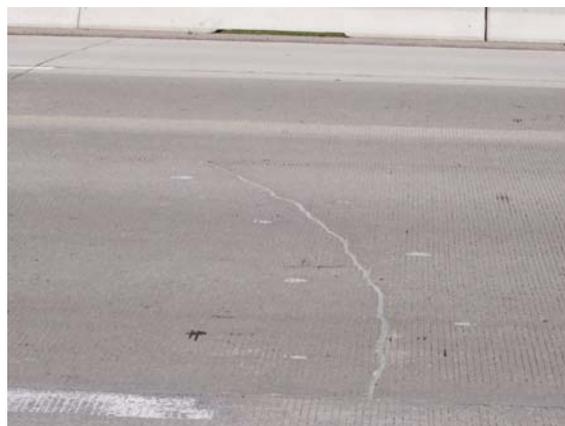
Figure 4. Completed crack stitch.

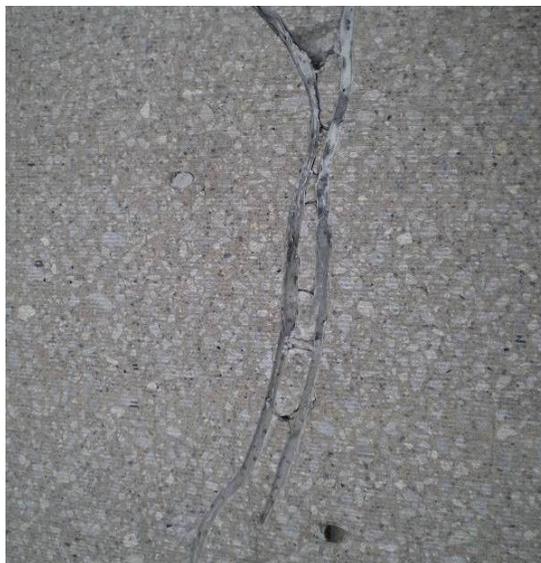
Figure 5. Cracking at a stitch that was completed too late.

407 ETR has completed cross stitching for over 350 cracks over the past 10 years. To date, the installation and performance has been excellent. The estimated service life for crack stitching is expected to be 10 or more years. Cracks stitched in 1998 still show excellent performance. The typical cost for crack stitching is in the order of US \$60 per bar (2008 dollars). This is substantially less than the cost and user inconvenience if the concrete slabs were removed and replaced. Crack stitching is a cost-effective tool in extending the service life of a concrete pavement while minimizing the impact on traffic. A key lesson learned with respect to crack stitching is the early identification of cracking and immediate stitching of the crack before any secondary cracking occurs. If secondary cracking has occurred, the effectiveness of the treatment is reduced (Figure 5). While crack stitching has been used successfully for some transverse cracks, it is best suited to longitudinal or diagonal cracks.

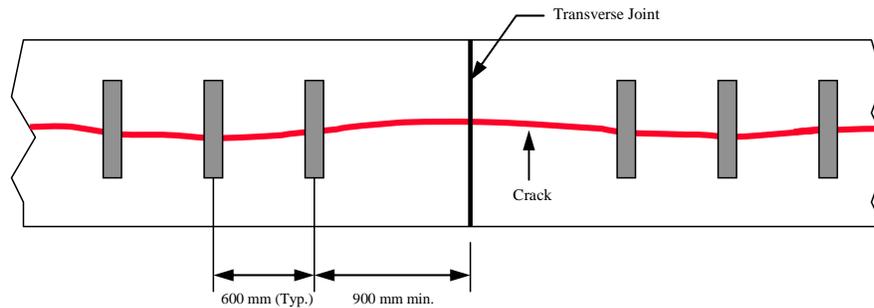
Figure 6. Typical spacing of dowels across a transverse crack.

The purpose of load transfer restoration (also called dowel bar retrofit) is to insert dowel bars across transverse cracks (Figure 6) or insert additional dowel bars across the transverse joints of jointed portland cement concrete (PCC) pavements. The objective is to increase load transfer and reduce potential for further progression of faulting (stepping of slabs), pumping (repeated deflections at transverse joints that can erode slab support), and slab cracking.

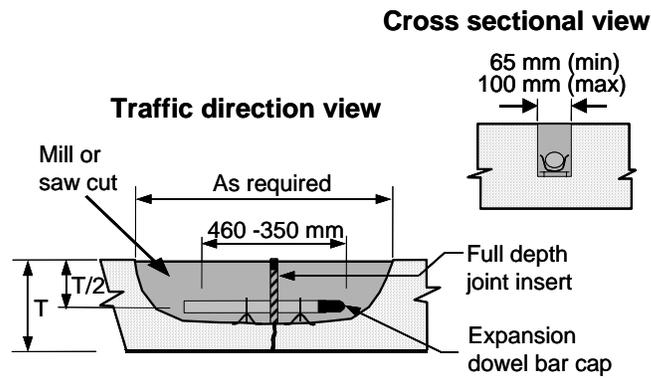
Figure 7. Dowel bar placement for load transfer retrofit.

- Removal of the concrete within the slot using light hammers. The slot must be properly cleaned by sand blasting followed by air blasting.
- Installation of the load transfer devices, which are typically smooth, epoxy-coated dowel bars. The size of the dowel bars depends on the slab thickness and anticipated loads. For the concrete pavement on 407 ETR, which is 280 mm (11 in.) thick, a dowel bar 32 mm (1.3 in.) in diameter and 450 mm (18 in.) long is used (Figure 7). One half of the dowel bar is coated with a bond-breaking compound (grease-based) and equipped with an expansion cap. A spacer is inserted in the middle to preserve transverse crack opening.

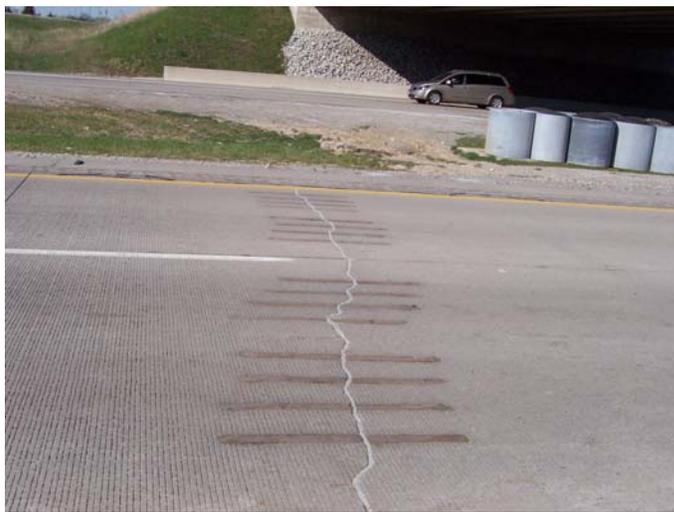
Figure 8. Load transfer retrofit for a mid-panel transverse crack.

Load transfer retrofit techniques are very rapid to complete, require minimal disruption to traffic, and can cost-effectively extend the life of a concrete pavement. A completed load transfer retrofit treatment for a mid-panel transverse crack is shown in Figure 8.

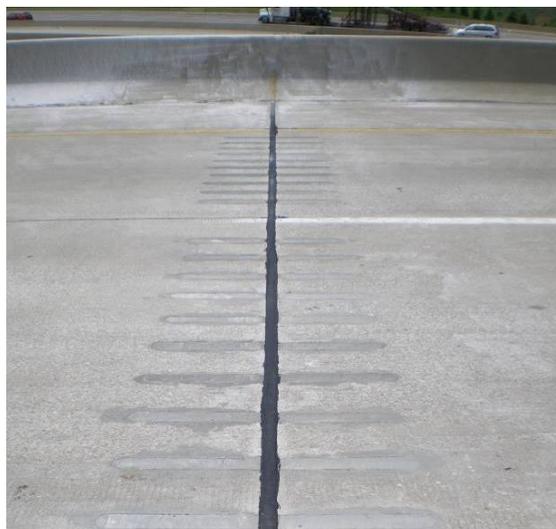
Figure 9. Expansion joint retrofit at bridge approach.

In the late spring/early summer of 2008, expansion joint retrofits were installed at several bridge structures. The expansion joint retrofit is similar to the load transfer retrofit for transverse cracks except, the existing dowel bars at the joint are cut using a diamond saw. A sec-

ond cut is then completed to widen the joint to a width of between 40 and 50 mm (1.6 and 2.0 in.). Slots are cut for new dowel bars in between the existing now cut dowel bars. A fibre expansion board is then placed in the joint to the bottom of the slot cuts and dowel placed in the slots. Dowel bars with expansion caps on one end are then placed within the slots with a plastic grout retention shield on either side of the bar at each slot to ensure that the grout is in the slots and does not flow into the joint. The grout is then placed in the slots to the top of the pavement, followed by additional expansion board, which is then topped with hot-poured rubberized asphalt sealant. A photograph of a typical installation is shown in Figure 9. Shortly after the expansion joint installation, the sealant was noted to be squeezing out of the joint, indicating that pressure is being relieved at the joint and the installation is working as designed.

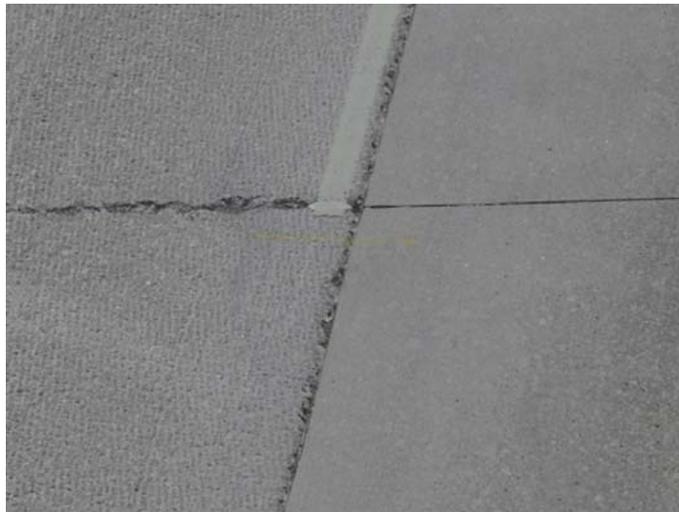
Figure 10. Difference between micro-milling (left) and diamond grinding (right).

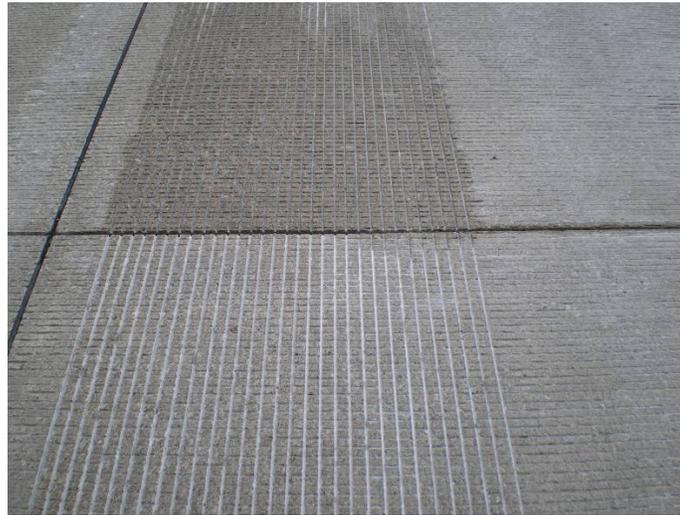
Figure 11. Longitudinal grooving completed perpendicular to the transverse tines.

Grooving of the pavement is not intended to improve pavement smoothness but rather to provide channels for the removal of surface water thus potentially improving the frictional properties of the pavement. Longitudinal grooving is shown in Figure 11.

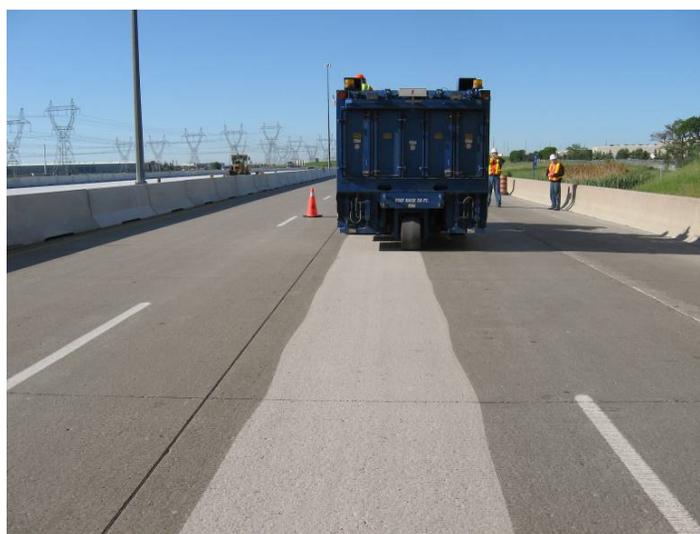
Figure 12. Blastrac concrete pavement surface texturization.

Surface abrading can be completed using a number of proprietary techniques such as Blastrac and Skidabrader. An example of Blastrac texturization is shown in Figure 12.

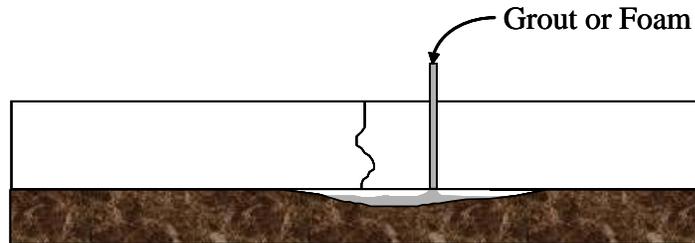
Figure 13. Concept of under-slab sealing and jacking.

Slab stabilization is a rehabilitation technique that fills voids underneath a PCC slab with grout or foam without raising the slabs. Slab jacking fills voids underneath PCC slabs and raises the grade of the slabs. Slab stabilization is also called slab subsealing and under slab grouting (Figure 13).

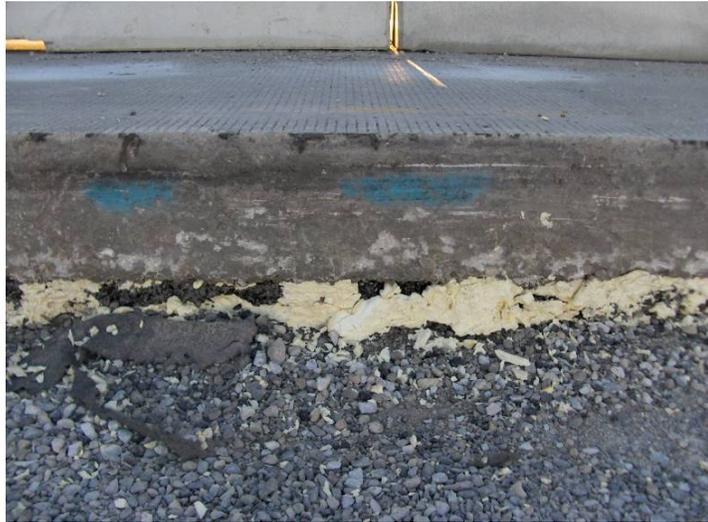
Figure 14. Slab jacking using foam.

While foam injection has been used extensively by 407 ETR, care must be taken in the amount of foam injected and its location. The concrete pavement on Highway 407 has an asphalt cement treated, open-graded drainage layer (OGDL) directly below the concrete. If foam is injected into the OGDL as shown in Figure 14, the permeability of the OGDL will be substantially reduced in the area of foam injection. This was accepted for the slab jacking as it provided the best layer to inject to lift the slabs. Also, it is very important to monitor the lifting of the slabs during the jacking operation. Lifting the slabs by more than about 50 mm (2 in.) can result in cracking of the slabs. In these situations, a load transfer retrofit treatment was used across any of the cracks to assist in stabilizing the slabs.

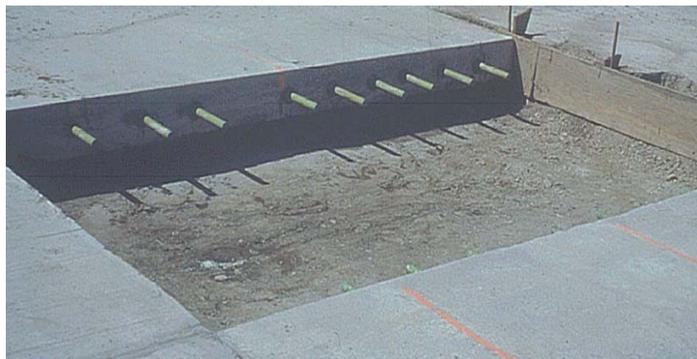
Figure 15. A 2-m full-depth repair area prepared for concrete placement.

Full-depth repair of PCC pavements (Figure 15) is a rehabilitation method that involves the removal of an entire slab, or a substantial portion of the entire slab (full depth), the installation of load transfer devices, and the replacement of the PCC material.

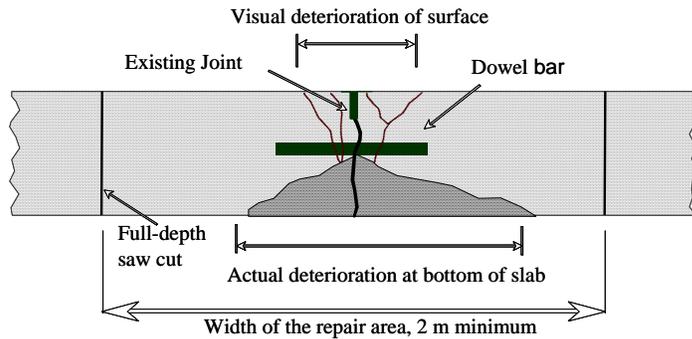
Figure 16. Cross section of deteriorated transverse joint.

Full-depth repairs should be done on the full width of the lane and should have the minimum length of 2.0 m (6.6 ft). The maximum length should be such that at least 2.0 m (6.6 ft) of the original slab remain in place. If the remaining slab is less than 2.0 m (6.6 ft) long, the entire slab should be replaced (figures 16 and 17).

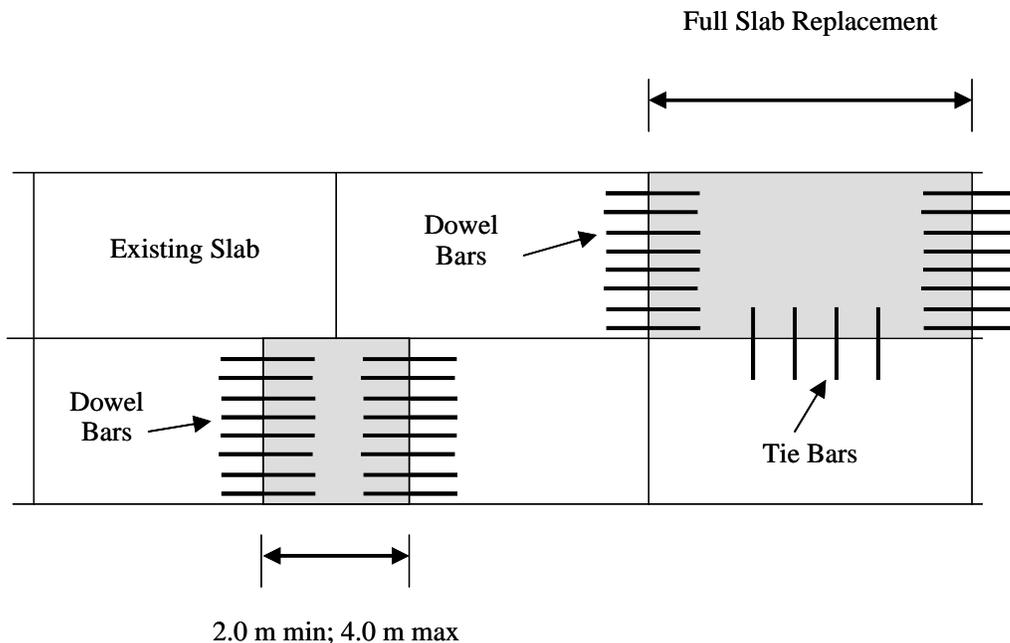
Figure 17. Example layout for full-depth repairs for a two-lane section.

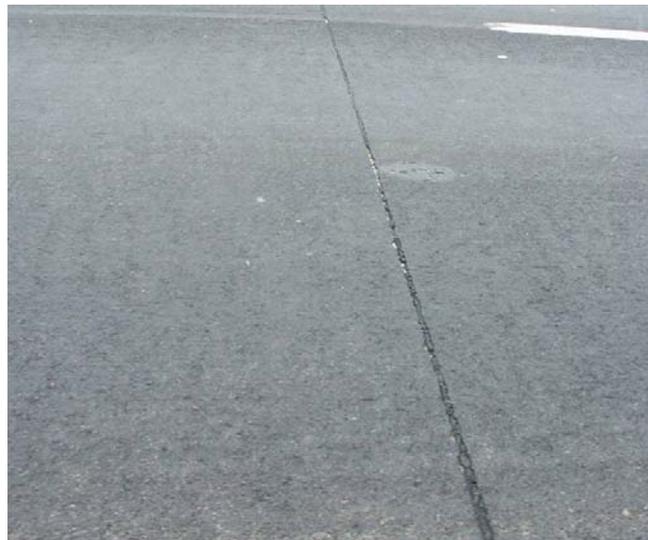
Figure 18. Micro-surfacing over a concrete pavement.

Microsurfacing is an unheated mixture of polymer-modified asphalt emulsion, high-quality frictional aggregate, mineral filler, water, and other additives, mixed and spread over the pavement surface as a slurry. The aggregate skeleton used for microsurfacing consists of high-quality interlocking crushed aggregate particles. Consequently, it is possible to place microsurfacing in layers thicker than the largest aggregate size, or in multiple layers, without the risk of permanent deformation (Figure 18).

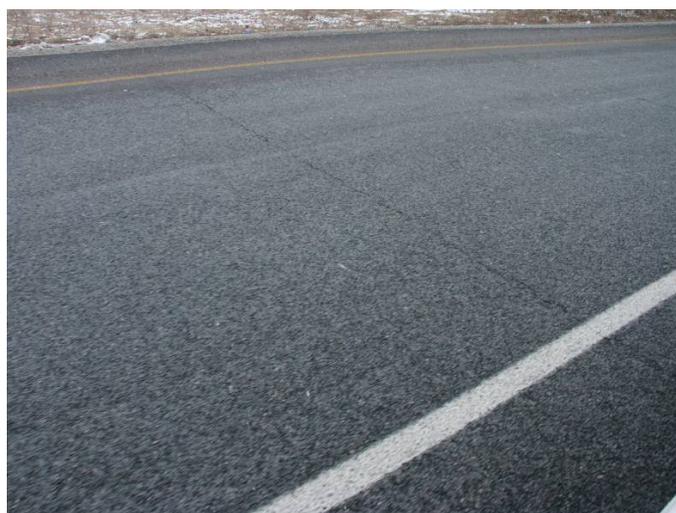
Figure 19. Thin asphalt concrete overlay over a concrete pavement.

Proprietary thin asphalt concrete overlays are typically 15 to 20 mm (0.6 to 0.8 in.) thick and include an open-graded, high-quality aggregate passing the 13.2-mm (0.5-in.) sieve size. The mix is applied by a specialized paver with built-in application of a tack coat. The tack coat assists to ensure that there is a good bond between the concrete pavement and hot-mix overlay. Thin hot-mix overlays such as this can improve pavement friction and provide a quiet pavement surface because of their porosity (Figure 19).
