# Load Transfer Restoration—A Survey of Current Practice and Experience

Linda M. Pierce<sup>1</sup>

## ABSTRACT

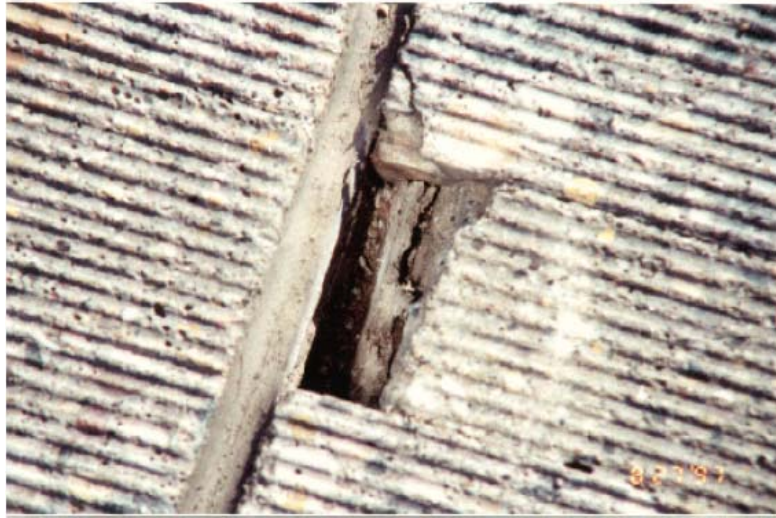
**Figure 9. Movement of foam core board (20).**

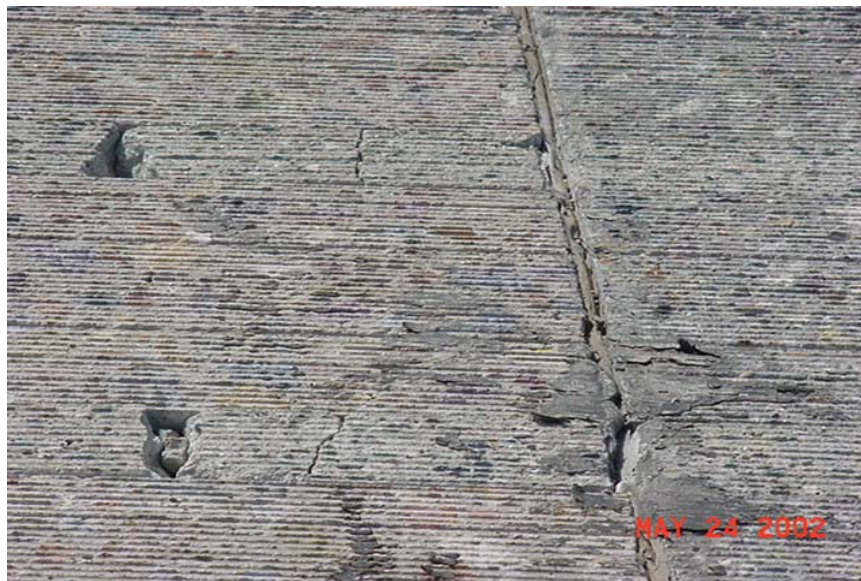
**Figure 13. Failure of dowel bar patching material (23).**

California DOT (Caltrans) initiated studies (21, 22) to determine the applicability of dowel bar retrofit as a concrete rehabilitation treatment. What makes these studies unique was the use of a heavy vehicle simulator. The result from these studies indicated that dowel bar retrofit improved load transfer efficiencies and is promising as a rehabilitation strategy for faulted concrete pavements (21, 22). At the same time (1998 to 2003), Caltrans was actively dowel bar retrofitting approximately 100 lane-mi (161 lane-km) of existing concrete pavements. In 2001, Caltrans noted several locations of patching material failure (Figure 13) and initiated a study to investigate the cause of the distress.

The Caltrans study included the review of all 12 dowel bar retrofit projects with an in-depth investigation of six representative (good to poor performance) sites. Conclusions from this study included the following (23):

- Several locations of misaligned dowel bars; however, very few of these locations had any type of patching material distress.

- Magnesium phosphate patching material showed less adhesion and lower bond strengths than the high alumina backfill material.
- Variation of dowel bar slot distress exists within a given project.
- On several projects, dowel bar retrofit installations were not conducted according to specification (24, 25). On one project, dowels were not placed at the correct depth, patching material was not adequately consolidated and the slot was not properly cleaned prior to placement of the dowel bar assembly and the patching material. On a second project, 60-lb (specification required 30 lb) jackhammers were used to remove the existing concrete from the dowel bar slot, slots were cut too short to accommodate placement of the dowel bar, and there was misalignment of foam core boards.

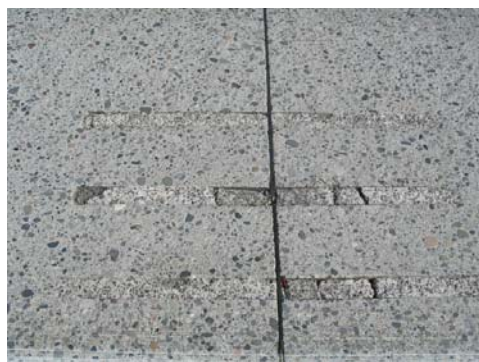
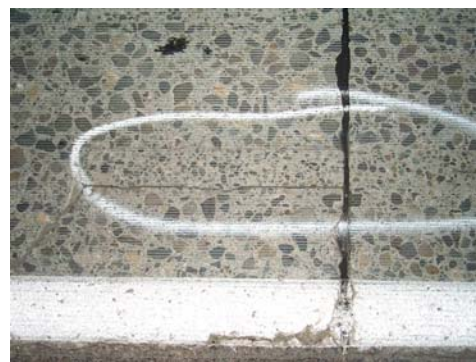
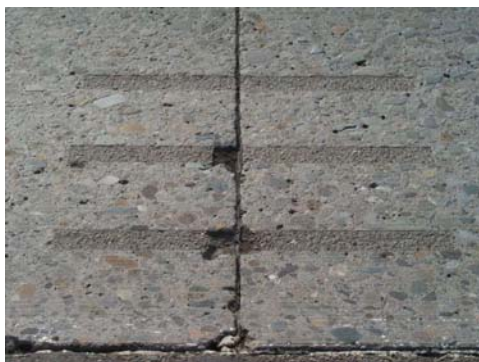
a. Cracking

b. Debonding

c. Spalling

d. Misaligned foam core board

**Figure 14. Dowel bar slot distress (15).**

Finally, the Washington State DOT has been dowel bar retrofitting concrete pavements since 1992, and to date has rehabilitated approximately 280 lane-mi (451 lane-km). In a detailed pavement condition review of approximately 180 lane-mi (290 lane-km) (or approximately 380,000 dowel bar retrofit slots) of dowel bar retrofit, it was determined that the majority of dowel bar slots have very little distress (15). Noted distresses include dowel bar slot cracking, debonding, spalling, and misaligned foam core board (Figure 14).

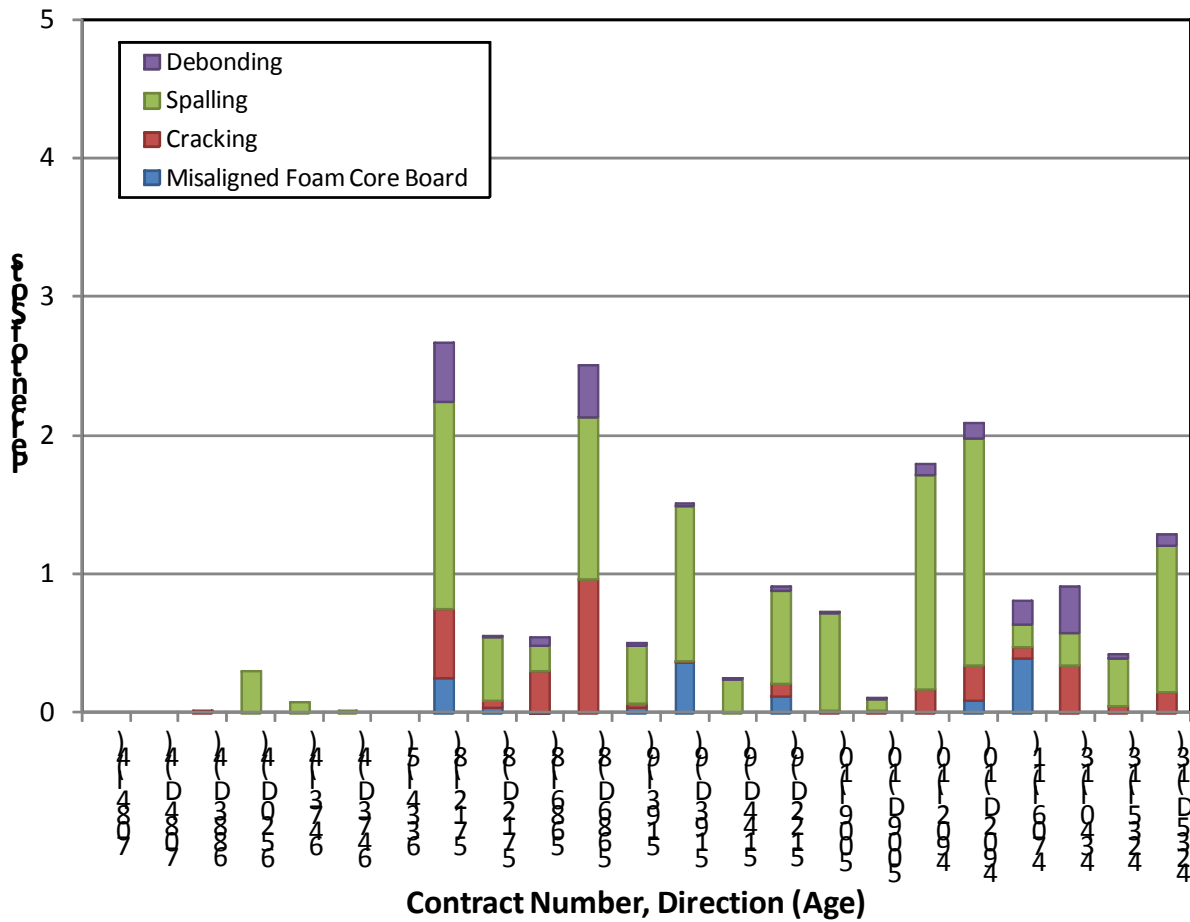
Figure 15. Summary of dowel bar retrofit slot distress (15).

Figure 15 summarizes the percent of slots that are distressed with cracking, spalling, debonding, or misaligned foam core board. On any given project, less than 3 percent (or 63 slots per mi) of the dowel bar retrofit slots have any form of distress. In total, less than 3,800 (or less than 10 percent) of all slots in Washington State have any form of distress. This not only is attributed to the dowel bar retrofit design and materials selection, but also to an increased awareness in construction details and quality control.
