Potential Applications of Paving Fabrics to Reduce Reflective Cracking

FINAL REPORT

Farshad Amini
Department of Civil & Environmental Engineering
Jackson State University

February 2005

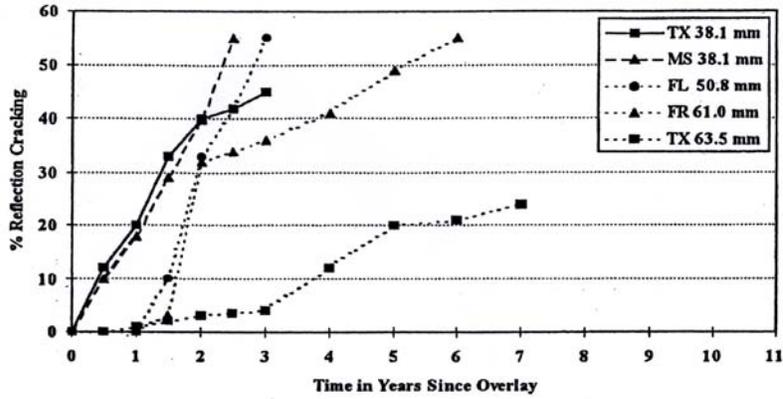
Figure 1. Performance of Pavements without Paving Fabrics for Various Overlay Thicknesses (Ahlrich, 1986; Button, 1989)

The effect of thickness of overlay has been studied by several investigators. A Texas study, and a combination of several other studies have provided information on the effect of thickness of overlay on performance (e.g., Ahlrich, 1986; Button, 1989; Predoehl, 1990). This effect for pavements without paving fabric is demonstrated in Figure 1, where percent cracking as a function of time in service is shown. As illustrated

in this figure, the 1.25 in. (31.8 mm), and 2.0 in. (50.8 mm) overlays behaved similar to each other, while the 2.4 in. (61.0) mm and 2.5 in. (63.5 mm) overlays exhibited much better performance. The thicker overlays [2.4 in. (61.0 mm) and 2.5 in. (63.5 mm)] had 2 to 3 times more years of service that the thinner overlays [2 in. (50.8 mm) or less]. Figure 1 also demonstrates that the 1.25 in. (31.8 mm) and 1.5 in. (38.1 mm) overlays displayed almost immediate reflective cracking, while the 2.0 in. (50.8 mm) and thicker overlays indicated a delay in the initiation of reflective cracking for one to two years. Similar relations for sections with paving fabric are shown in Figure 2. Although the performance trends for both figures are basically the same, the inclusion of paving fabric significantly increased the service life. For example, at a 25 percent level of reflection cracking, the inclusion of fabric increased the performances of the 1.5 in. (38.1 mm) overlays by a factor of 3 (4.5 years versus 1.5 years).

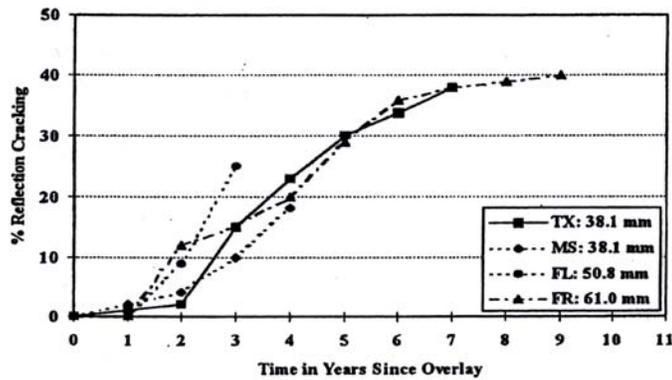
Figure 2. Performance of Pavements with Paving Fabrics for Various Overlay Thicknesses (Ahlrich, 1986; Button, 1989)

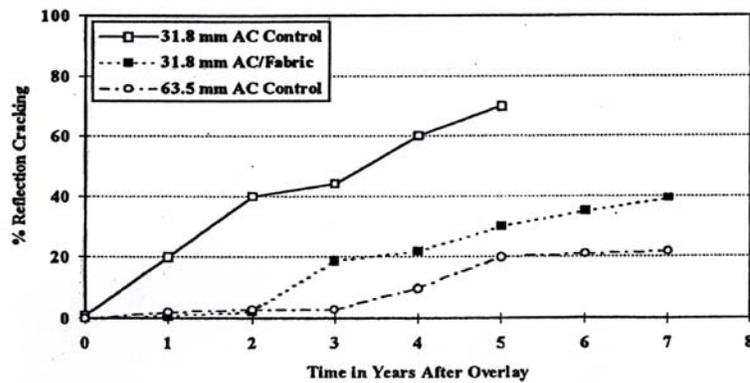
Figure 3. Performance of Pavements with and without Paving Fabrics for Various Overlay Thicknesses, Odessa, Texas (Button, 1989)

Figure 3 shows the performance of pavements with and without paving fabrics in Odessa, Texas. As shown in this figure, an increase in the overlay thickness from 1.25 in. (31.8 mm) to 2.5 in. (63.5 mm) would increase the time to 25 percent cracking from 1.25 to 7 years. As shown in this figure, the time based-reflection cracking relationships for the 1.25 in. (31.8 mm) overlay with fabric and the 2.5 in. (63.5 mm) overlay without fabric are very similar. Thus, it may be concluded that an equivalent overlay to fabric thickness of approximately 1 in. (25.4 mm) to 1.25 in. (31.8 mm) may be appropriate for the conditions in this study (Ahlrich, 1986).

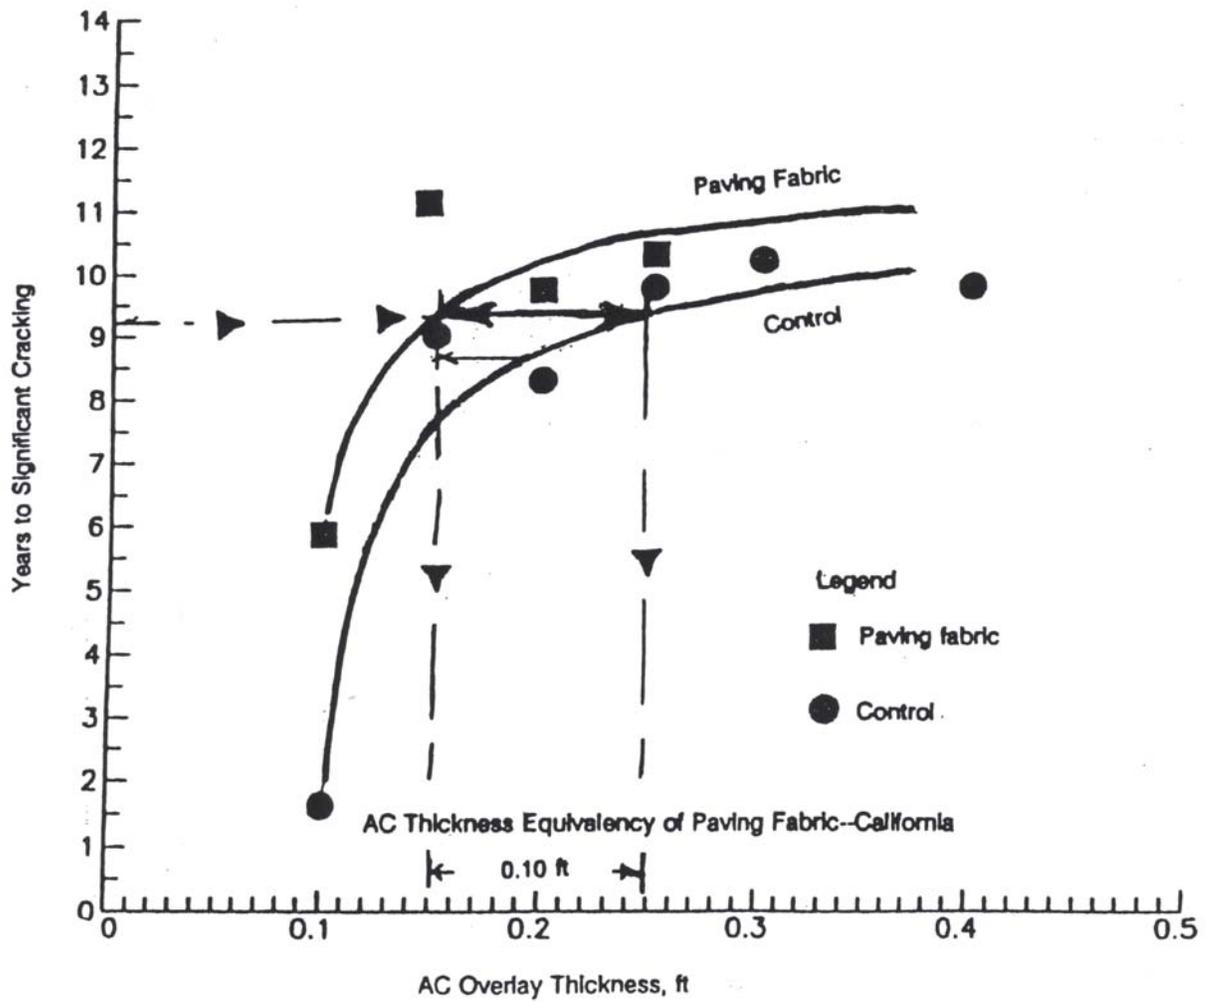
Figure 4. Estimated Paving Fabric Equivalency as a Function of AC Pavement Thickness (Prdoehl, 1990)

The field data from a California study have indicated the benefit of increasing overlay thickness, either with or without a fabric (Predoehl, 1990). These results (demonstrated in Figure 4) have indicated that when a fabric is not used, the benefit of increasing

overlay thickness reduces rapidly for overlay thickness greater than about 3.0 in (76.2 mm). When a paving fabric is used, the breakpoint for rapidly increasing benefits is probably in the vicinity of 2.0 to 2.5 in. (50.8 to 63.5 mm). Other researchers have suggested relatively thick overlays to achieve the most benefit from paving fabrics. For example, Ahlrich (1986) suggests using a minimum of 2.0 in. (50.8 mm) in the warm climates, and 3 to 4 in. (76.2 to 101.6 mm) in cooler climates. In moderate to high volume roads, thin overlays less than 1.5 in. (38.1 mm) thick, have led to premature failure (e.g., Button, 1989; Pourkhosrow, 1982). Epps and Button (1984) recommend using a minimum overlay thickness of 1.5 in. (38.1 mm) with paving fabrics, whereas Dykes (1980) recommends using 1 in. (25.4 mm).
