April 24, 2009, St. Louis, MO

Evaluation of Concrete Pavement Repair Using Precast Technology in Virginia

US 60 Project

Demo on I-66

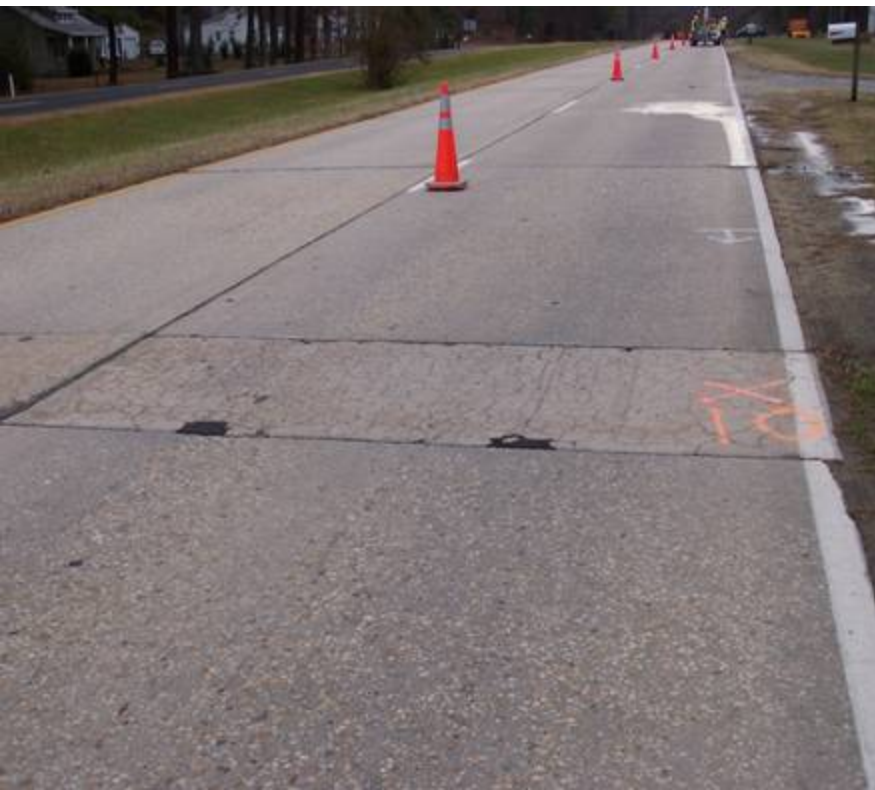
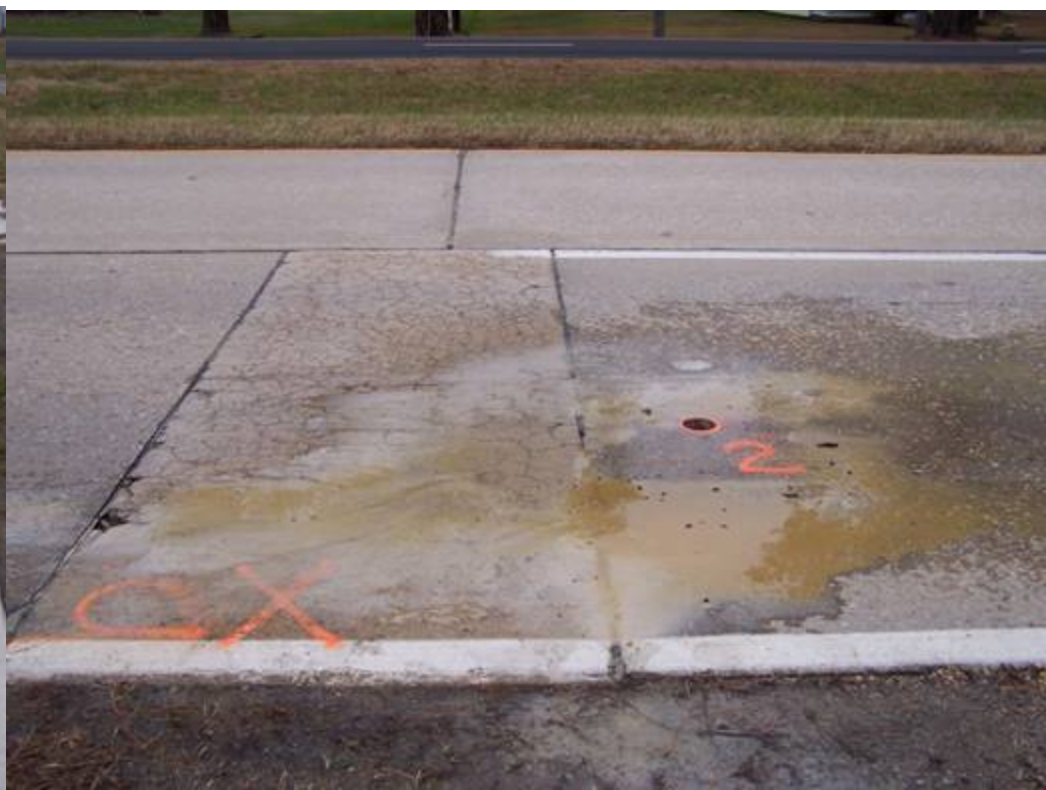
US 60 Eastbound - Constructed in 1948

- 9-inch-thick JRCPC
- 30-ft joint spacing
- Supported on 6-inch of soil cement

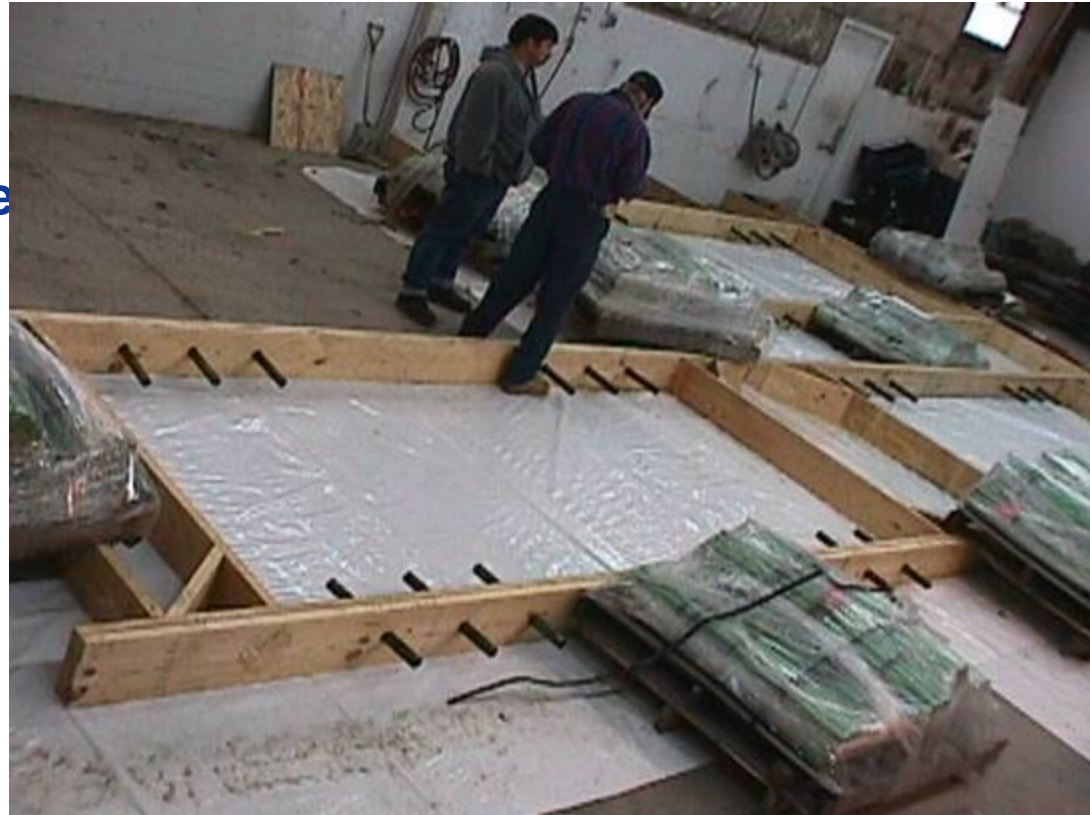
- Six PCP slabs: 12' x 6'
- 8.5-inch plain concrete (less than old 9-inch)
- Class A3 concrete
 - Air entrained
 - 3000 psi compressive strength (28 days)

**3 slabs with
preinstalled dowel**

**3 slabs with dowel
bar retrofit**

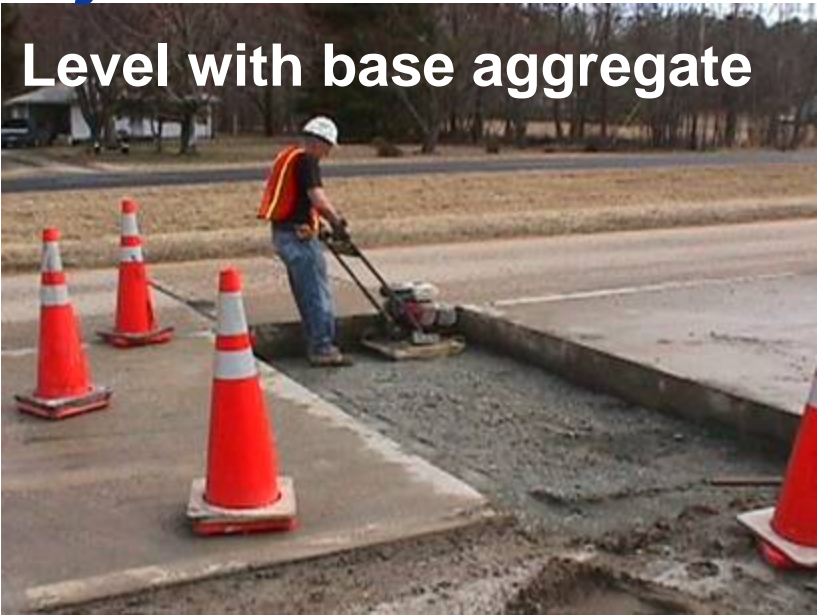
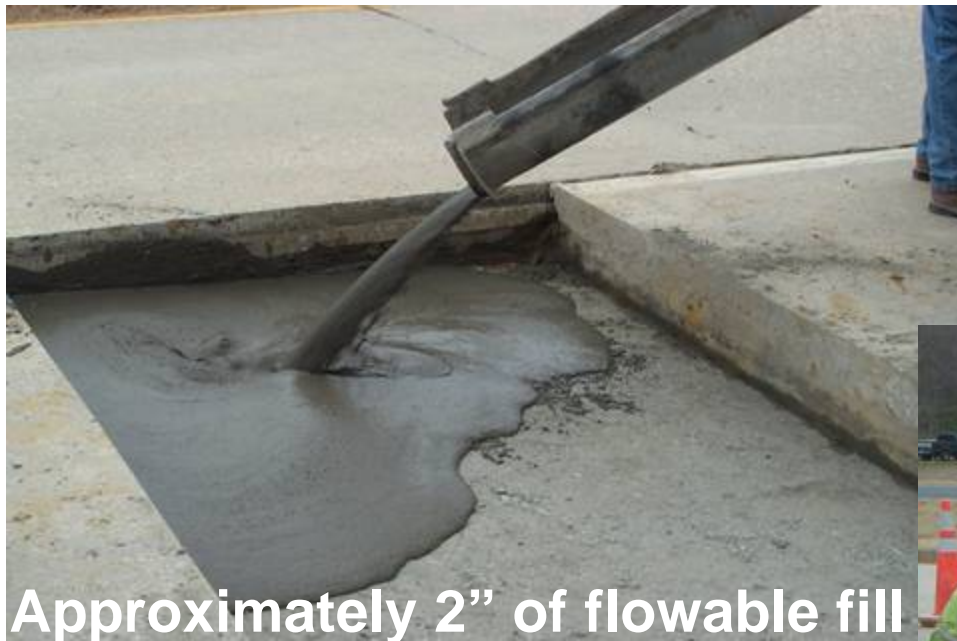
- Removal of old pavement and loose soil cement

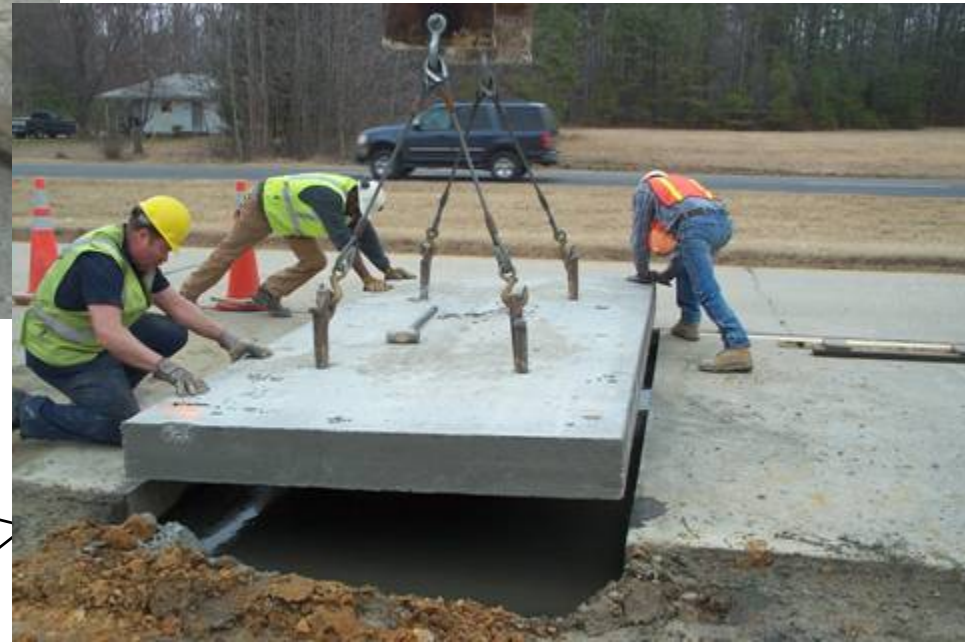
Precast slab was lifted and placed with an excavator

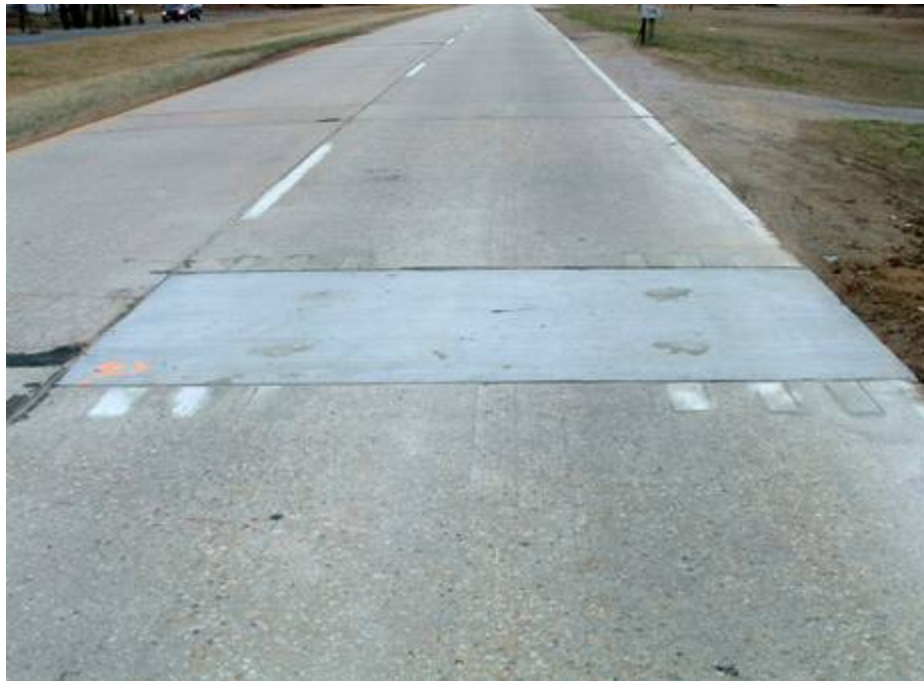
- Three in each wheel path
- Receiving end in existing slab was slotted before placement
- Dowels aligned in the slot –difficulty encountered
- Slots filled with high-strength general purpose Grout
 - 7-day bond strength 1000psi & compressive strength 4000psi

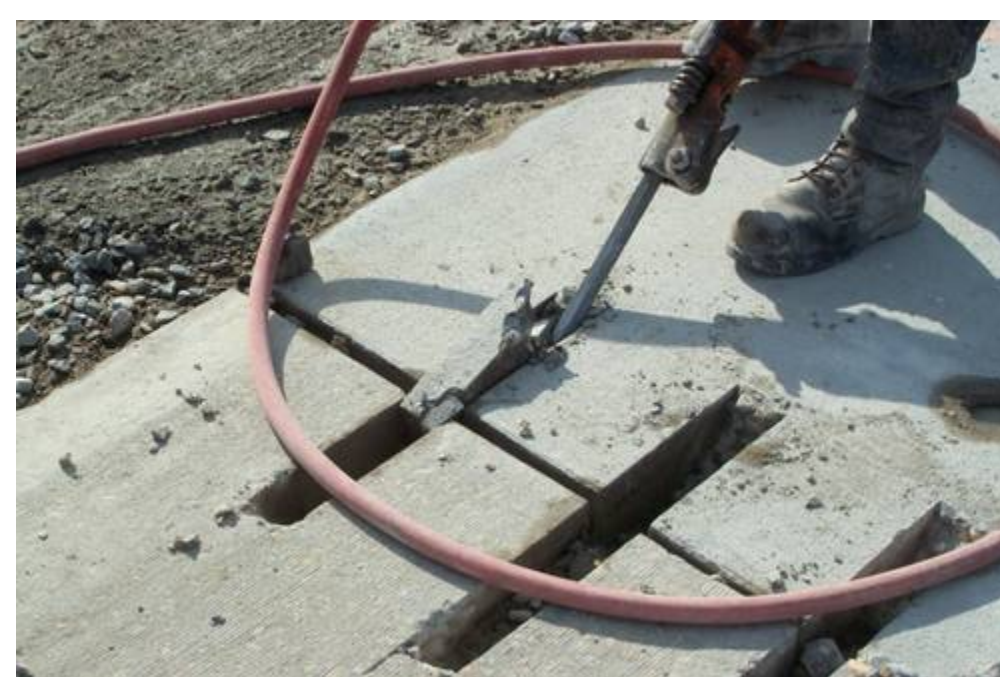
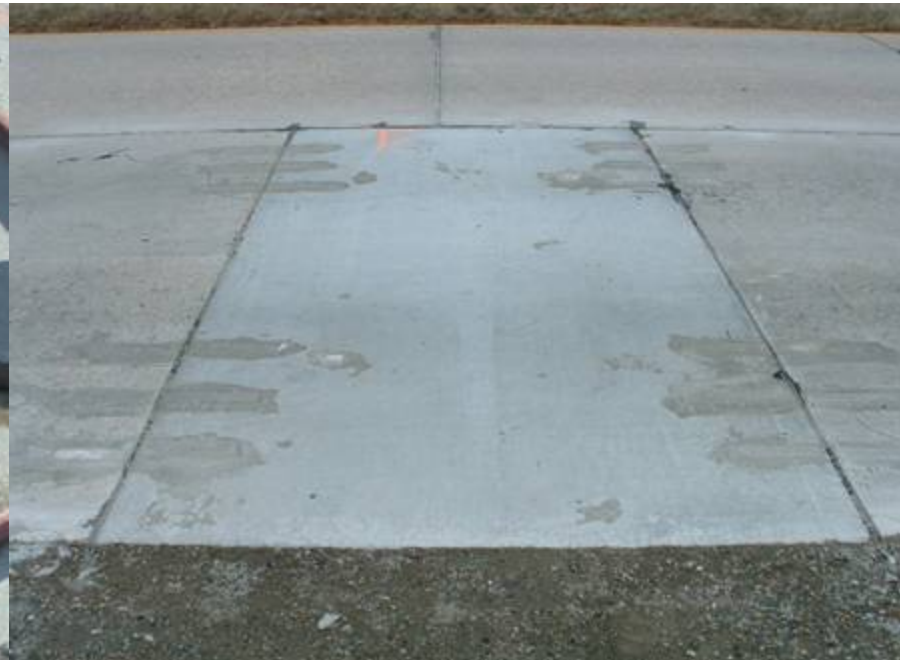
- **Dowel bar retrofit – 3 slabs**
 - Dowel bars were installed in the wheel path after slab placement
 - Old and new slab slotted together
 - Dowel bars were placed and grouted
- **Joints were sealed with silicone over the backer rod**

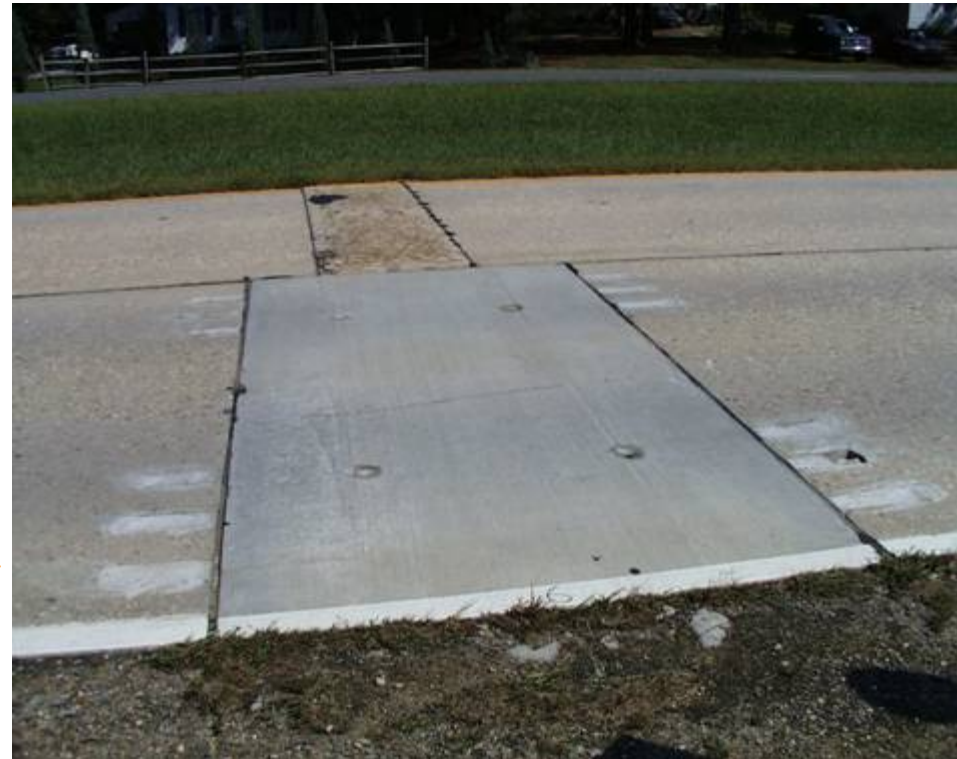
- **Slab condition (6 slabs)**
 - **Retrofit – 3 slabs**
 - No major slab distress
 - Only one slab has minor edge break
 - **Preinstalled – 3 slabs**
 - Cracks propagated from dowel
 - Mid slab crack in 2 slabs
 - **Dowel misalignment and poor load transfer**

- **Precast technology another rehab option**
 - Workable in limited lane closures
 - Construction problems need to be resolved
- **Problems encountered in this limited study**
 - Aligning the dowels
 - Consolidating grout around the dowels
 - Poor load transfer
 - Need durable, strong, and non-shrink grout to provide longevity
- **Poor ride quality**
 - Mainly because of poor joint areas
 - Base leveling issues/ thickness tolerance
- **The new demonstration project will document and present information on placement and performance and enable comparison of cast-in-place, precast (PCP), and precast prestressed patches (PPCP)**

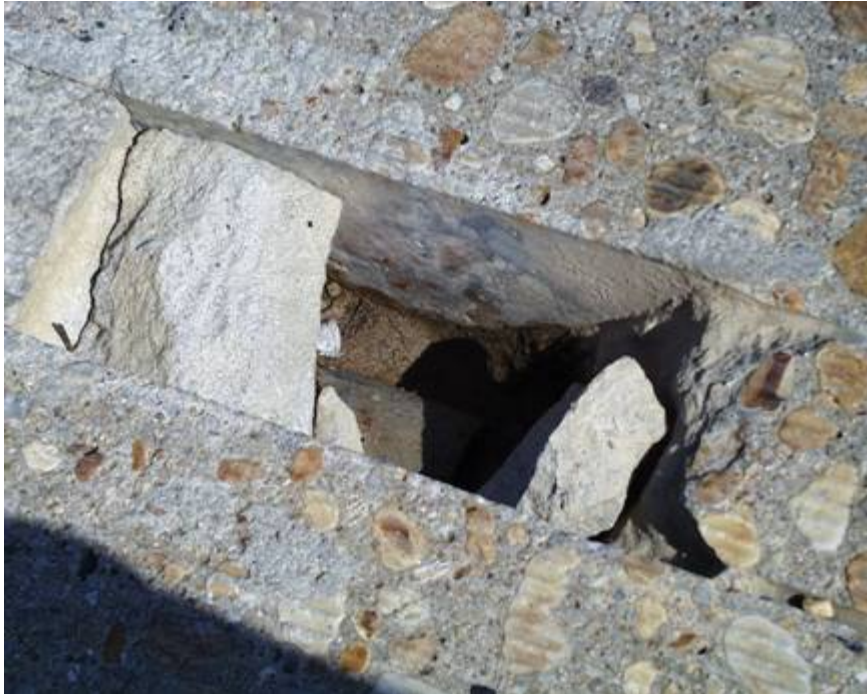
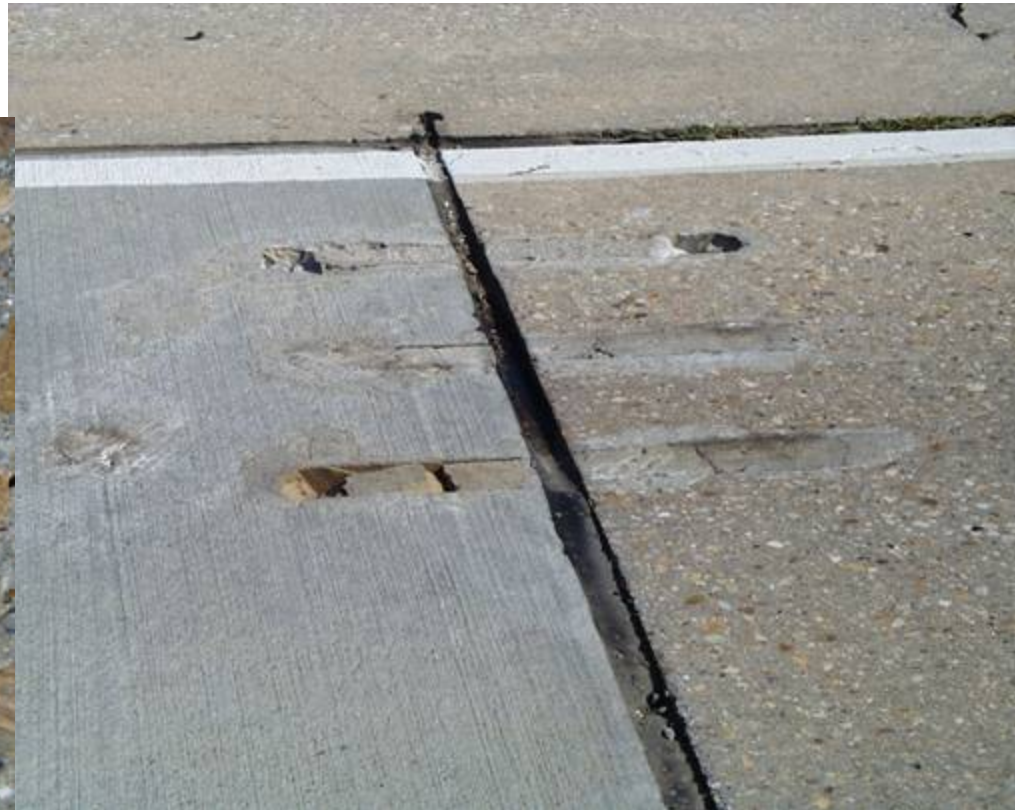
- Lack of proper joint between old and new slabs
 - Silicon joint materials were missing in grouted area
 - Sealer surface was depressed up to 1 inch
 - Poor load transfer

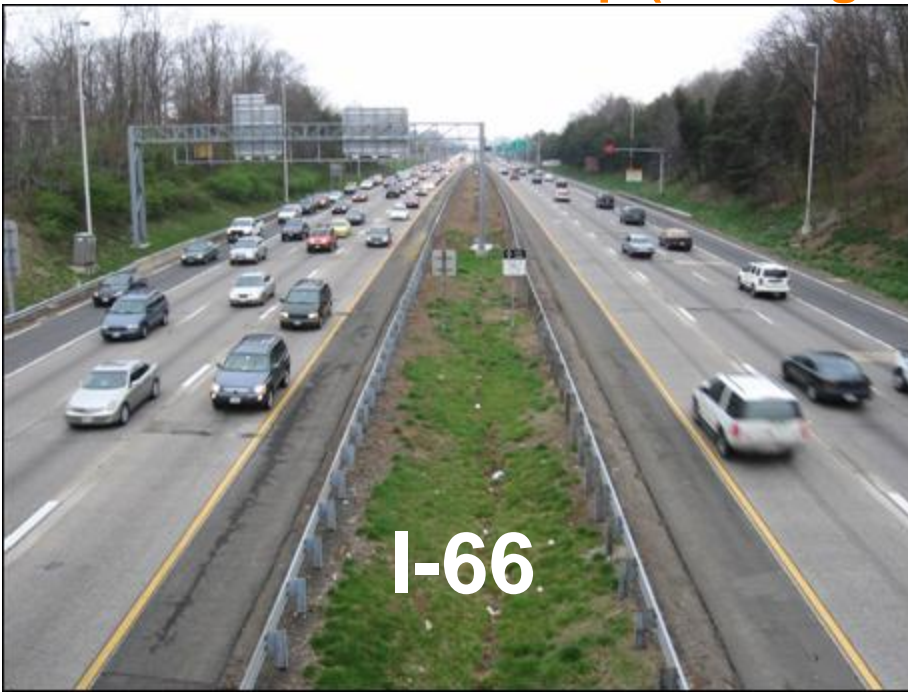
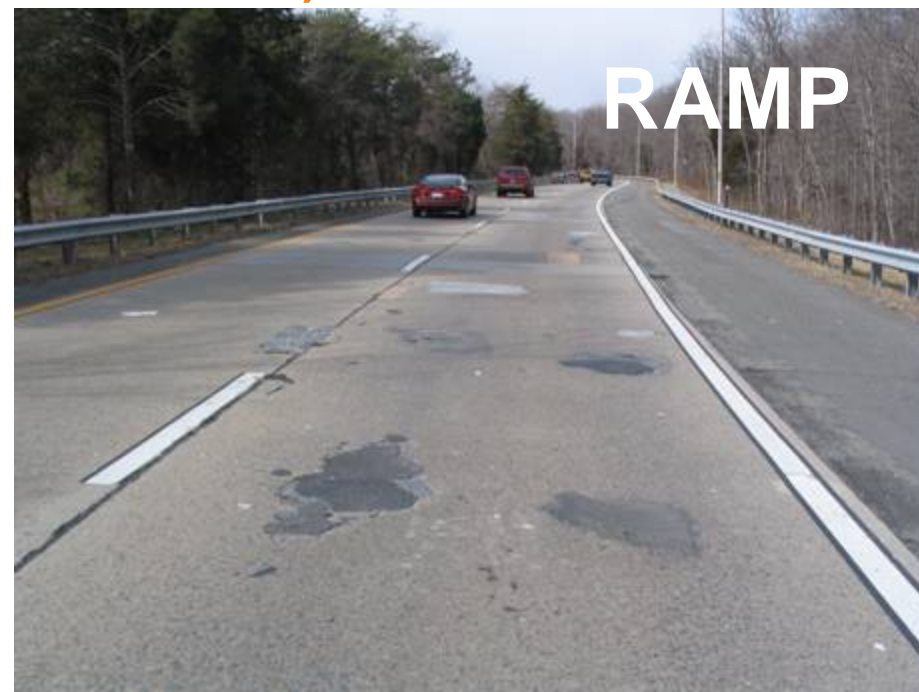
- **Precast prestressed concrete panel (PPCP)**
 - Four lane 1000 ft section on I-66W near Jermantown Rd
- **Precast concrete panel (PCP)**
 - 2000 ft on right lane of RAMP from I-66W to US 50W
- **Conventional cast-in-place repair**
 - Rest of the ramp (both right and left lanes)

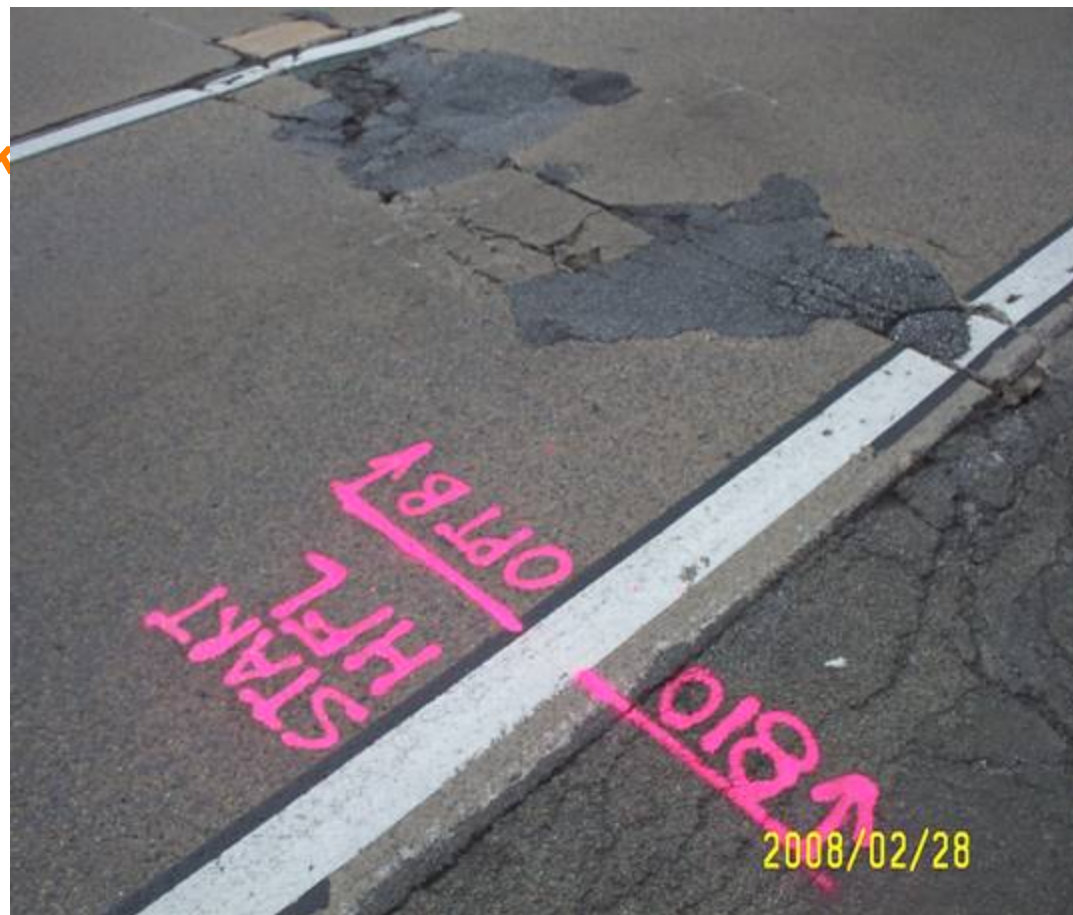
- Mid slab cracks, spalls and joint problems

- Thickness
 - On the Ramp: 9-inch-thick
 - On mainline: 9 to 11-inch
- 6-inch of aggregate subbase
- Supported on 6-inch of soil cement
