CHAPTER 1 INTRODUCTION

1.1 PURPOSE OF PAVEMENT PRESERVATION

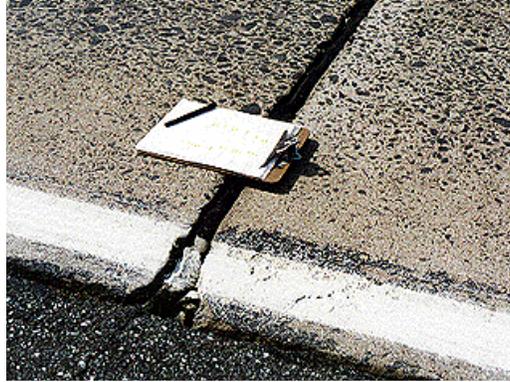
Faulting – Faulting is the difference in elevation across a joint or crack (see Figure 1-5). Faulting is caused in part by a buildup of loose materials under the approach slab near the joint or crack as well as depression of the leave slab. The buildup of eroded or infiltrated material is caused by pumping from under the leave slab and shoulder (free moisture under pressure) due to heavy loadings. The warp and/or curl upward of the slab near the joint or crack due to moisture and/or temperature gradient contributes to the pumping condition. Lack of load transfer devices like dowel bars contributes greatly to faulting. Faulting is the most prominent failure type in California because Caltrans did not begin building doweled concrete pavements until 1998. A detailed discussion on the faulting mechanism is provided in Section 1.2.3.

Figure 1-5 Faulting (FHWA, 2003)

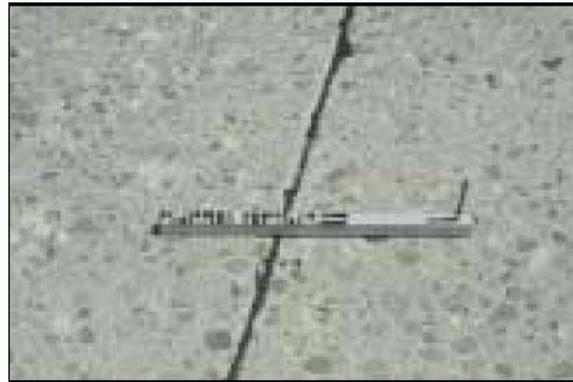
Joint seal damage – Joint seal damage exists when incompressible materials and/or water are allowed to infiltrate the joints (Figure 1-6). This infiltration can result in pumping, spalling, and blow-ups. A joint sealant bonded to the edges of the slabs protects the joints from accumulating incompressible materials and also reduces the amount of water seeping into the underlying pavement structure. Typical types of joint seal damage are: stripping of joint sealant, extrusion of joint sealant, weed growth, hardening of the filler (oxidation), loss of bond to slab edges, and the lack or absence of sealant in the joint. Poor construction of the joint seal can be a factor in the extent of joint seal damage.

Figure 1-6 Example of joint seal damage (FHWA, 2003)

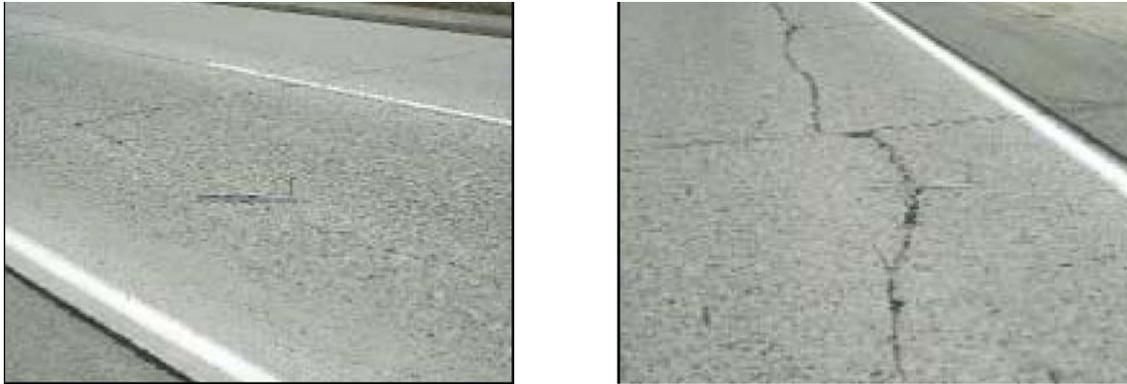
Longitudinal cracks – longitudinal cracks occur generally parallel to the centerline of the pavement (Figure 1-7). They are often caused by a combination of heavy load repetitions, loss of foundation support, and thermal and moisture gradient stresses. Longitudinal cracking is more prevalent in the western states, which have a drier climate than in the more humid eastern states. Early longitudinal cracks can be caused by improper construction of longitudinal joints, inadequate saw-cut depth, late sawing of longitudinal joints, and/or opening the pavement to traffic before the concrete has achieved adequate strength.

Figure 1-7 Examples of longitudinal joint crack (FHWA, 2003)

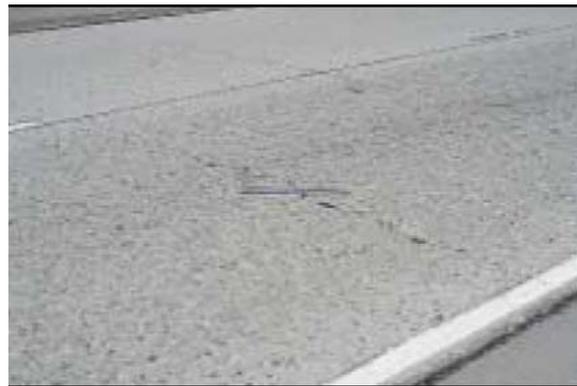
Transverse cracking – transverse cracks are predominantly perpendicular to the pavement centerline and the direction of traffic (Figure 1-8). Typically, JPCP slabs crack when tensile stresses within the slab exceed the slab’s tensile strength. Early-age cracking may occur from a combination of restraining forces due to temperature changes, shrinkage, thermal curling, base constraint, and moisture warping combined with traffic loads imposed on the concrete before it has gained sufficient strength. Transverse cracks that occur in the years following construction are primarily the result of fatigue of the concrete slab caused by repeated heavy axle loads and temperature curling. The cracks develop when the accumulated fatigue damage approaches or exceeds the fatigue life of the JPCP. Note that the potential for transverse cracking increases with increased joint spacing. Old JPCP designs used 18 ft (5.5 m) and 19 ft (5.8 m) spacing, which historically have cracked over twice as often as shorter 12 ft (3.7 m) and 13 ft (4 m) joint spacing. Caltrans now limits joint spacing to 15 ft (4.6 m).

Figure 1-8 Transverse cracking (FHWA, 2003)

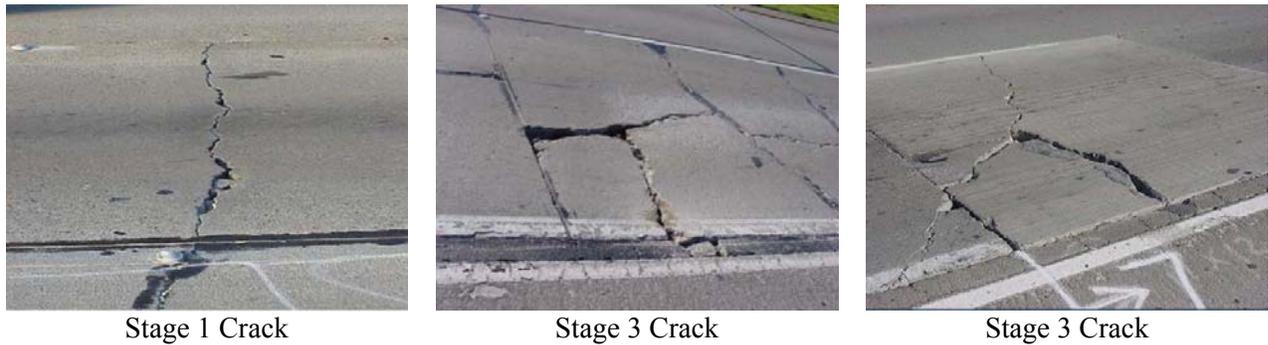
Slab cracking – Caltrans classifies slab cracking by stages based on the severity of the cracks (Caltrans, 2004). Figure 1-9 shows examples of cracks at stage 1 and stage 3. First stage cracking is defined as transverse, longitudinal or diagonal cracks that do not intersect and that divide the slab into two or more large pieces. Third stage cracks are interconnected cracks that divide the slab into three or more large pieces. Fragmented slabs are characterized by interconnected, irregular multiple cracks which divide the slab into several small pieces. Fragmented slabs are a severe form of third stage cracking. Third stage cracking and first stage cracking cannot co-exist in the same slab. However, corner cracking may co-exist with both first stage and third stage cracking. Slab cracking is usually

Figure 1-9 Examples of cracks at different stages (Caltrans, 2004a)

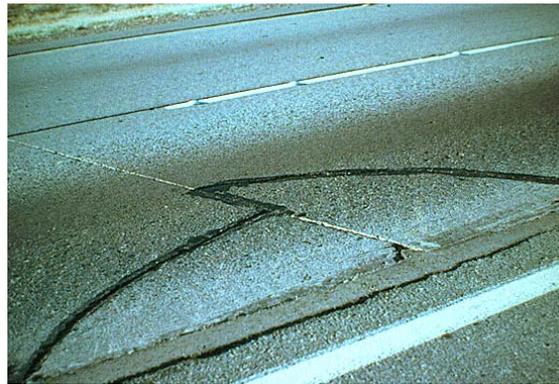
Corner break (or cracking) – A corner break is a crack that occurs in JPCP at the joints situated a distance less than 6 ft (1.8 m) on each side of the slab, as measured from the corner of the slab. A corner break extends vertically through the entire slab thickness. Corner breaks result from heavy repeated loads combined with pumping, poor load transfer across joints, and thermal curling and moisture warping stresses as shown in Figure 1-10. Corner breaks can also result from a weak or a thin concrete section constructed on a weak base.

Figure 1-10 Corner break/cracking (Caltrans, 2004a)

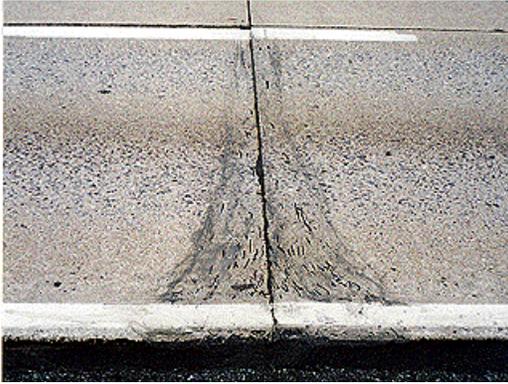
Durability (“D”) cracking – “D” cracking is a series of closely spaced crescent-shaped hairline cracks that appear at a JPCP pavement slab surface adjacent and roughly parallel to transverse and longitudinal joints, transverse and longitudinal cracks, and the free edges of a pavement slab. These relatively narrow surface cracks often curve around the intersection of longitudinal joints/cracks and transverse joints and cracks (Figure 1-11). These surface cracks often contain calcium hydroxide residue which causes a dark coloring of the crack and immediate surrounding area. “D” cracking is caused by freeze-thaw expansive pressures of certain types of coarse aggregates and typically begins at the bottom of the slab which disintegrates first.

Figure 1-11 D-Cracking (Caltrans, 2004b)

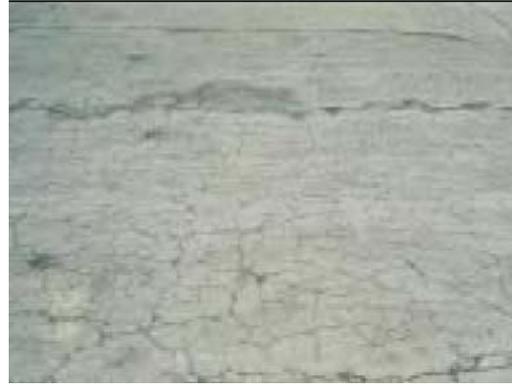
In California, alkali-silica reactivity (ASR) related distress is far more prominent. ASR is another durability-related distress which typically produces “map-cracking” type cracks as shown in Figure 1-12. ASR is caused by a chemical reaction that occurs when free alkalis in the concrete combine with

Figure 1-12 Map-cracking (FHWA, 2003)

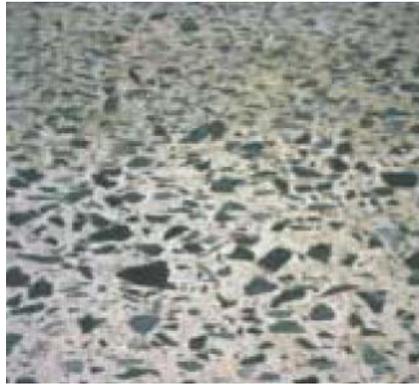
Surface polish/polished aggregate – Surface polish is the loss of the original surface texture due to traffic wear. Aggregate polishing occurs when the surface mortar and texturing have been worn away, exposing coarse aggregate, and is caused by repeated traffic applications. An example is shown in Figure 1-14.

Figure 1-14 Example of surface polish/polished aggregate (FHWA, 2003)

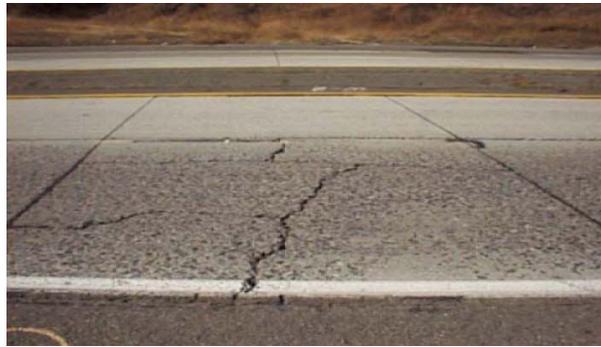
Surface attrition/abrasion – Surface attrition or abrasion is abnormal wear of the concrete pavement (Figure 1-15). It can result from either a poor quality surface material or the coarse aggregate, or by the action of tire chains and studded tires. Excessive wear in wheel paths may cause “rutting”, a condition which typically occurs in the high elevation mountain or desert climatic regions of California, due to the use of tire chains during snow storms.

Figure 1-15 Severe surface abrasion with third stage cracking (Caltrans, 2004b)

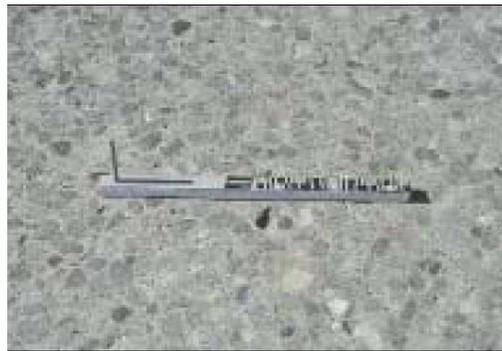
Popouts – A popout is a small piece of concrete that breaks loose from the surface due to freeze-thaw action, expansive aggregates, and/or nondurable materials. Popouts may be indicative of unsound aggregates and “D” cracking (Figure 1-16). Popouts typically range from approximately 1 inch (25 mm) to 4 inches (100 mm) in diameter and from ½ inch to 2 inches (13-51 mm) in depth.

Figure 1-16 Example of popouts (FHWA, 2003)

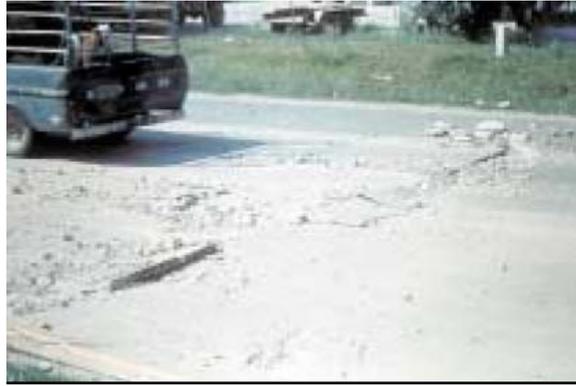
compressive stresses during hotter periods when slabs expand (Figure 1-17). When this compressive pressure becomes too great, a localized upward movement of the slab and a complete shattering occurs near the joint. Blow-ups are accelerated due to the spalling away of the slab at the bottom, thus creating reduced joint contact area. The presence of “D” cracking (although this distress type does not exist in California’s rigid pavements) or freeze-thaw damage also weakens the concrete near the joint, resulting in increased spalling and blow-up potential.

Figure 1-17 Example of blow-ups (FHWA, 2003)

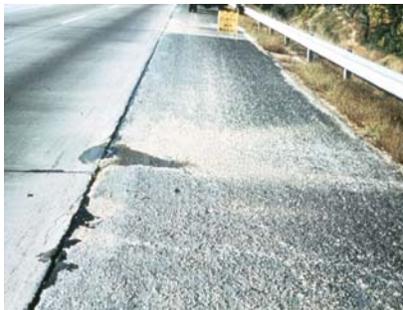
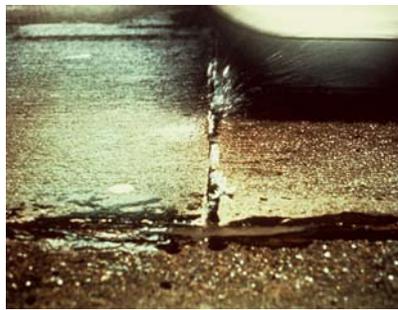
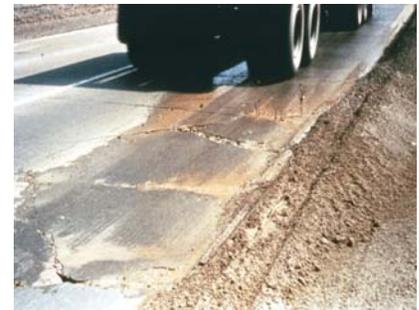
Pumping and water seepage – Pumping is the movement of material by water pressure beneath the slab when it is deflected under a heavy moving wheel load (Figure 1-18). Sometimes the pumped material moves around beneath the slab, but more often it is ejected through the joints and/or cracks (particularly along the longitudinal lane/shoulder joint with an asphalt shoulder). Beneath the slab there is typically particle movement that occurs counter to the direction of traffic across a joint or crack, resulting in a buildup of loose materials under the approach slab near the joint or crack. Pumping occurs even in pavement sections containing stabilized subbases. Pumping can oftentimes increase joint faulting. Water seepage occurs when water seeps out of joints and/or cracks. Oftentimes it drains out over the shoulder in lower-lying areas.

Figure 1-18 Examples of pumping and water seepage (Caltrans, 2004a)

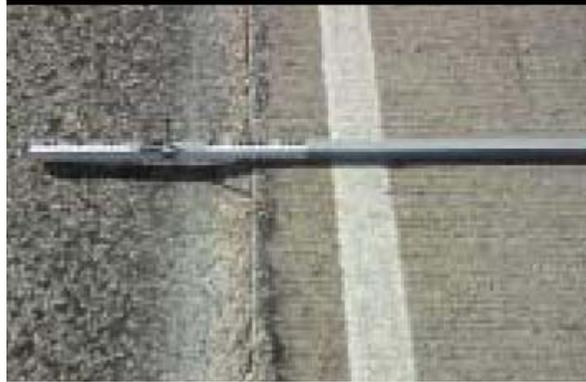
Lane/shoulder drop-off – Lane/shoulder drop-off occurs when there is a difference in elevation between the traffic lane and the shoulder (Figure 1-19). Typically, the outside shoulder settles due to a settlement of the underlying granular or subgrade materials or to pumping of the underlying material. This condition is found only in the case of an asphalt shoulder, or as a result of pumping.

Figure 1-19 Lane/shoulder drop-off (FHWA, 2003)

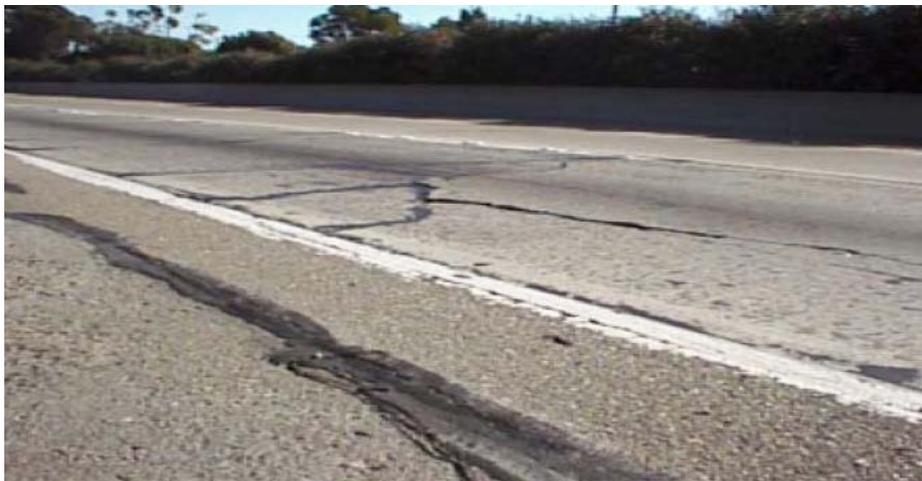
Settlement – Settlement is a local sag in the pavement structural section due to differential settlement, consolidation, or movement of the underlying layer material (Figure 1-20). Sag most commonly occurs above culverts due to the settlement or densification of backfill or at grade points between cut and fill sections. Pavement slippage could also contribute to differential settlement of the pavement and longitudinal cracking.

Figure 1-20 Settlement (Caltrans, 2004b)
