Retrofit Dowel Bars in Jointed Concrete Pavement— Long-Term Performance and Best Practices

Thomas Burnham¹ and Bernard Izevbekhai²

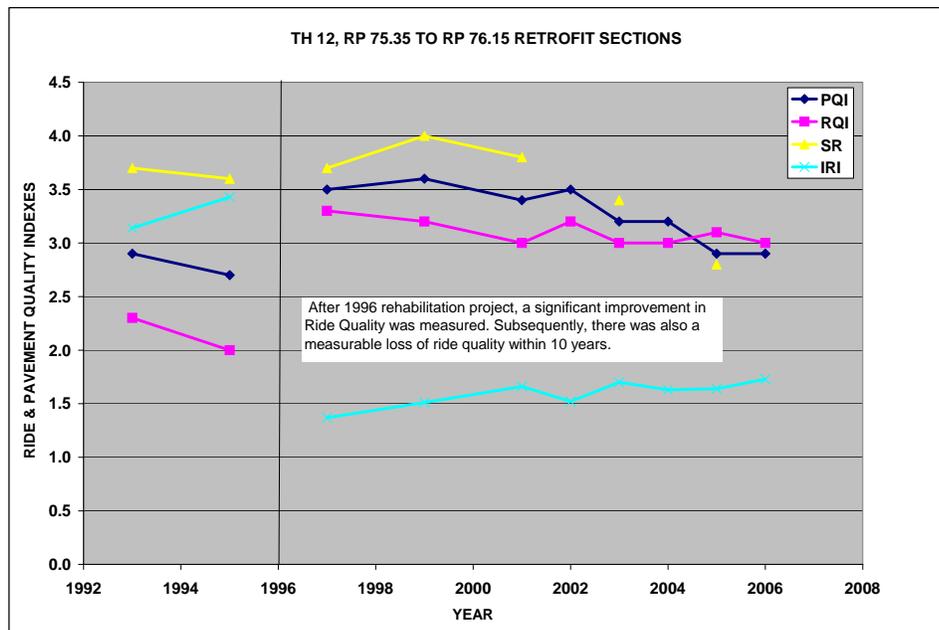
Figure 5. TH 12 pavement quality index trends.

Figure 5 shows a performance decay model for the TH 12 project. The rate of decay can be significantly influenced by the residual life and existing condition of the concrete prior to

rehabilitation. It is sufficient to note that there was a significant increase in ride quality after the retrofit project was completed, and after 10 years of service, the PQI is still above the value before the retrofit project was done. Unfortunately, the network-level data available for the other projects in this study did not allow for the establishment of similar decay curves at this time.
