# **Retrofit Dowel Bars In Jointed Concrete Pavement - Long Term Performance and Best Practices**

Office of Materials and Road Research  
Minnesota Department of Transportation

**NATIONAL CONFERENCE ON PRESERVATION, REPAIR, AND  
REHABILITATION OF CONCRETE PAVEMENTS**

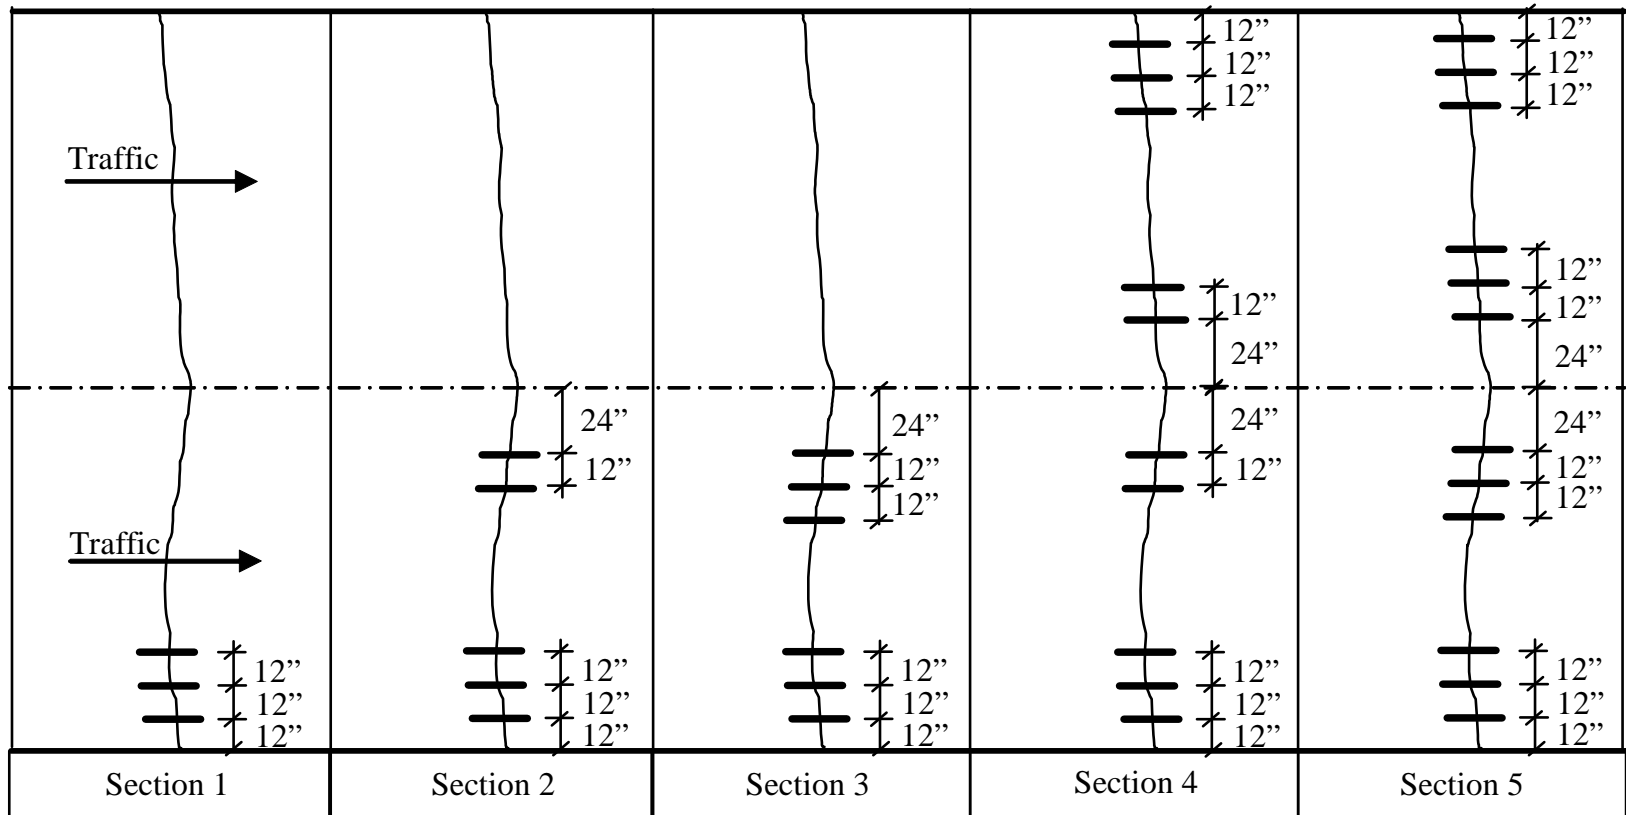
## *TH 52, Zumbrota, Minnesota*

- Observed Performance (14 years after retrofit)
  - Faulting of mid-panel cracks minimal (avg = 1.7 mm)
  - Small number of distressed retrofit dowel bar slots caused by longitudinal cracking
  - Backfill material performance very good
    - PMQP had some loss of material near surface
    - Mn/DOT 3U18 patch mix good despite early shrinkage cracking around slots
  - LTE (2006)
    - 60 to 80 percent

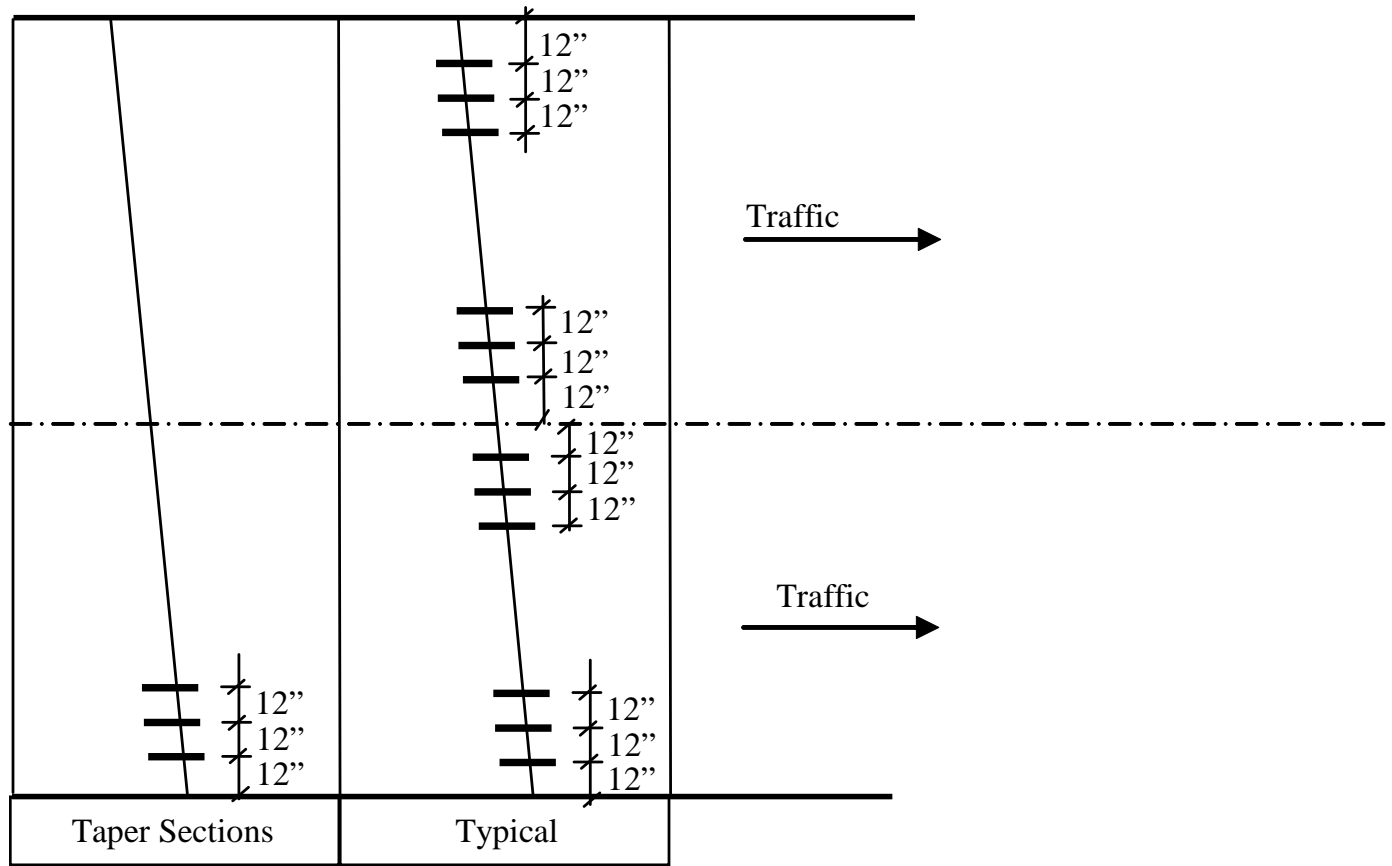
## *TH 12, Willmar, Minnesota*

- Observed Performance (12 years after retrofit)
  - Faulting of transverse joints minimal (avg = 1.5 mm)
  - Backfill material performance good
    - Minor surface distress in slots near joint
    - May be linked to milling process
  - LTE (2006)
    - 51 to 65 percent

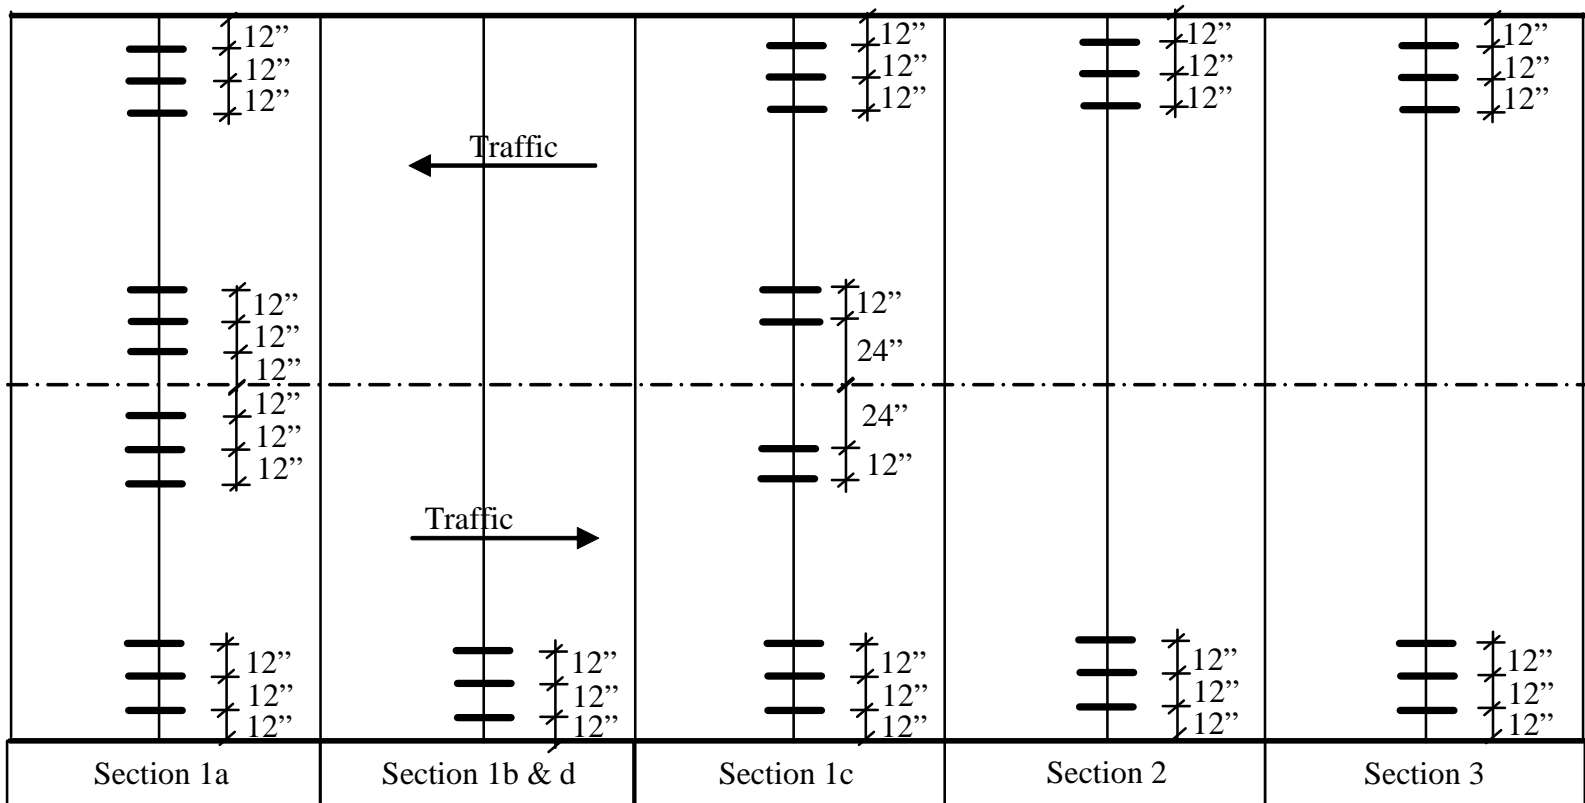
## *TH 23, Mora, Minnesota*

- Observed Performance (10 years after retrofit)
  - Faulting of transverse joints minimal (avg = 0.5 mm)
  - Backfill material performance very good
  - LTE (2006)
    - 64 to 80 percent

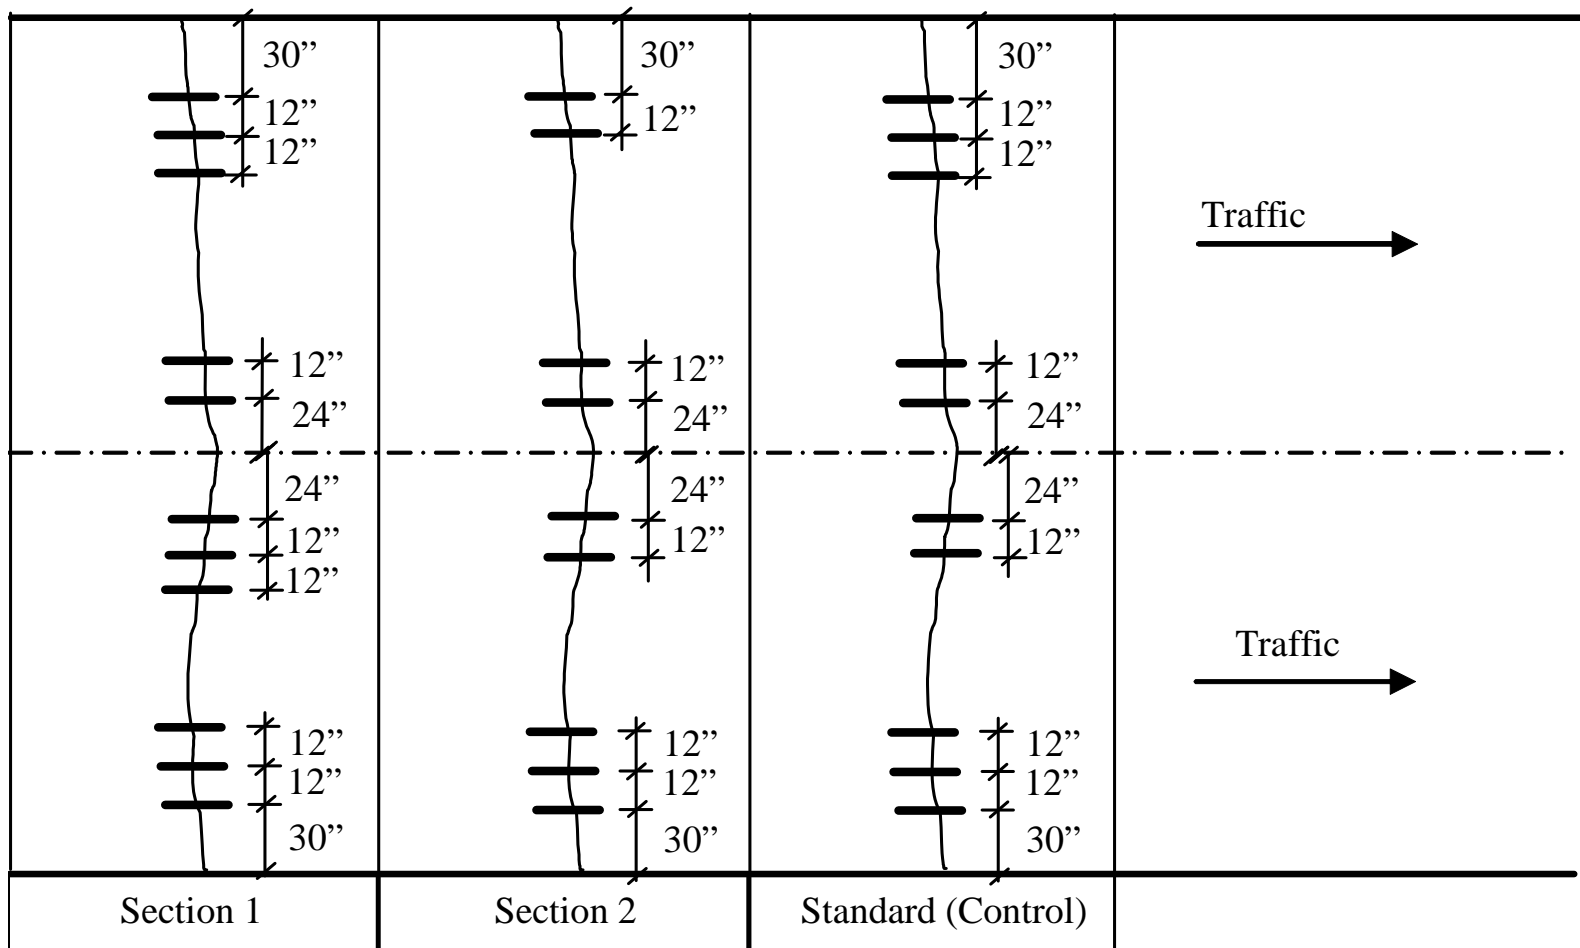
## *I-90, Beaver Creek, Minnesota*

- Observed Performance (9 years after retrofit)
  - Faulting of mid-panel cracks minimal (avg = 0.3 mm)
  - Backfill material performance very good
  - Some slot distresses caused by transverse and longitudinal panel cracking after retrofit installation
  - LTE (2006)
    - 70 to 89 percent
