SLOPE STABILITY ANALYSIS OF A SMALL
INTERMITTENT FAILURE

A Thesis
Presented
to the Faculty of
California State University, Chico

In Partial Fulfillment
of the Requirement for the Degree
Master of Science
in
Geosciences
Hydrology/Hydrogeology Option

by
Chloe Adams
Spring 2015

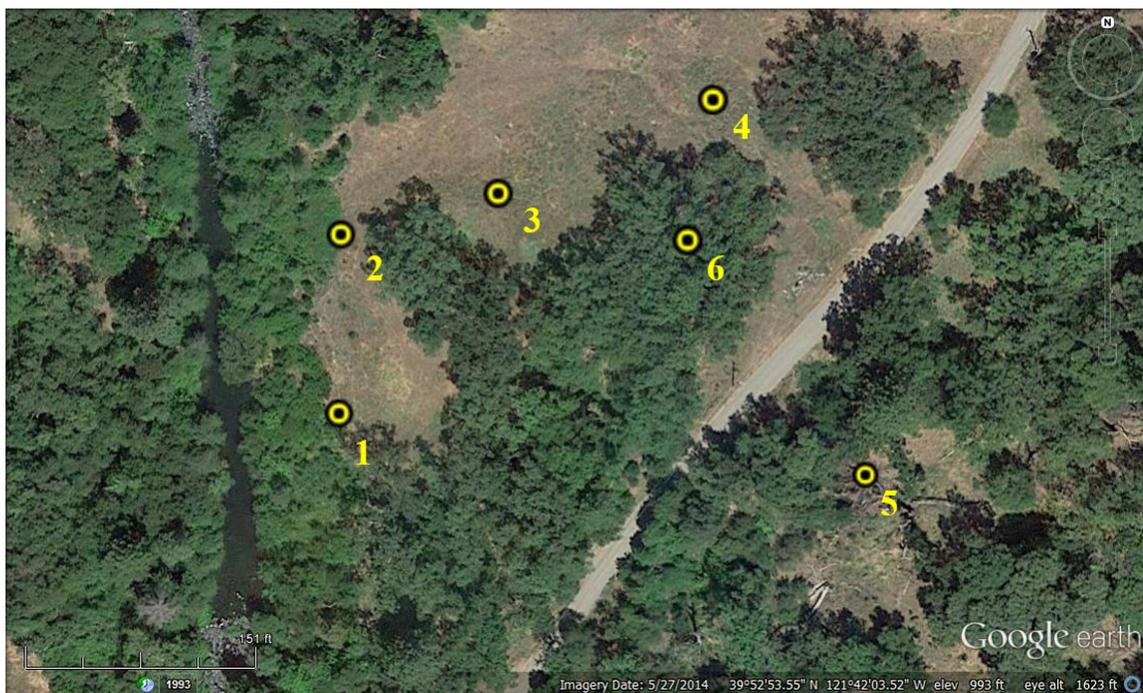
Figure 4. Locations of the piezometers within the study area.

Piezometer 1, located in the toe of the failure on a small hummock (Figure 4) was the least responsive of the sensors; water levels in the piezometer ranged from 0.0 to 2.9 feet with high levels corresponding to three of the nine events. The piezometer also exhibited a high water level during a storm not considered a significant event according to the criteria set forth earlier. A water level of 2.6 feet corresponded to the period of greatest rainfall intensity during precipitation event 4 (Figure 5); the piezometer then

Piezometer 2, located in a swale on the west side of the failure near Big Chico Creek (Figure 4), exhibited a response to all of the precipitation events and maintained water from January 12, 2010 to July 1, 2010. A water level of 0.9 feet corresponded to precipitation event 1 (Figure 6); Piezometer 2 was the only piezometer to register the event. A water level of 1.1 feet corresponded to the highest rainfall intensities for precipitation event 2 and a water level of 3.2 feet corresponded to the peak rainfall intensity for event 3b. After this event a permanent perched water table was formed. High water tables were recorded for events 4, 5b, and 6 with a peak water level of 5.3 feet corresponding to precipitation event 8. The response of Piezometer 2 to precipitation

Piezometer 3, located in the northern third of the slide between the road and the creek on a mild 13° slope (Figure 4), maintained water from January 18, 2010 to June 15, 2010. Water levels ranging from 0 feet to 4.7 feet in Piezometer 3 corresponded to precipitation intensity peaks for events 4, 5b, 7b, and 8 (Figure 7) with the highest peak of 4.7 feet occurring on March 3, 2010 during precipitation event 7b. High water levels also occurred during precipitation events on March 10, 2010 (S1) and April 4, 2010 (S2), although the storms occurring on those dates did not produce enough precipitation to be considered significant events, producing 0.8 inches in 5 hours and 0.9 inches in 7 hours, respectively. High water levels and the formation of a more permanent perched water

Piezometer 4, situated in shallow soils just outside of the north end of the landslide (Figure 4), exhibited a perched water table from January 20, 2010 to April 26, 2010 and then again from April 27, 2010 to May 27, 2010. High water levels of 0.8 and 2.0 feet occurred during precipitation event 4, a series of storms lasting 9.5 days (Figure 8). These storms produced enough precipitation to create a sustained perched water table. The high water level of 2.9 feet during precipitation event 5b did not correspond to peaks in rainfall intensity, unlike water levels of 2.7 and 2.8 feet during events 7b and 8, which did correspond to increases in rainfall intensity. The high water level recorded on May 2, 2010 corresponded to a brief 2 hour storm (S3) that occurred 4 days earlier. The

piezometer was located in thin soils just outside the failure on a slope dipping 15° west toward the creek. This allowed for more runoff and less infiltration due to its placement on the slope.

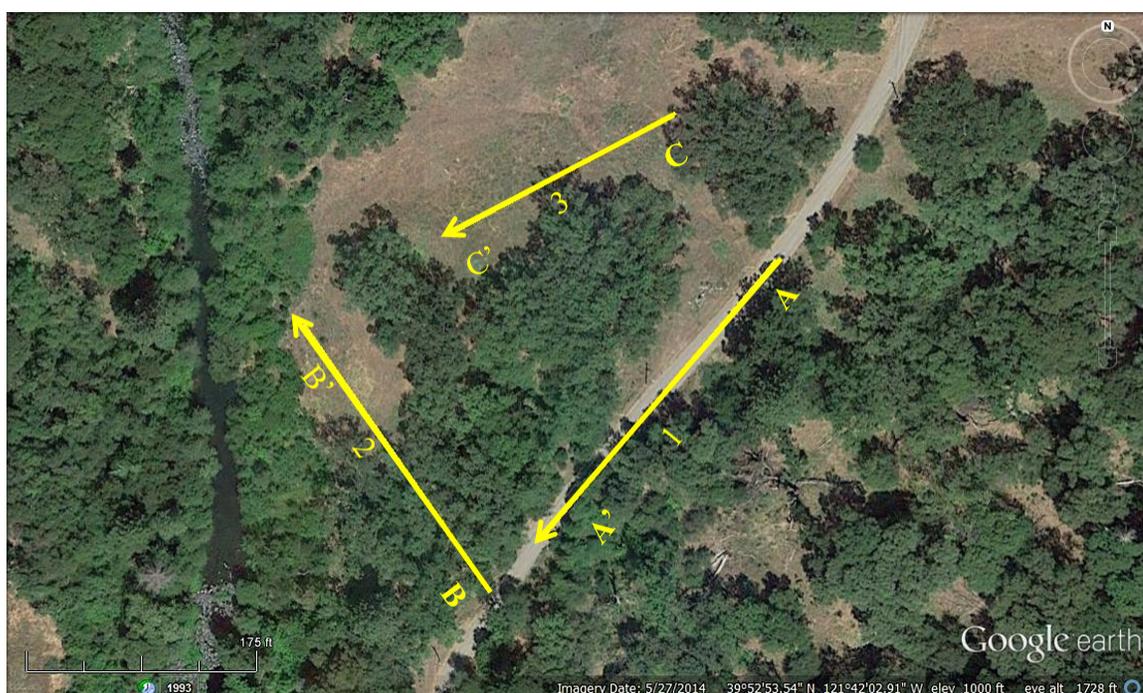
Figure 10. Satellite photo showing ground penetrating radar transect locations.

Three reflectors were also present in Line 2. Located in the southern section of the slide (Figure 10), Line 2 was 84 m long and penetrated to a depth 12 m near the beginning and a depth of 9 m toward the end (Figure 13). The first reflector was a weak reflector visible from the beginning of the line and ending at a distance of 75 m (Figure 14). It was somewhat concave in shape with a maximum thickness of 10 m. The second reflectors were medium strength, beginning at a depth of 4 m near the start of the line and ending at a depth of 8 m 40 m along. The third reflector began at 40 m distance at a depth of 8 m and rose to near the surface at the end of the line.

Line 3, located in the northern section of the study area (Figure 10), transected the graben across the landslide. This line was 56 m long and penetrated approximately 15 m deep at the start of the line to 12 m deep near the end (Figure 15). There were two types of reflectors on this line. The first was a small wedge of weak reflection at the beginning of the line near the surface with a thickness of approximately 2 m and a length of 9 m (Figure 16). The second reflector was strong and chaotic and encompassed most of the line. The reflection gradually declined in strength to medium reflections at depth. There was no distinct separation between the medium and strong reflections. There was

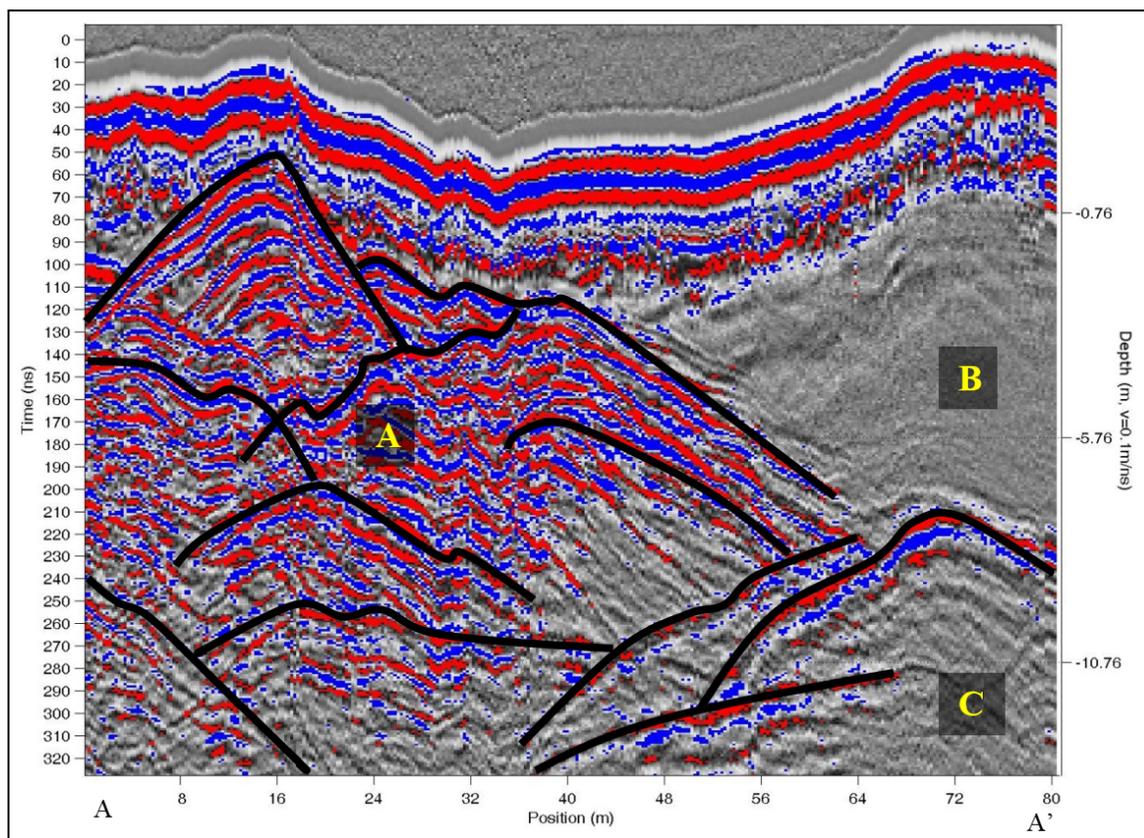
Figure 12. GPR profile of line 1 with highlighted subsurface features. (A) Represents the strong reflectors, (B) represents the weak reflectors and (C) represents the medium reflectors.

Line 1, located along the road and running northeast to southwest, was 80 m long and penetrated to a depth of approximately 13 m (Figure 11). All three types of reflectors were visible in this line. The first reflector was strong and encompassed more than half of the GPR line, beginning at the start of the line and pinching out at 64 m distance at a depth of 7 m (Figure 12). The associated reflections were stronger and more chaotic near the surface, gradually weakening with the depth. Because there were several jumbled interbedded reflections within this section, separation of the surfaces was difficult. The second type was weak reflector beginning at 36 m, near the surface, and gradually thickens from 0.5 m to a maximum of 7 m. It was smoothly textured, with only minor reflections. The third reflector began 35 m along the line at a depth of 13 m increasing to a maximum thickness of 6 m at 70 m and declining to 4 m at the end of the line. There were two distinct reflections within this section with smaller parallel medium-strength reflections beneath them.

According to these guidelines, Line 1 showed the strong parabolic signature of the debris flow and alluvium (Figure 17). The debris flow is approximately 18 m wide and sits upon the alluvial deposits. The contact between the colluvium and the Chico Formation can be seen between 38 and 80 m. Because some faults in ground penetrating radar surveys are seen as one-sided diffractions (Bano et al., 2000). A single dipping parabolic arm visible in the survey could suggest the presence of a micro-fault. Although near the contact, the reflection cuts across reflections parallel with the alluvial deposits.

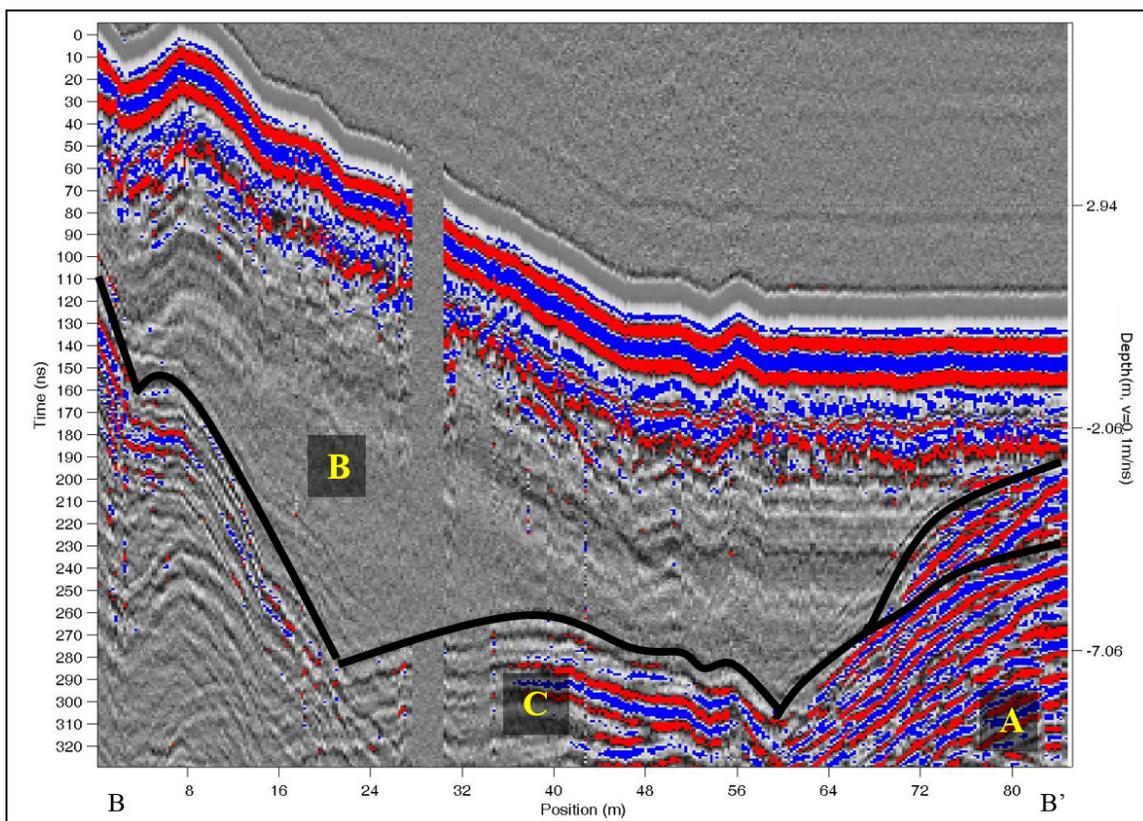
Figure 14. A GPR profile of line 2 with highlighted subsurface features. (A) Represents the strong reflectors, (B) represents the weak reflectors and (C) represents the medium reflectors.

The GPR survey suggests Line 2 is composed of mostly colluvium. A 10-meter thick section of Chico Formation can be seen thinning to 2 m when it contacts another section of Chico Formation at 20 m. These both exhibit medium parallel reflections consistent with the other lines. At 60 m alluvial deposits can be seen (Figure 18).

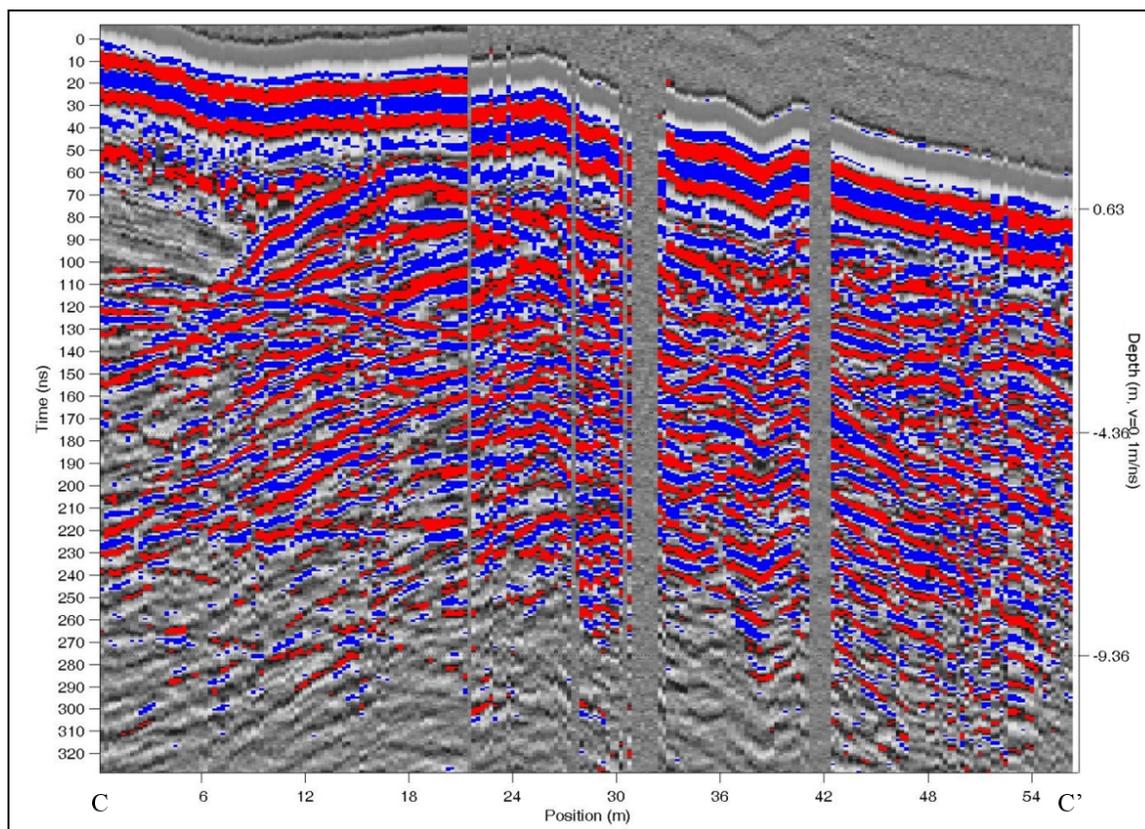
Figure 15. GPR profile of line 3.

significant interference on this line most likely caused by uneven terrain causing the quality of the reflections to be inferior.

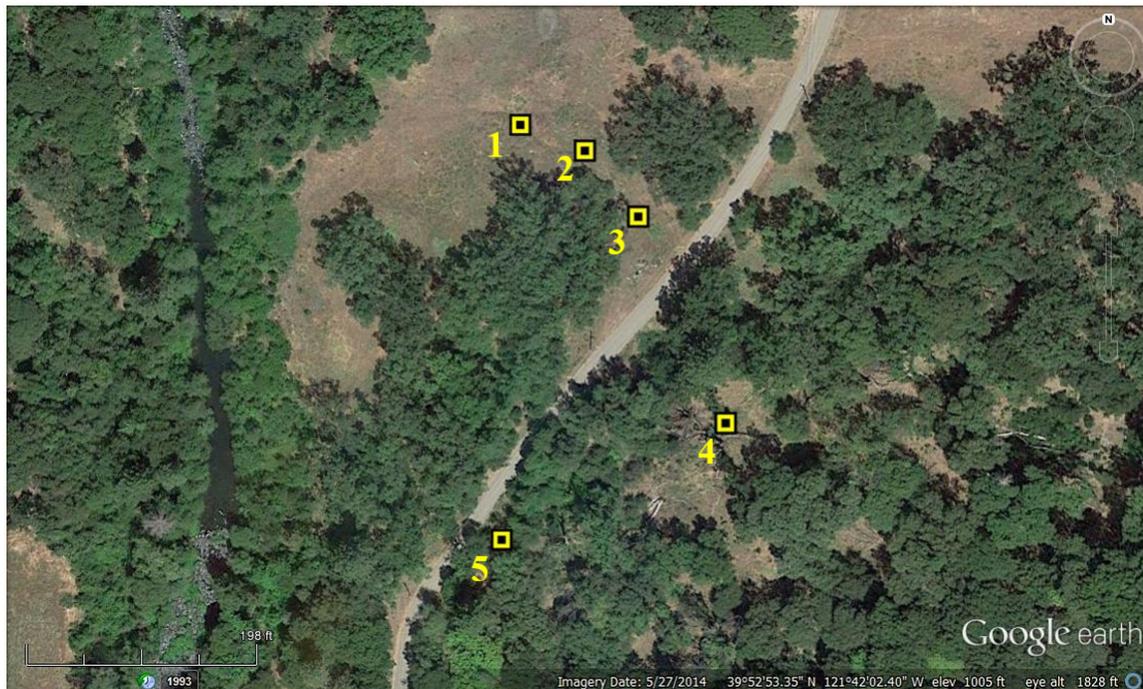
Figure 20. Satellite photo showing survey flag locations.

The magnitude and direction of periodic movement of the failed mass were assessed by installing pairs of survey flags in five different sections of the slide graben (Figure 20). Flag placement was dictated by access to the graben; pairs of survey flags were placed as evenly as possible across the graben to accurately capture movement. Within each pair, one survey flag was placed above the graben and one at the base of the

that the failure was moving downslope, some of the measurements indicated backward movement because the distance between flags decreased. The most probable cause of the appearance of backward movement was vegetal growth. The grasses that the survey flag pairs were placed in were thick and varied in height and thickness throughout the monitored seasons causing flag displacement.

Average rates of movement for each pair of flags in the graben (Figure 20) were calculated to determine if, overall, measurements indicated downslope movement even though some of the individual measurements indicated backward movement.

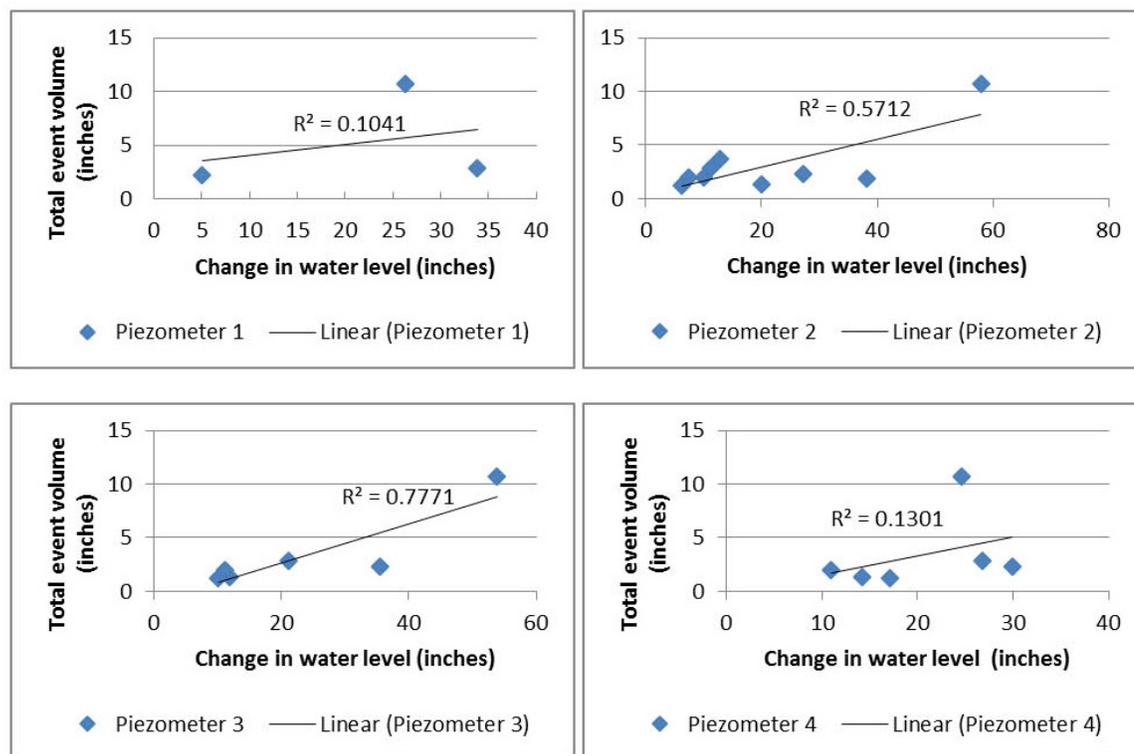
Figure 22. Graphs depicting the correlation between the total precipitation event volumes and the change in water level in piezometers 1-4.

The strength of the relations between precipitation volumes and the response of the perched water table were assessed using linear regression and cross-correlation analyses. Correlation between the total volume of the each significant precipitation event and the change in rise of the water level in each of the piezometers was determined by fitting a linear regression to the data points for each of the piezometers (Figure 22). Piezometers 2 and 3 exhibited the highest correlations with correlation coefficients of

0.75 and 0.88. Much lower correlation coefficients of 0.32 and 0.36 were exhibited by piezometers 1 and 4, respectively. The strong correlation between the volume of precipitation and the change in rise of the water level in Piezometers 2 and 3 is probably the result of piezometer location with respect to slide surface topography. Both piezometers were located at the base of slope beaks, Piezometer 2 on the east near the creek and Piezometer 3 near the center of the failure (Figure 4); these locations captured more runoff and allowed for more infiltration. In support of this theory is the observation that Piezometer 3 showed a response before the other piezometers during many of the precipitation events having shorter response times than the lower piezometers in the landslide (Figure 24) suggesting subsurface flow from upslope may be partially

responsible for the rapid rise in water level in the piezometer. Weak correlation between the volume of precipitation and the change in rise of the water level in Piezometers 1 and 4 can also be attributed to their locations; Piezometer 1 is in a hummock in the south east section of the failure and piezometer 4 is on a 15° slope outside of the failure (Figure 4). The location of the piezometers on high ground and a 15° slope resulted in poor correlation due to precipitation running off and not infiltrating locally.

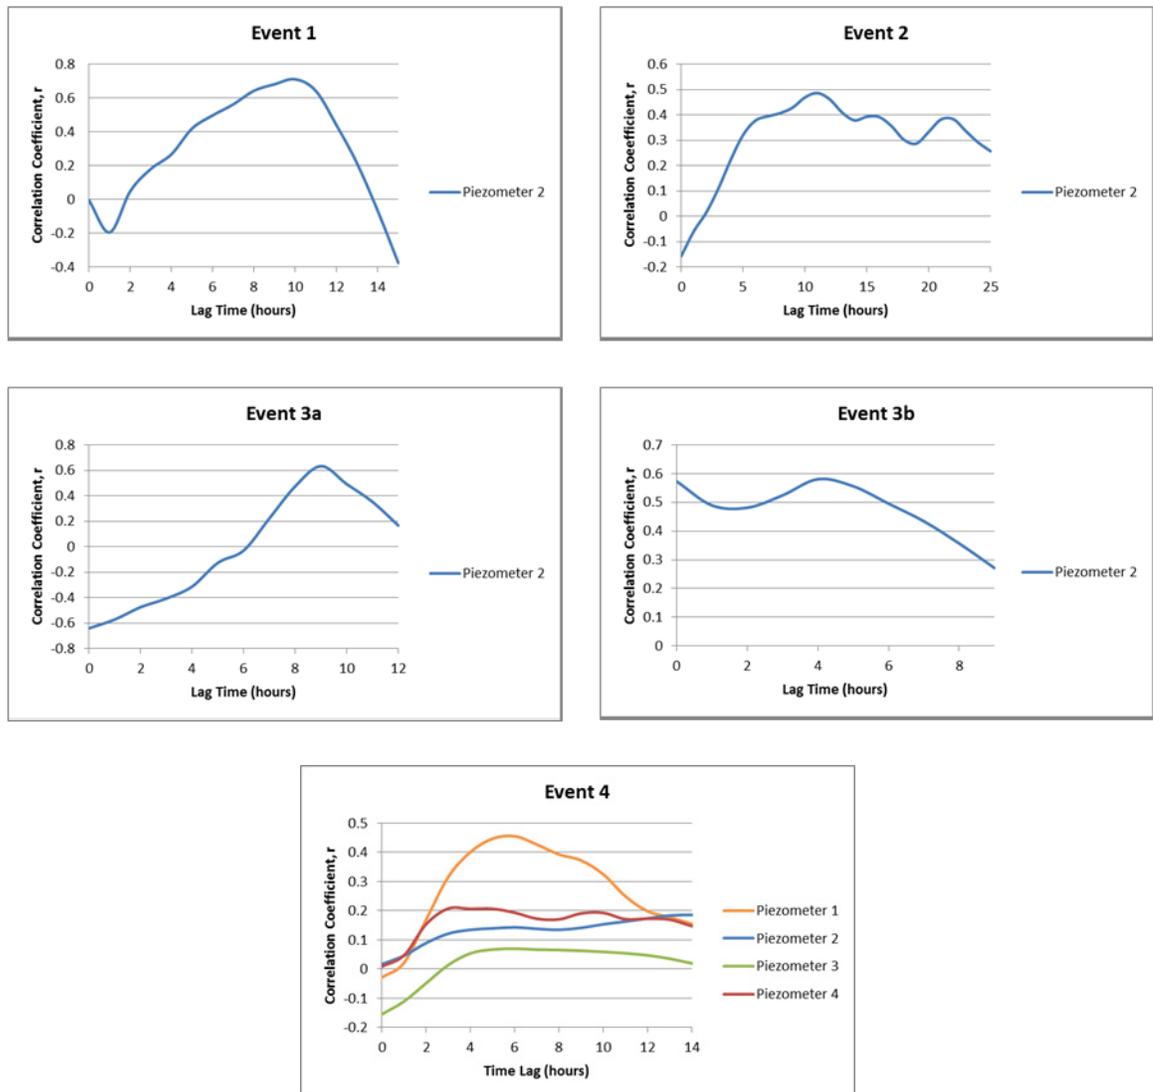
Figure 24. Correlation coefficient, r , and time lag for precipitation events 1-4.

The results suggest that correlation between precipitation events and height of the perched water table is greatly influenced by periods of little to no precipitation within storm events. During periods of light precipitation, antecedent moisture conditions rise but not enough to cause a rise in the perched water table adversely affecting correlation. Consequently, the highest correlations occur when high antecedent moisture conditions are followed by high intensity precipitation and a subsequent dry period. For example, Event 7b followed event 7a by 7 hours and the time lag was short at 4, 5 and 6 hours for piezometers 3, 2 and 4 respectively (Figure 23). This event showed a strong correlation between the amount of precipitation and the water levels in the piezometers. Conversely, event 4 was a series of storms lasting 9.5 days with many periods of no precipitation followed by light precipitation. Because the storms were so close together, there was little correlation between the precipitation and the water-level rise in the piezometers (Figure 24).

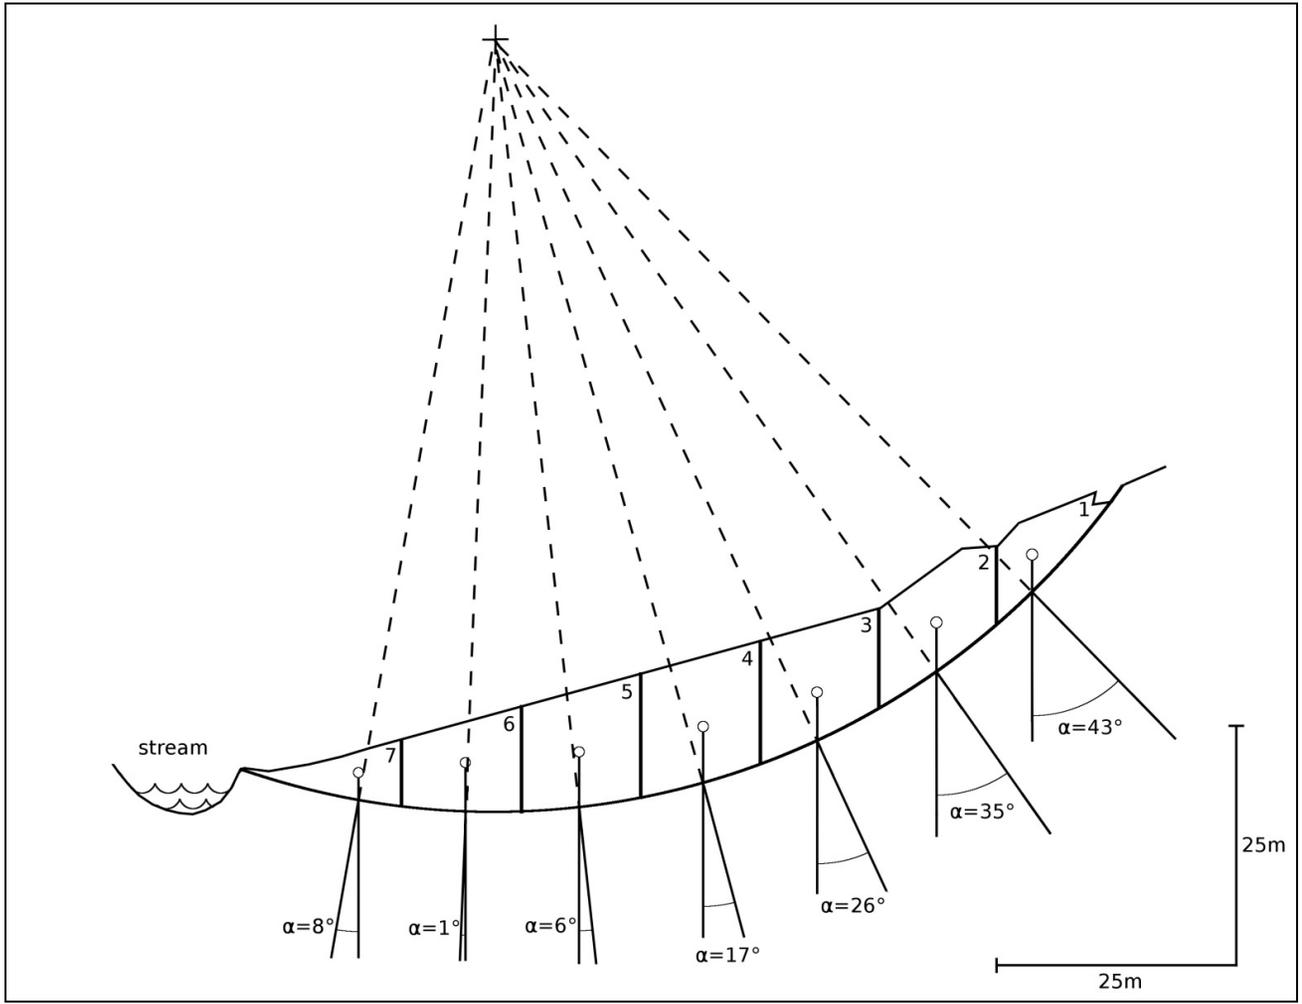
Figure 25. Swedish Method of Slices slope reconstruction and slice division.

The surface topography was reconstructed based on field measurements. An arc was then fitted to the failure surface based on the depth of impermeable layers recorded in GPR transects and the failure divided into seven slices. The center of gravity and associated dropped vertical were then determined for each slice and a radius of the circle extended through the failure plane to determine α , the angle of inclination (Figure 25). From the figure, values for depth, z (m), length of the base, l (m), and area (m^2), could be measured. Slope, β , was determined on a per slice basis from topographic data used in the slope reconstruction.

loam and gravelly loam. Based on average percentages of sand, silt, and clay, deeper slide areas were determined to consist of a sandy clay loam (National Resources Conservation Service, 2012). Corresponding values for the effective cohesion, c' (10 kN/m²) and the angle of internal friction with respect to effective stresses, ϕ' (34°), were obtained from the literature (geotechdata.info, 2013). The unit weight of soil at natural moisture conditions, γ (13.7 kN/m³), was calculated using values for bulk density of the soil (USDA, 2008) and gravity. Pore water pressure, u , was calculated using the equation $u = \gamma_w m z \cos^2 \beta$ where the pore pressure variance, m , represents the height of the perched water table above the impermeable surface divided by the depth of the slice. For a value of $m = 1$ the water table is at the ground surface, whereas for $m = 0$, the water table is just below the slide plane. For the purposes of this study m was varied to determine what fraction of saturated soil thickness above the slide plane would be needed for failure to occur. Slices 6 and 7 were assigned a negative driving force value because they were assumed to resist sliding (Appendix A).

The model was run several times to determine how high the perched water table needed to be to instigate slope instability. The results suggest that when the pore pressure variance, m , is equal to 0.5, the factor of safety, F , is equal to 1 (Figure 26). Perched water tables that sat at levels greater than half the distance up from the failure surface in the soil column would cause the slope to be unstable, while those sitting at less than half the distance would allow the slope to remain stable. Field measurements indicate that two of the piezometers in the lower section of the slide consistently showed the water table to be within 1 meter of the surface during and after precipitation events. For example, Piezometer 2, located near the creek, was within six inches of the ground
