**NONWOVEN PAVING FABRICS STUDY**  
**FINAL REPORT**

**Industrial Fabrics Association International**  
**Geotextile Division**

**Maxim Technologies, Inc.**  
**4150-B Freidrich Lane**  
**Austin, Texas 78744**

December 1997

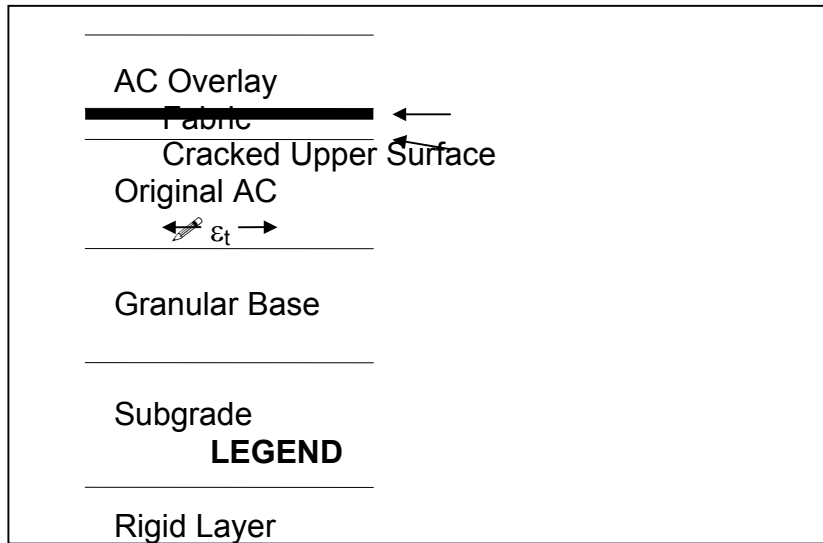
**Sketch 1. Structural Model**

MODEL SOLVED FOR  $F_L$  (FATIGUE LIFE) TO BE EQUAL  
 (i.e.,  $\epsilon_t = \epsilon_t'$  thus  $T_{ol} < T_{ol}'$ )

Layer	Model without Fabric		Model with Fabric*	
	Thickness	Modulus	Thickness	Modulus
AC Overlay	$T_{ol} = 2-6''$	$E_0 = 500 \text{ ksi}$	$T_{ol}' < T_{ol}$	$E_0' = E_0$
Fabric	N/A	N/A	$T_f = 0.15''$	$E_f' = 5 \text{ ksi}$
Cracked Upper Section	N/A	N/A	$T_{top}' = 0.25''$	$E_{1top}' = 750 \text{ ksi}$
Original AC	$T_{orig} = 2-6''$	$E_1 = 500 \text{ ksi}$	$T_{orig}' + T_{top}' = T_{orig}$	$E_1' = E_1$
Granular Base	$T_{base} = 6''$	$E_2 = 25 \text{ ksi}$	$T_{base}' = T_{base}$	$E_2' = 2 * E_2$
Subgrade	$D_{rl} = 5-30'$	$E_3 = 2.5-15 \text{ ksi}$	$D_{rl}' = D_{rl}$	$E_3' = 2 * E_3$

\* Improved soil support provided by moisture control offered by fabric.

1. The Structural Design Model - Accounts for the equivalent thickness contribution of paving fabrics. Sections with and without fabric are modeled to provide an equal performance (fatigue life).
2. The Environmental Design Model - Accounts for the equivalent thickness contribution of paving fabrics. Sections with and without fabric are modeled to provide an equal serviceability - performance life (number of 18 kip ESAL to deteriorate from Initial Present Serviceability Index to Terminal Present Serviceability Index).

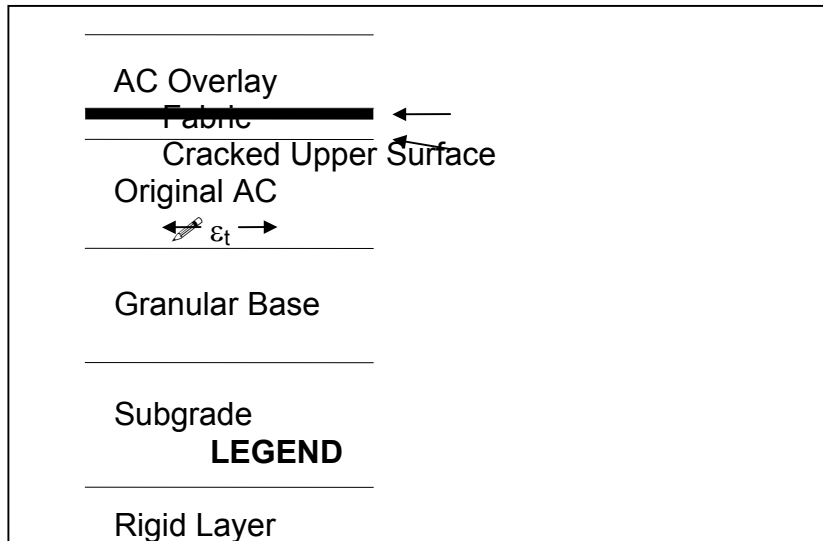
**Sketch 2. Environmental Design Models**

MODEL SOLVED FOR  $N_{ESAL}$  to  $p_i=2.5$  EQUAL SERVICEABILITY LOSS  
 (considering AASHTO Soil Swelling and Heaving algorithms)

Layer	Model without Fabric		Model with Fabric <sup>*1</sup>	
	Thickness	Modulus	Thickness	Modulus
AC Overlay	$T_{ol} = 2-5''$	$E_0 = 500 \text{ ksi}$	$T_{ol}' = T_{ol}$	$E_0' = E_0$
Fabric	N/A	N/A	$T_f = 0.15''$	$E_f' = 5 \text{ ksi}$
Cracked Upper Section	N/A	N/A	$T_{top}' = 0.25''$	$E_1' = 750 \text{ ksi}$
Original AC	$T_{orig} = 2-6''$	$E_1 = 500 \text{ ksi}$	$T_{orig}' + T_{top}' = T_{orig}$	$E_1' = E_1$
Granular Base	$T_{base} = 6''$	$E_2 = 25 \text{ ksi}$	$T_{base}' = T_{base}$	$E_2' = 2 * E_2$
Subgrade <sup>*2</sup>	$D_{rl} = 5-30'$	$E_3 = 2.5-15 \text{ ksi}$	$D_{rl}' = D_{rl}$	$E_3' = 2 * E_3$

<sup>\*1</sup> Improved soil support provided by moisture control offered by fabric.

The environmental design module for paving fabric applications in AC overlays is based on the AASHTO pavement design serviceability concept, as a function of road roughness (i.e. slope variance), because of the major impact of a number of environmental parameters (Figure 13). The other parameters involved in the AASHTO flexible pavement serviceability concept i.e., cracking and patching, as well as rutting, are principally load induced phenomenon and are believed to be addressed in the structural design model. The installation of a paving fabric reduces the infiltration of surface water and maintains the moisture contents at or near existing levels. This combination of benefits offers significant control of the subsequent amount of soil swell, shrinkage and heave and, by inference, the amount of road roughness (i.e. slope variance). The basic approach used in this module consists of the definition of equivalent designs with reduction in the required AC overlay thickness with the addition of a paving fabric.

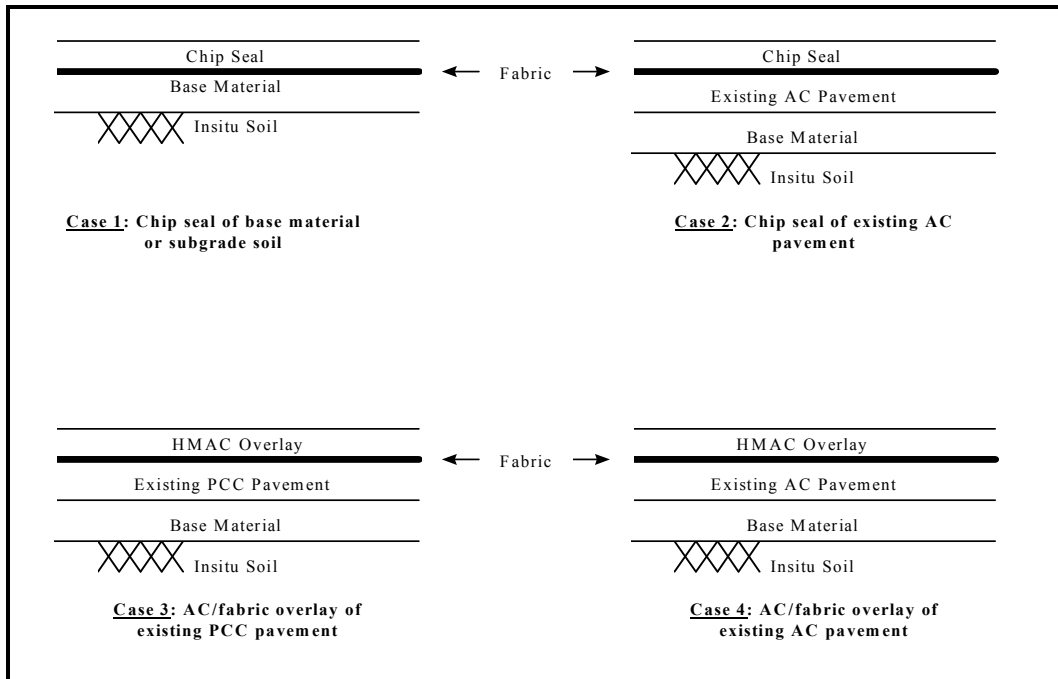
Figure 1. Correct Typical Uses of Nonwoven Paving Fabrics

found 4 principal end use applications of the nonwoven paving fabric system: 1) Paving fabric with a chip seal over unpaved roads and subgrades, 2) Paving fabric and chip seal over existing AC (Asphalt Cement Concrete) pavements, 3) Paving fabric and AC overlay over existing PCC (Portland Cement Concrete) pavements, and 4). Paving fabric and AC overlay over existing AC pavements. Most applications included an asphalt cement concrete overlay (Conditions 3) and 4) and the comments of this summary are based on those conditions. These four basic applications are illustrated in Figure 1.

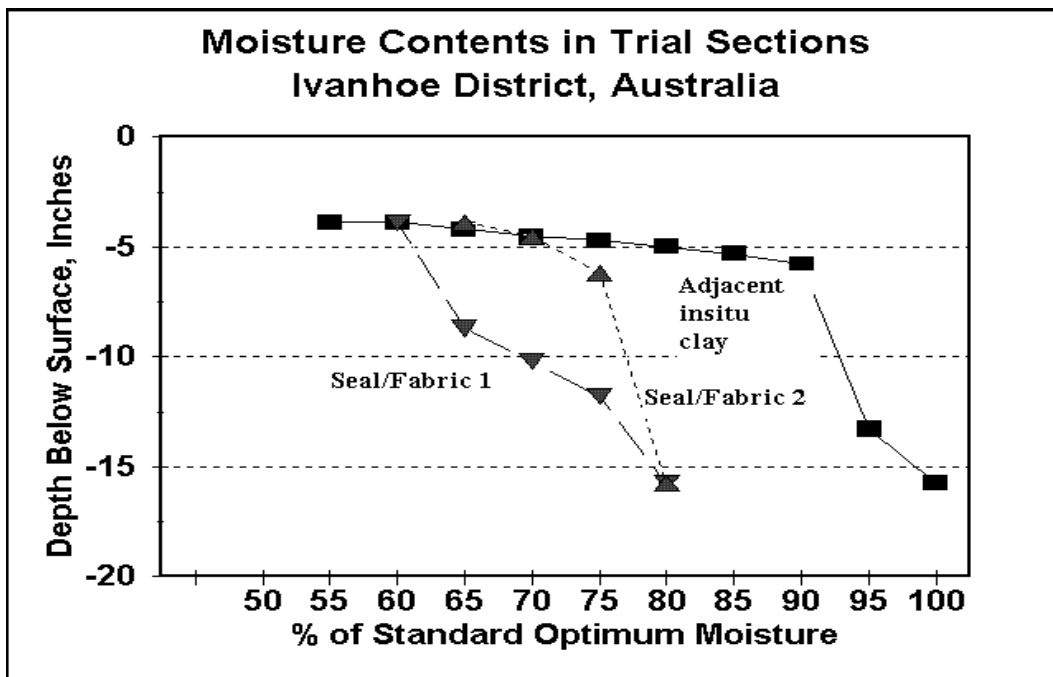
Figure 2. Subgrade Moisture Content Condition - Ivanhoe, Australia Case Study (Ref. 2)

The rationale for the development of uniform subgrade support under these circumstances can be better understood in reviewing the moisture distribution with depth for the Ivanhoe, Australia case study (Ref. 2). In Figure 2, moisture distributions are defined in terms of depth below the top of seal or existing subgrade surface associated with the insitu moisture content as a percentage of the standard optimum moisture content. The results shown were acquired in August 1988, about twenty (20) months after construction and after two months of wet weather (about 4 inches of rain in the months of June and July).

It can be seen from the results that the moisture content for the soils underlying the seal/fabric sections was 15 to 25 percent lower than the moisture contents for adjacent insitu soils located outside the influence of the fabric placement. During the Ivanhoe, Australia case study the moisture content of the soils underlying the fabric sections remained within  $\pm 2$  percent regardless of the season of the year (i.e. between the dry and wet seasons). From these results, the fabric provided not only protection from infiltration of free surface water but it also maintained a uniform subgrade moisture regime through control of subgrade moisture gain and loss.

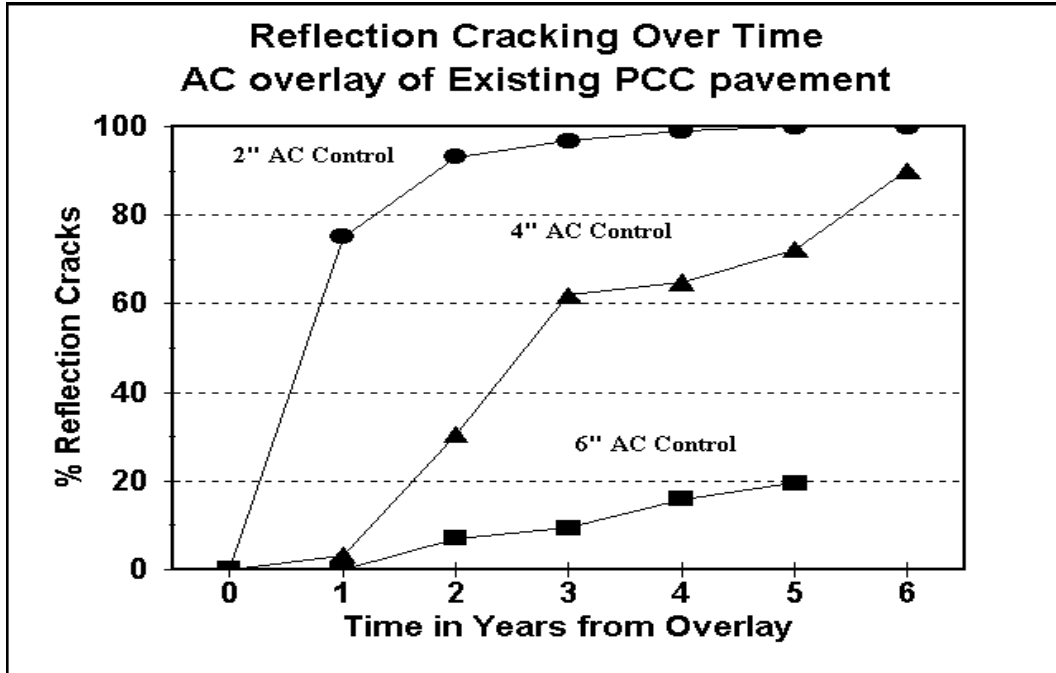
Figure 3. AC Overlay of Existing PCC Pavements - Atlanta, Georgia Case Study (Ref. 11)

A case study in Georgia (Ref. 11) provides important information concerning the impact in rehabilitation overlays involving AC overlay thickness alone (Figure 3) and the combination of AC overlay thickness with fabric (Figure 4) on the eventual development of reflection cracking related to original conditions of PCC pavements. From Figure 3 it can be seen that reflection cracking at a 60 percent level can be anticipated at one year for a 2" AC overlay; three years for a 4" overlay and nine years for a 6" AC overlay. In the same study (Ref. 11) the impact of the combination of AC overlay with paving fabric was also investigated and the results are presented in Figure 4. The 60 percent performance levels, based on percent reflection cracking, was three years for a 2" AC overlay with fabric, and six years for a 4" AC overlay with fabric. The 60 percent performance time for the 6" AC overlay with fabric, could not be reasonably be projected because of the low level of percent reflection cracking achieved during the observation period.

It can be noted from Figures 3 and 4 that the addition of a paving fabric to a 2" AC overlay increased the time to 60 percent reflection cracking from one year with no fabric to three years with fabric. With this information in mind the results from Figures 3 and 4 were combined in Figure 5 to allow a visual assessment of the benefit of paving fabric in the rehabilitation overlay of existing PCC pavements. From Figure 5, it is apparent that the 2" AC/fabric section is equivalent to the 4" AC control section since one plots practically on top of the other. The inference is that an equivalent

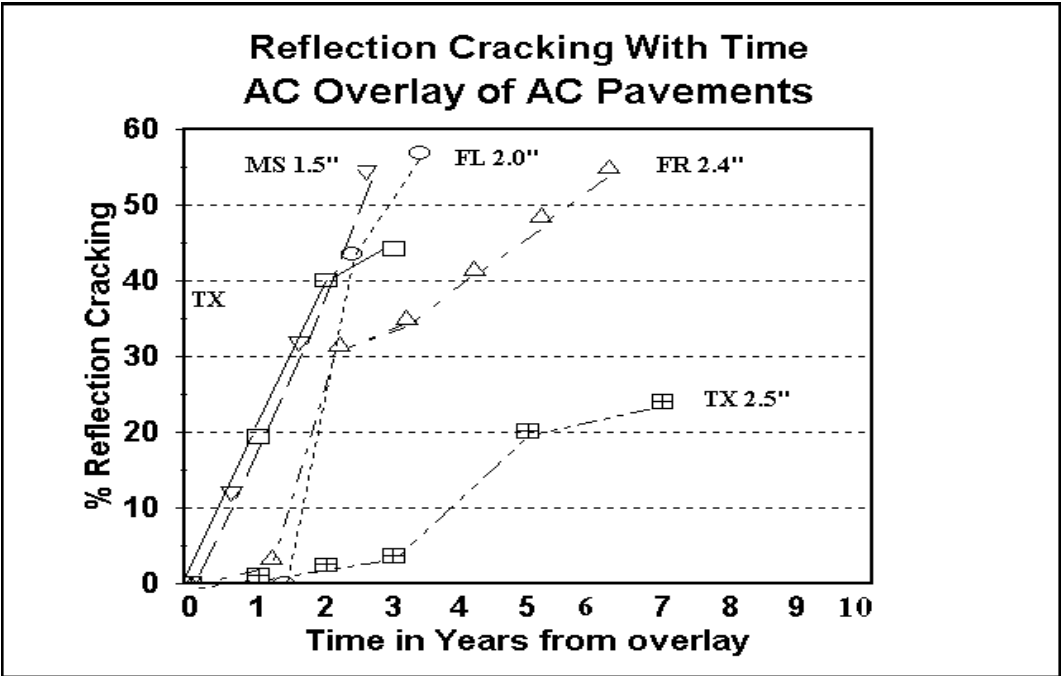
Figure 6. AC Overlay of AC Pavements - Various Case Studies (Refs. 11, 17)

The results from a Texas case study (Ref. 17) and a combination of results from several other case studies (Refs. 11) provide information on improvement in performance of AC overlay of existing AC pavements which include paving fabrics. In Figure 6 the impact of AC thickness on the performance of the AC overlay without fabric, as defined by percent reflection cracking, can be observed. The AC overlays of 1.25", 1.5" and 2.0" display similar times to development for various percent reflection cracking, while AC thickness of 2.4" and 2.5" display significantly better performance in retarding reflection cracking. The greater thickness overlays (i.e. 2.4" and 2.5") demonstrate 2 to 3 times the performance of the thinner overlays (i.e. 2" and less). In addition the 1.25" and 1.5" AC overlays exhibited almost immediate reflection cracking (i.e. 10 to 20 percent in the first year), while the 2.0" and thicker AC overlays appear to forestall the initiation of reflection cracking for a 1 to 2 year period.

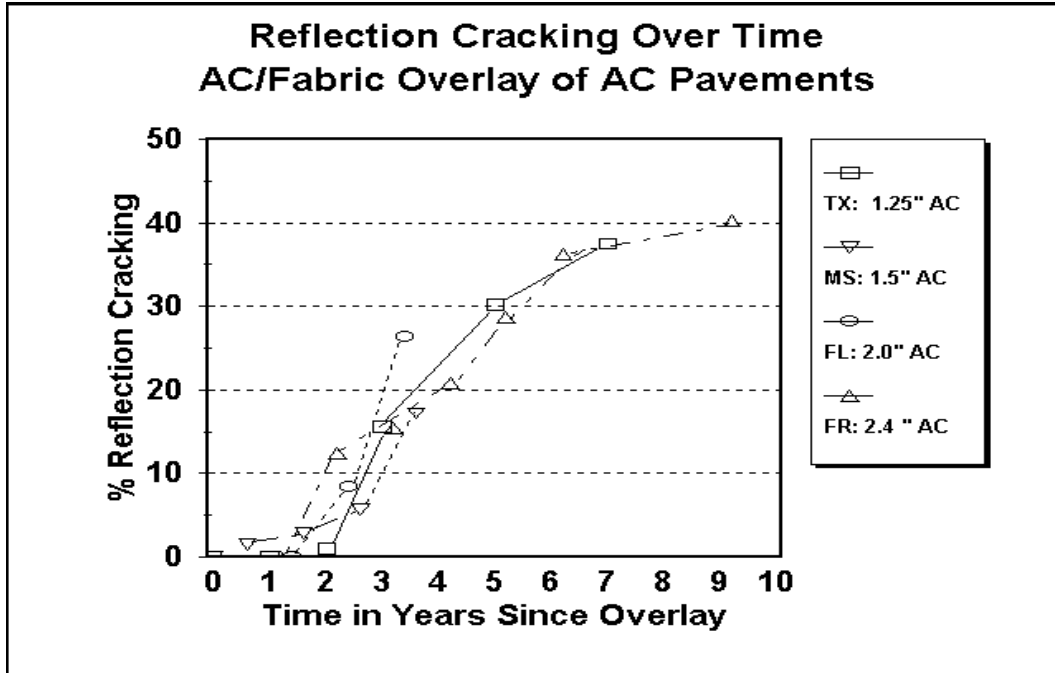
Figure 7. AC/Fabric Overlay of Existing AC Pavements - Various Case Studies (Ref. 11, 17)

The companion AC/fabric trial sections to those AC overlay sections of Figure 6 are presented in Figure 7. It is interesting to note that the performance trends for these case studies related to reflection cracking are essentially the same regardless of the thickness of the overlying AC thickness. From the Figures it can be seen that approximately 10 percent cracking developed within 3 years, 20 percent in 3 1/2 years and 40 percent within 9 years. These numbers (from Figure 7) can be compared directly with the results for the thinner (i.e. 1.25", 1.5" and 2.0") AC overlay control trial sections (Figure 6), where 10 percent reflection cracking occurred within 1/2 to 1 1/2 years, 20 percent reflection cracking occurred within 1 to 1 1/2 years, and 40 percent reflection cracking occurred within 2 years. For instance, at a 25 percent level of reflection cracking the inclusion of fabric in AC overlays enhanced the performances of the 1.25" and 1.5" AC overlays by a factor of 3 (i.e. 4.5 years versus 1.5 years), the performance of the 2.0" AC overlay by a factor of 1.75 (i.e. 3.5 years versus 2 years) and the performance of the 2.4" AC overlay by a factor of 2.5 (i.e. 5 years versus 2 years).

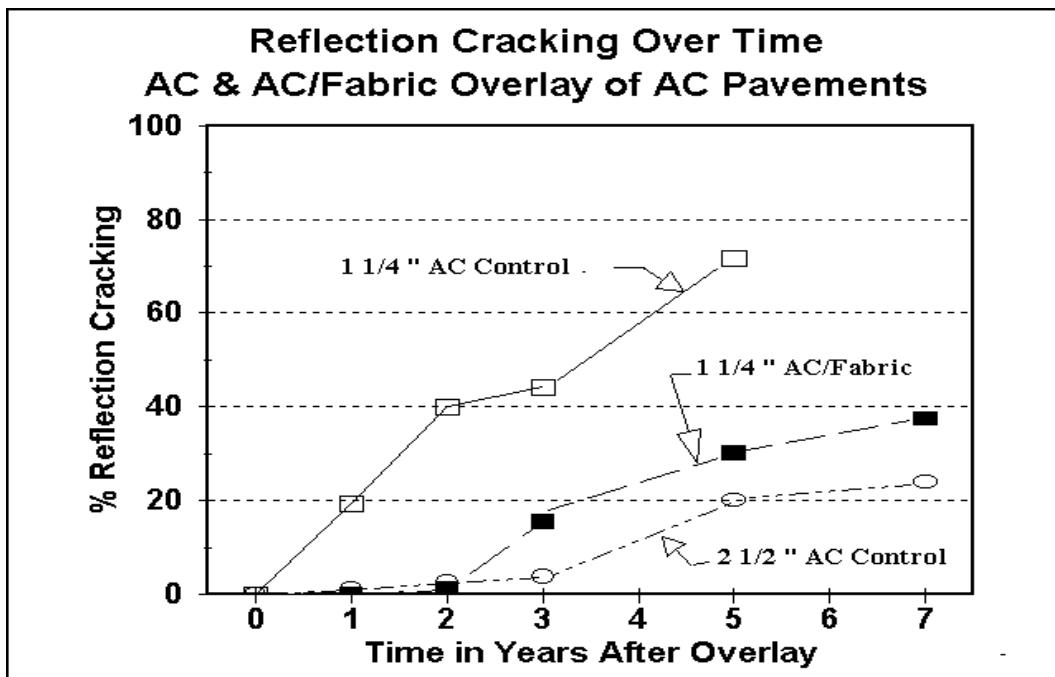
Figure 8. AC and AC/Fabric Overlay of AC Pavements - Odessa, Texas Case Study (Ref. 17)

In the Texas case study (Ref. 17) relatively thin AC overlays (i.e. 1.25") were constructed in the Odessa, Texas area. As Figure 8 shows, when the AC overlay thickness was increased from 1.25" to 2.5" (i.e. doubled) the period of time until 25 percent of the original AC pavement cracks reflected through the AC overlay was increased from 1 1/4 years to 7 years, a significant increase in performance. In addition the inclusion of a paving fabric with a 1.25" AC overlay increased the period of time within which 25 percent reflection cracking had developed from 1 1/4 years to 4 1/2 years. Because of the similarity in the time based reflection cracking results for the 1.25" AC overlay with fabric and the 2.5" AC overlay without fabric, it can be inferred that an equivalent AC to fabric thickness of about 1 to 1.25 inches may be appropriate for the conditions similar to Odessa, Texas.

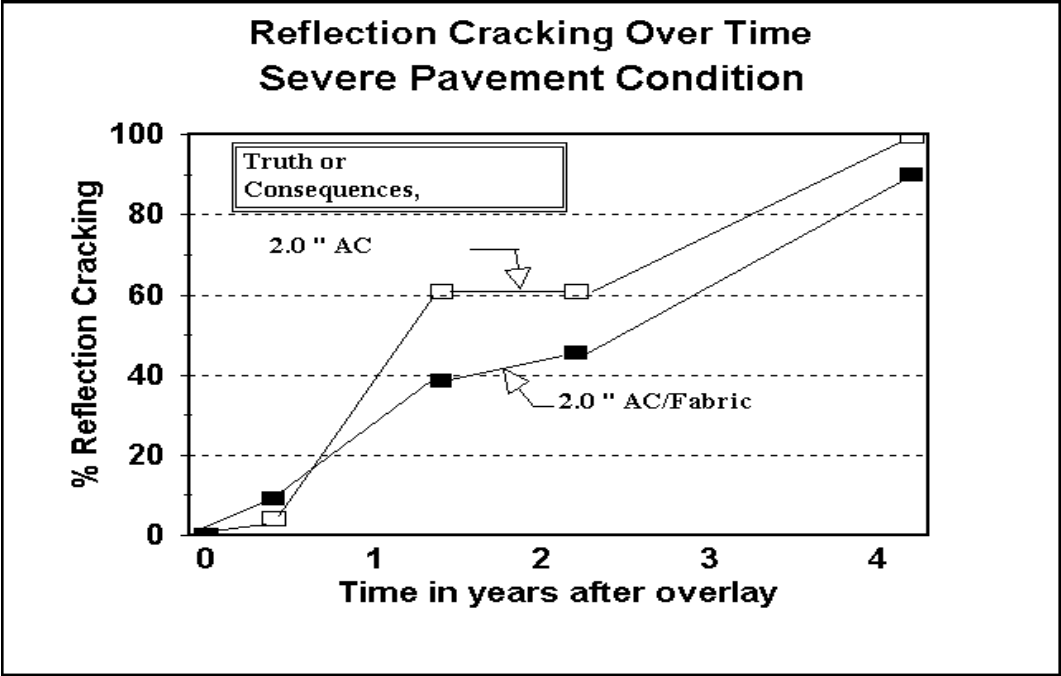
Figure 9. AC/Fabric Overlay of AC Pavement - Severe AC Pavement Condition - New Mexico Case Study (Ref. 31)

An example of the impact of inadequate preparation of existing pavement conditions on the performance of an AC/fabric overlay is presented in Figure 9. In this case study (Ref. 31) initial severe pavement condition led to almost immediate initiation of reflection cracking in both the control AC overlay and AC/fabric trial sections. In this instance the performance in terms of reflection cracking of the AC/fabric section was only marginally better (i.e. about a half year) than

the control AC overlay section. The paving fabric can be expected to bridge over small, thin cracks without the need for crack filling; however severe cracking of significant width (>0.25") and depth must be appropriately addressed during construction of the rehabilitation overlay. Adequate surface preparation procedures are well addressed in paving fabric manufacturers' literature and should be followed.

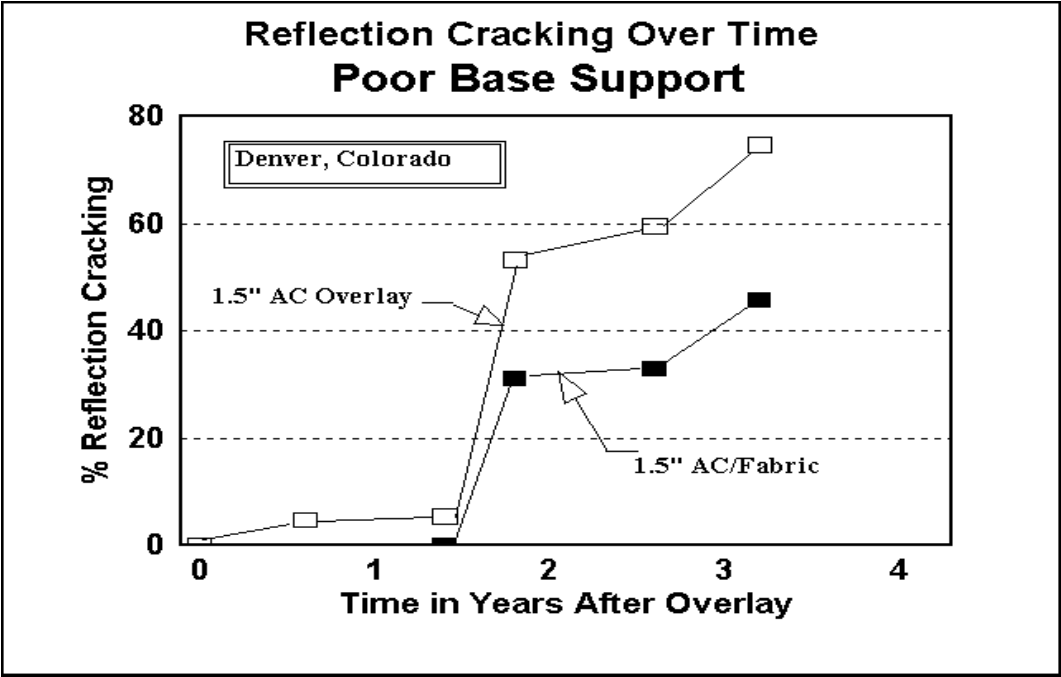
Figure 10. AC and AC/Fabric Overlay of AC Pavements - Poor Base Support - Denver, Colorado Case Study (Ref. 11)

A case study (Ref. 11) involving poor base support is presented in Figure 10. From the Figure it can be seen that the fabric delayed the initiation of reflection cracking for about 1 1/2 years; however the reflection cracking after the initial period essentially tracked the development of reflection cracking in the AC control section at about a 1 year delay in time. Based on these results, it is important to address and correct any inadequacy in the existing pavement structure during the rehabilitation overlay design phase. Inclusion of fabric alone can not be expected to resolve existing structural inadequacies. Even though short lived, the fabric section provided twice as much time until cracks appeared.

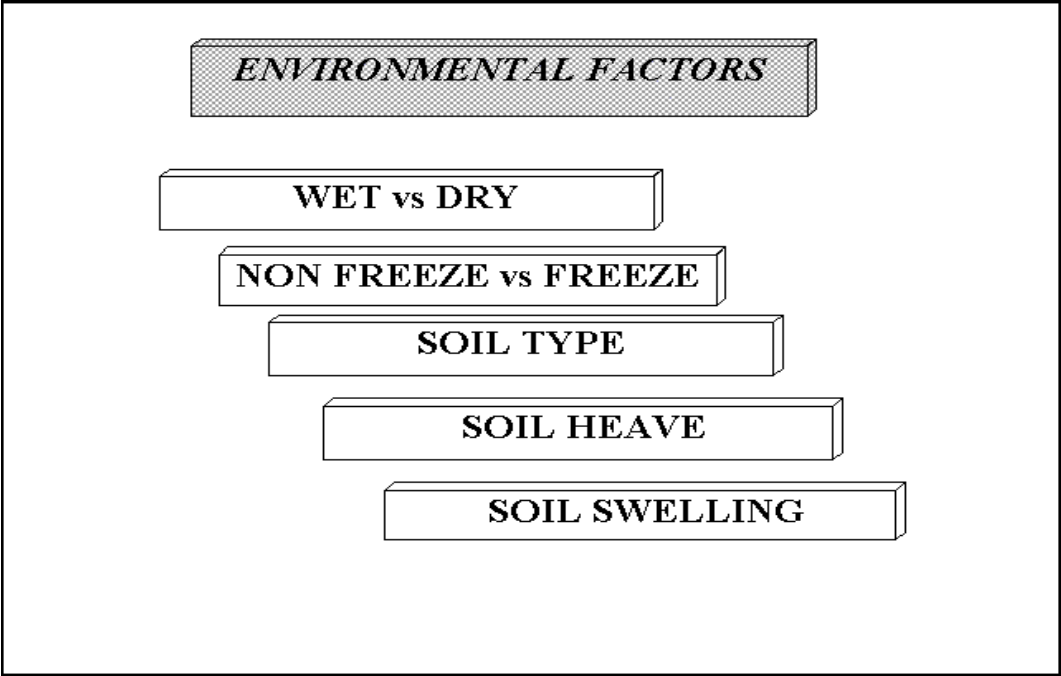
Figure 13. Environmental Factors Considered for Rehabilitation Overlays with Fabric

One of the principal requirements of this research effort was the development of technically based justification for the use of paving fabric in pavement overlay design. In order to assure broad based acceptance, use and application of the method, the AASHTO flexible pavement structural design procedure, supplemented by elastic layer theory analytical techniques was used in the development of recommendations. This approach considers the fundamental impact of vehicular loading, pavement structure, and the influence of environmental effects on pavement roughness development (or increased serviceability losses) on the layers of the pavement overlay. The final procedure incorporates the benefits of paving fabrics (Figure 12) in AC overlay rehabilitation and considers of environmental factors (Figure 13), as well as pavement structural conditions (Figure 14).

The factors selected for the AC overlay analysis (Figures 13 and 14) include general moisture classification (wet or dry region), temperature or climatic designation (freeze or non freeze zones), subgrade type (fine, mixed or coarse grained soils), subgrade support characteristics (resilient modulus), geological formations (depth to underlying rigid layer), existing pavement structure (existing AC thickness), as well as the proposed pavement improvements (overlay thickness) for the proposed project site.

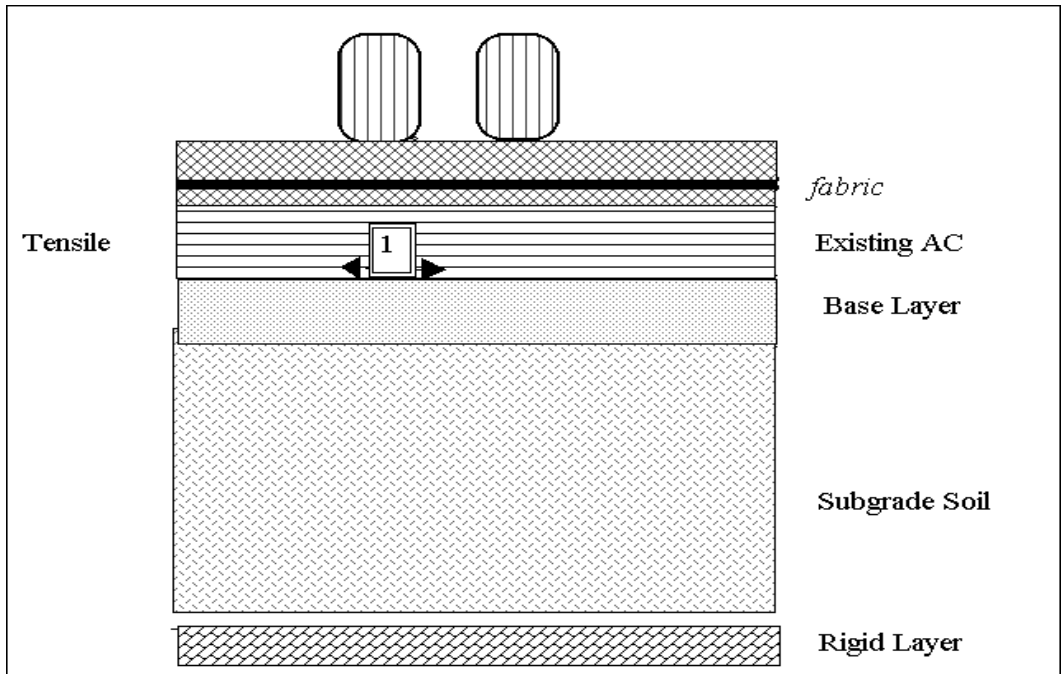
Figure 15. Tensile Strain Criteria Based on Strain at Bottom of Existing AC Layer

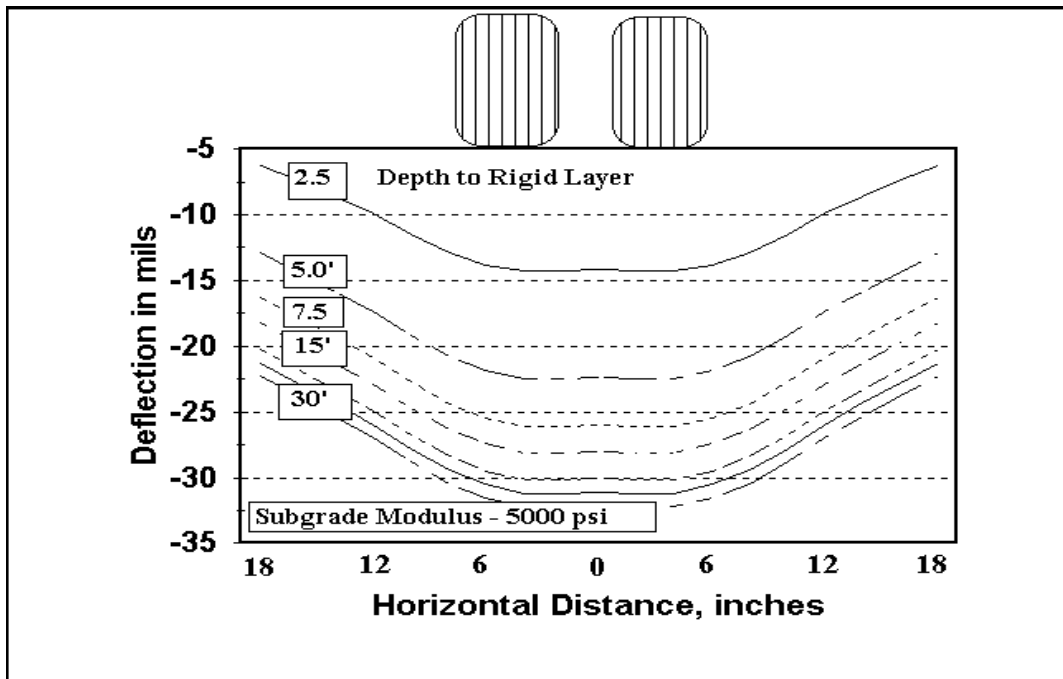
Figure 16a. Effect of Rigid Layer Depth on Deflection Value

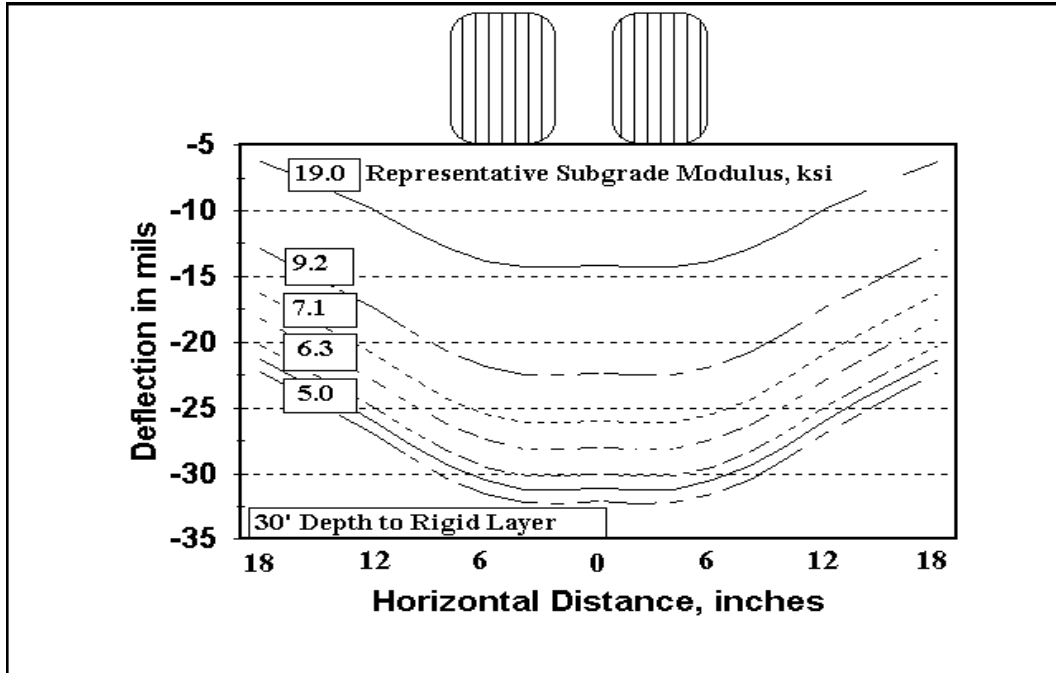
Figure 16b. Effect of Subgrade Modulus on Deflection with a 30 ft Depth to Rigid Layer

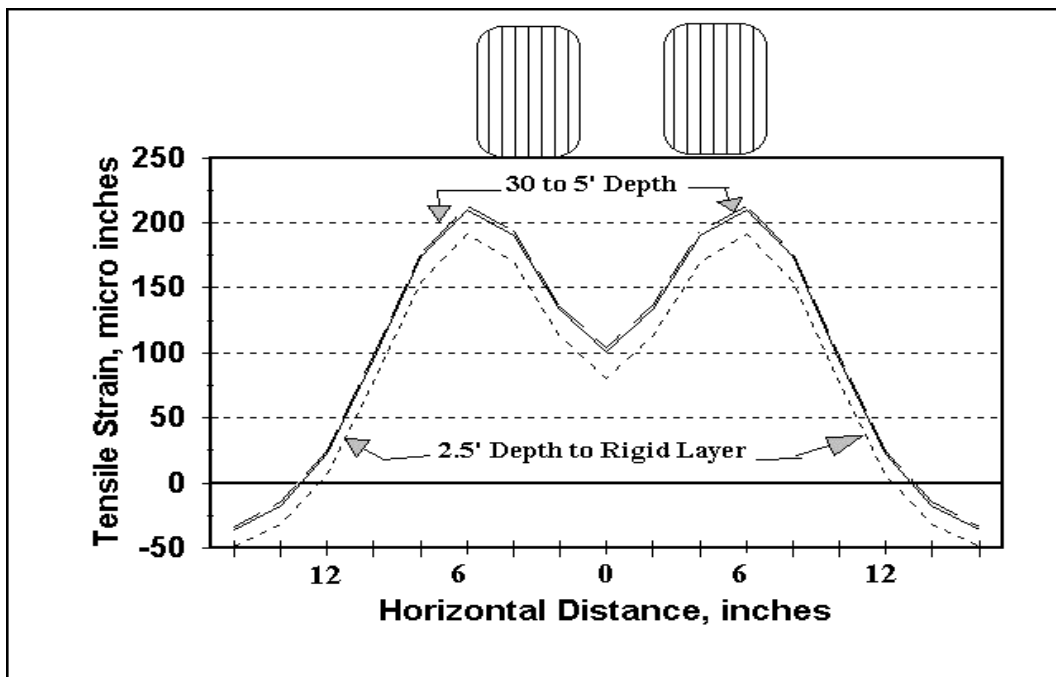
Figure 17. Effect of Depth of Rigid Layer on Tensile Strains at the Bottom of the Existing AC Layer

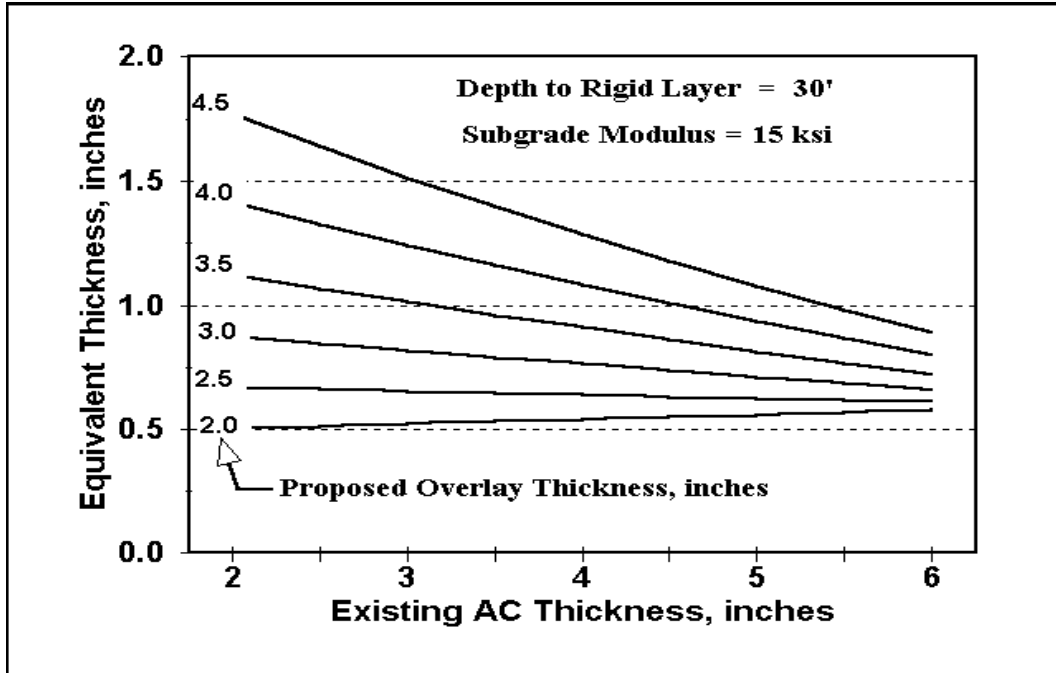
Figure 18. Equivalent Thickness ( Amount of Reduction in AC Overlay Thickness) Nomograph for a Strong Subgrade Modulus and Deep Rigid Layer

psi) condition and little influence of an actual or perceived underlying rigid layer (i.e. depth to rigid layer of 30'). The second case (Figure 19) displays the relationship between the equivalent AC-fabric overlay thickness and combinations of existing AC thickness and proposed conventional AC overlay thickness for weak soil support (resilient modulus of 5,000 psi) condition and strong influence by an actual underlying rigid layer (i.e. depth to rigid layer of 5'). The first nomograph (Figure 18) would represent a pavement located in a relatively dry (i.e. drier soil condition) plains area (no rock outcroppings), while the second nomograph (Figure 19) would represent a pavement section located in a wet (i.e. low soil modulus), mountainous (shallow depth to rigid layer) area.

For a dry, plains area (Figure 18), the AC-fabric equivalent overlay thickness values range from 0.5" to 1.75", respectively for a thin (i.e. 2") and thick (i.e. 4.5") proposed AC overlays of a thin existing AC pavement (i.e. 2") thickness. On the other hand the AC-fabric equivalent thickness values cover a minimal 0.6 to 0.9" range for the thicker original AC pavements (i.e. 6"). It should be noted that the 1.75" value compares well with the 0.15' (or 1.8") guideline for AC -fabric replacement thickness advocated by the State of California.

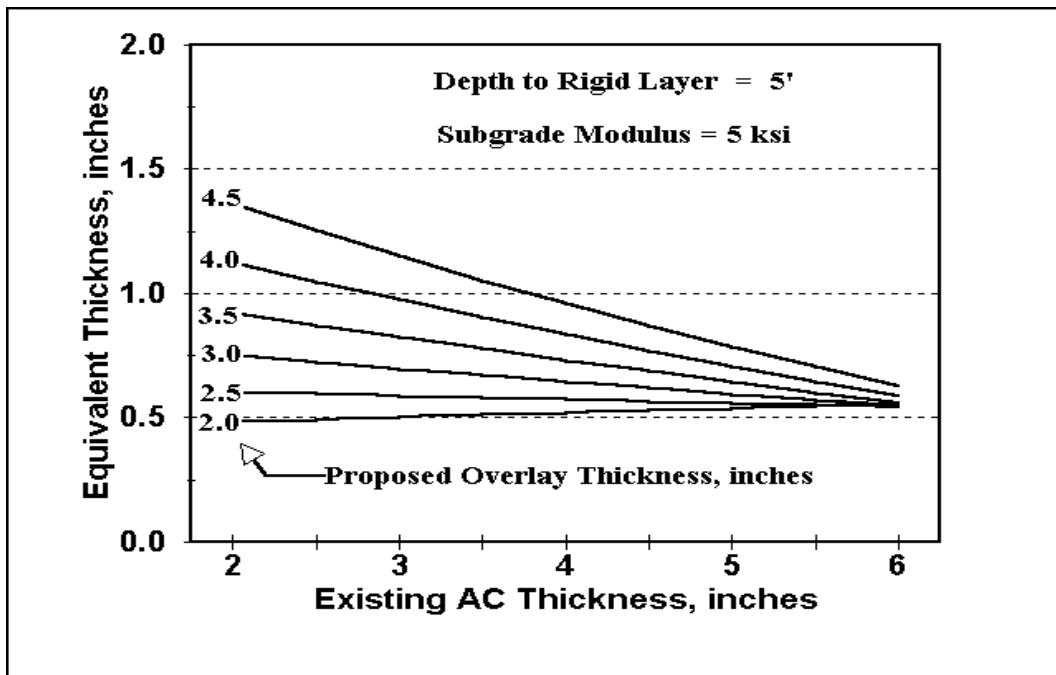
Figure 19. Equivalent Thickness ( Amount of Reduction in AC Overlay Thickness) Nomograph for a Weak Subgrade Modulus and Shallow Rigid Layer

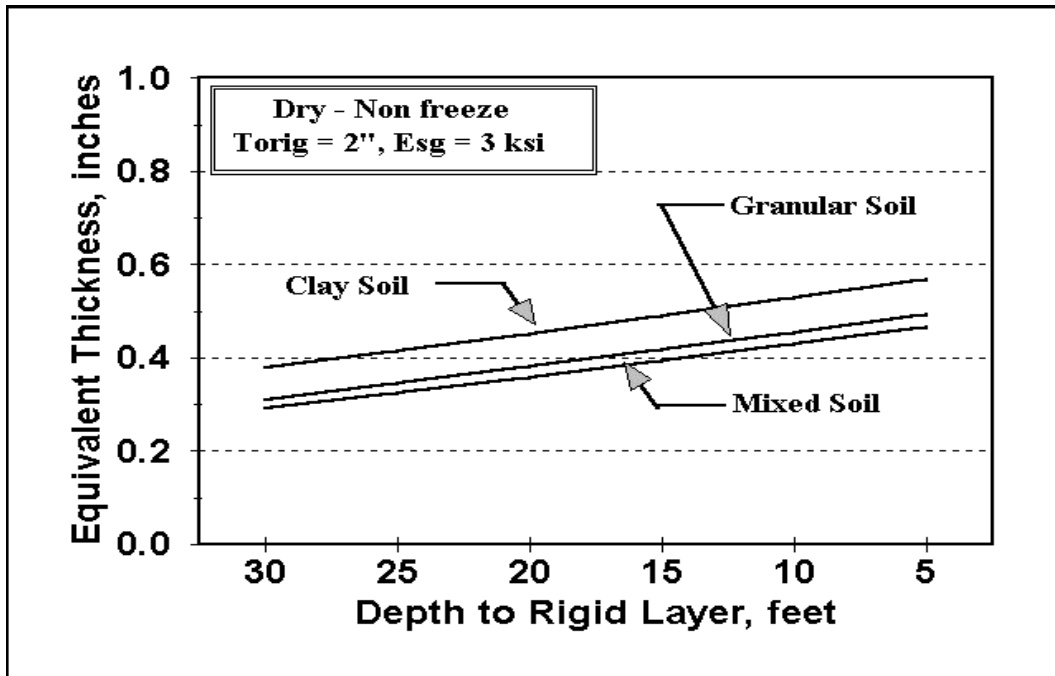
Figure 20. AC/Fabric Equivalent Thickness ( Amount of Reduction in AC Overlay Thickness) Nomograph for Dry-Non Freeze Zones

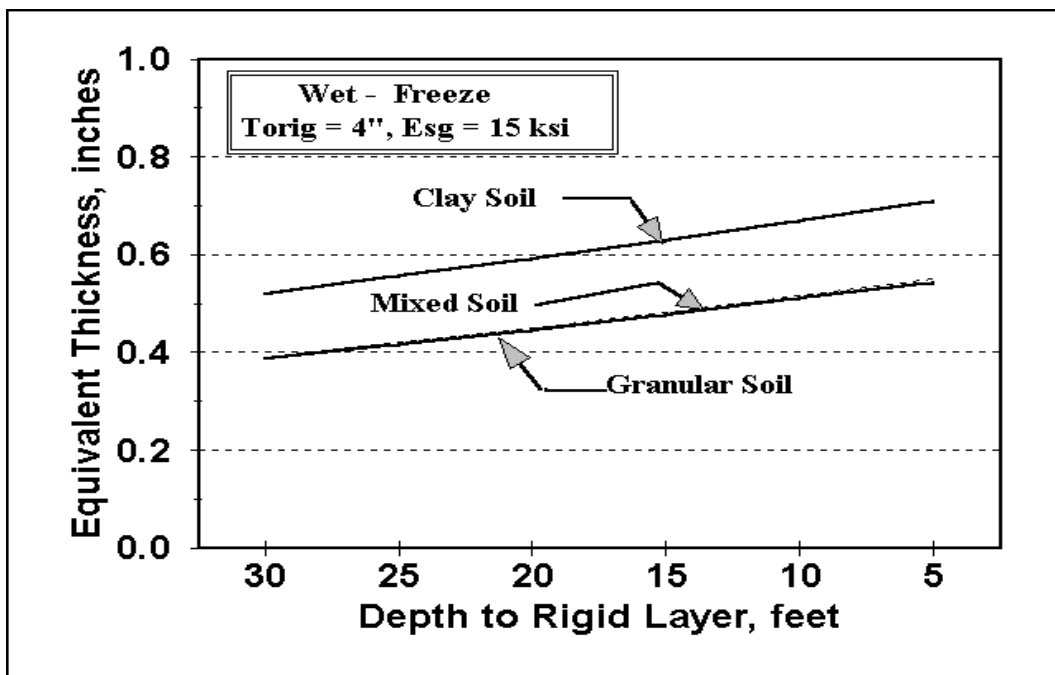
Figure 21. AC/Fabric Equivalent Thickness ( Amount of Reduction in AC Overlay Thickness) Nomograph for Wet-Freeze Zones

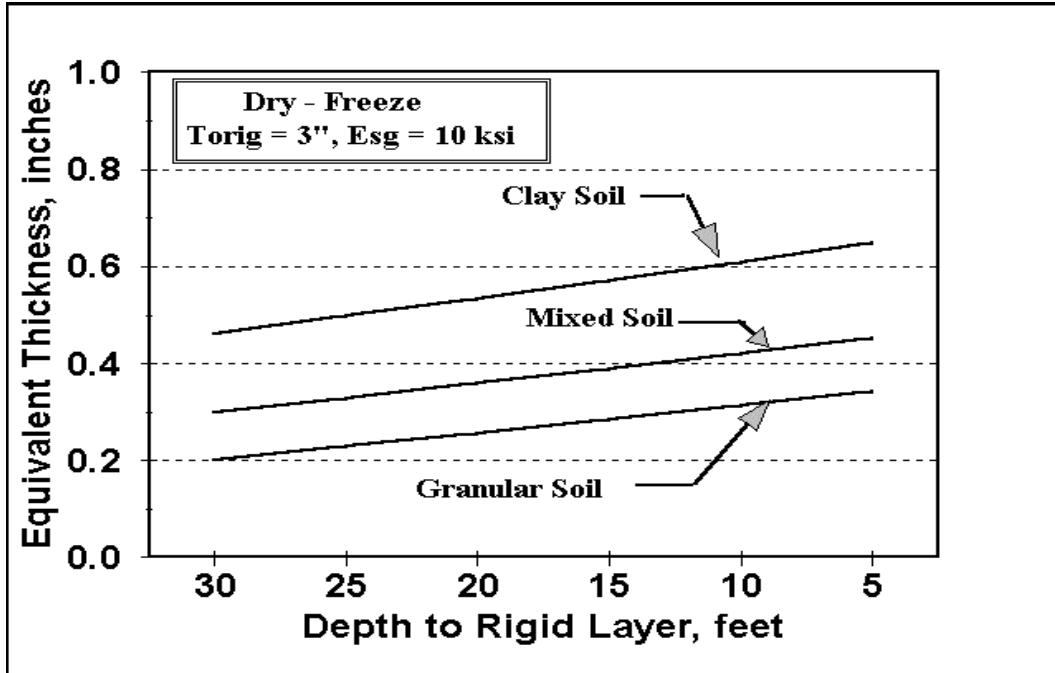
Figure 22. AC/Fabric Equivalent Thickness ( Amount of Reduction in AC Overlay Thickness) Nomograph for Dry-Freeze Zones

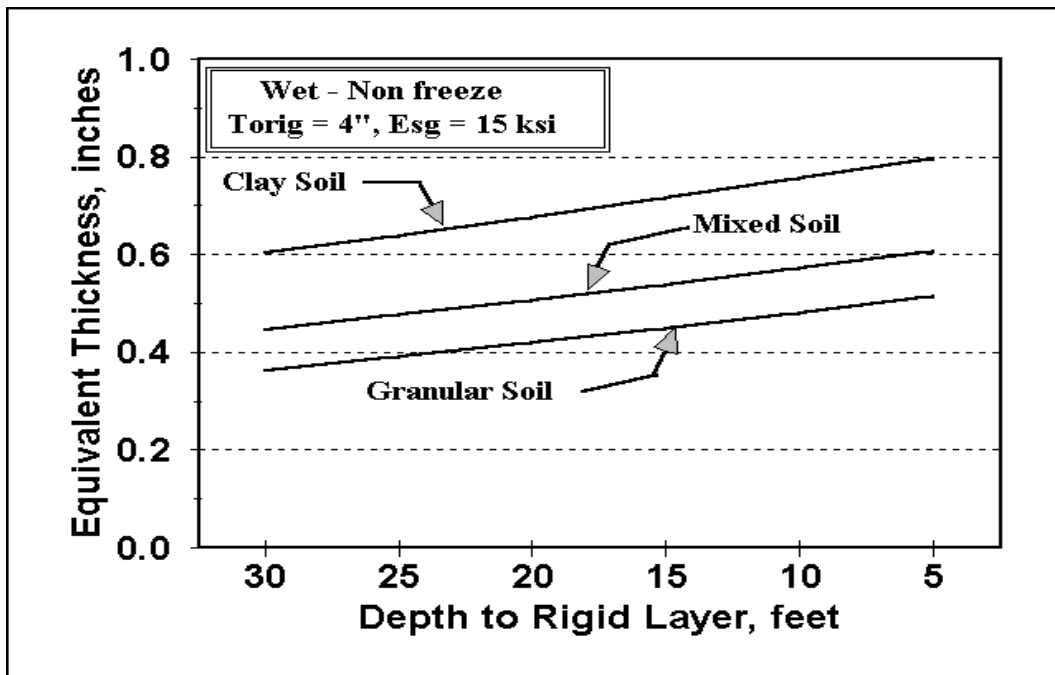
Figure 23. AC/Fabric Equivalent Thickness ( Amount of Reduction in AC Overlay Thickness) Nomograph for Wet-Non Freeze Zones
