## Preventing Interlayer Bonding Failures in Asphalt Pavement

*This brief summarizes Project 0092-02-13, “Evaluation of Interlayer Bonding in HMA Pavements,” produced through the Wisconsin Highway Research Program for the Wisconsin Department of Transportation Research Program, 4802 Sheboygan Ave., Madison, WI 53707.*

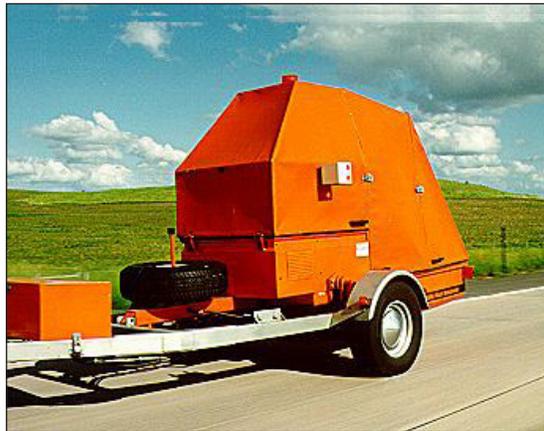
A falling weight deflectometer can identify the extent of delamination, or de-bonding, between pavement layers.

Stiffness ratios, a comparison of the stiffness or stability of the top layer to that of the second layer, were determined with the help of a falling weight deflectometer. High deflection measurements should indicate stiff, well-bonded pavement structures.
